Garhwal Earthquake of Oct. 20, 1991

EERI Special Earthquake Report, EERI Newsletter, Vol.26, No.2, February 1992

Sudhir. K. Jain, Ramesh P. Singh, Vinay K. Gupta and Amit Nagar
Department of Civil Engineering
Indian Institute of Technology Kanpur

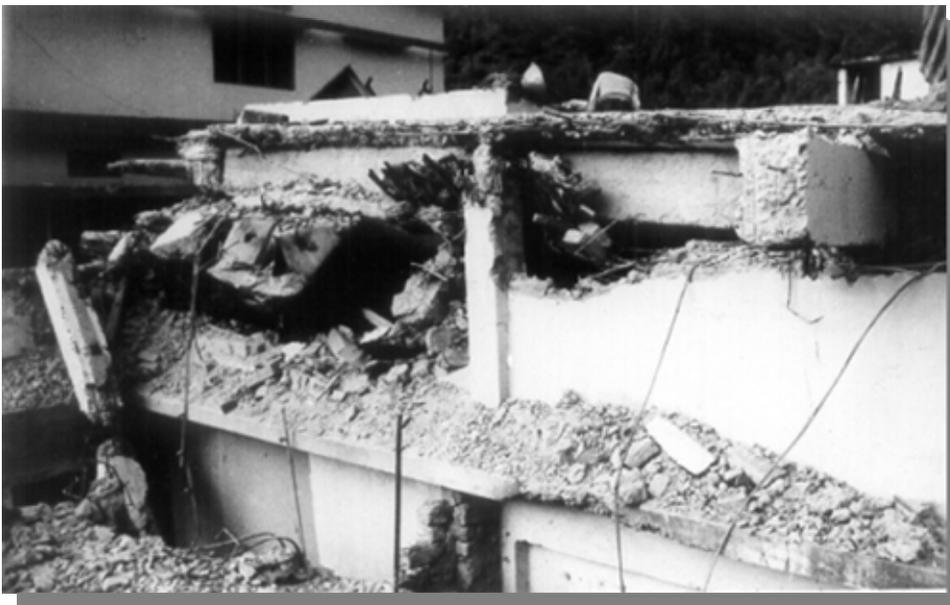
Figure 2 shows the State Bank building in Uttarkashi. During the earthquake, the upper two stories collapsed on the first story. Informations from the local residents revealed that the building was first constructed as one story only; the upper two story was added subsequently. The beams has only two normal rebars on the top face near the column joint and those were incorrectly placed.

Figure 2: State Bank Building at Uttarkashi

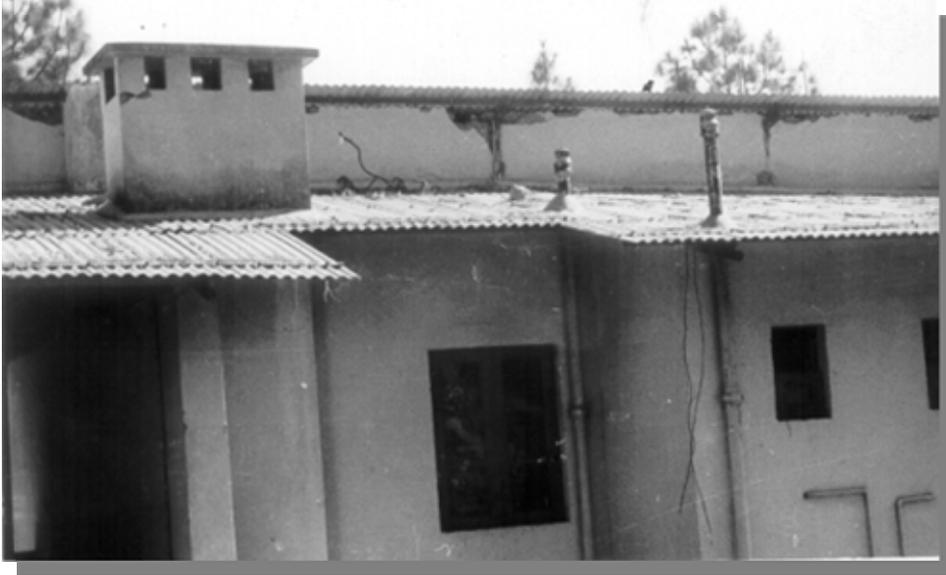
RC lintel bands, but no roof bands or gable bands. The construction is about 10 years old. The damage to buildings consisted of (I) diagonal cracks below window sills, (ii) damage at the connection between masonry walls and RC roof slabs, (iii) in buildings with corrugated iron sheet roofs, damage at seat of purlins on the gable end walls, and (iv) damage to walls supporting roofs at different heights at either end (*Figure 3*). Roof and gable bands would have prevented damage of types (ii), (iii), and (iv) above.

Figure 3: Damage to wall supporting Split Level roof - ITBP campus, Mahidanda.

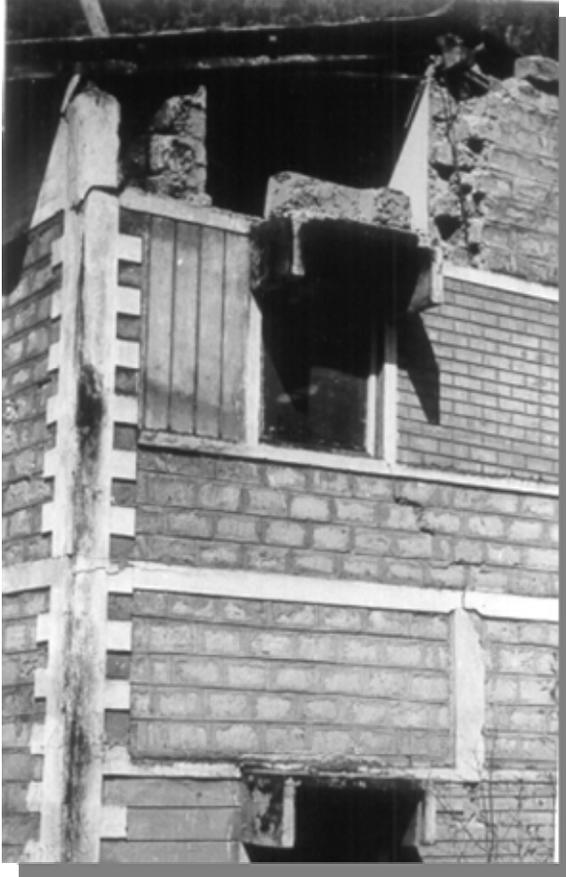
The Maneri Hydel power project colony campus has two-storey buildings with concrete block masonry bearing walls, of poorer quality construction than that seen on the ITBP campus. Many buildings were damaged beyond repair. Damage consisted of (I) severe damage to gable walls (*Figure 4*), and (ii) diagonal cracks in ground story walls.

Figure 4: Damage to Gable Wall -Maneri Hydel Project Colony

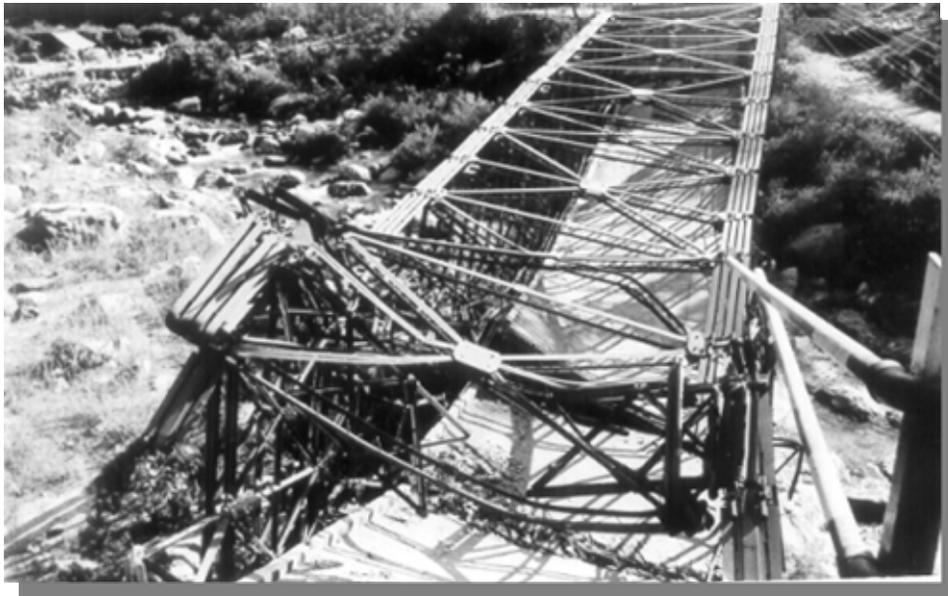
The Gawana Bridge is a 56.0 m span steel truss bridge build in 1974. It is located at 6km from Uttarkashi towards Maneri. The entire bridge came off the abutments and fell into the river (*Figure 5*) causing the entire area beyond Uttarkashi to be cut off from the rest of the country. Inadequate design of the bearings and anchor bolts as well as absence of any suitable means of preventing the span from falling off the supports were responsible for the damage.

Figure 5: Collapsed Gwana bridge
