A BRIEF REPORT ON IMPACTS AND IMPLICATIONS OF 2011 SIKKIM (INDIA-NEPAL BORDER REGION) EARTHQUAKE

Durgesh C Rai, Goutam Mondal, Vaibhav Singhal, Neha Parool and Tripti Pradhan

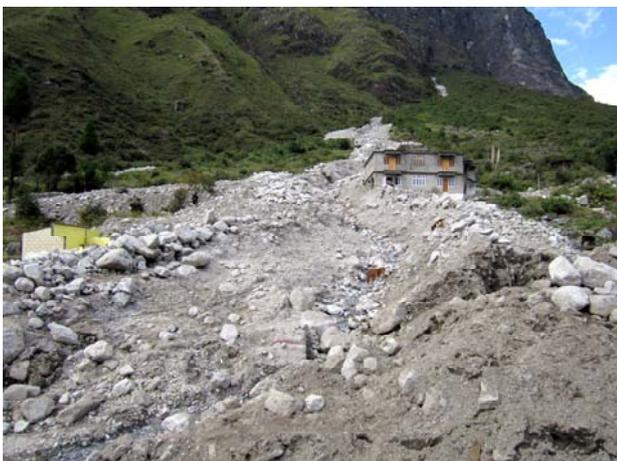
The earthquake followed by heavy seasonal rains triggered more than 300 landslides, rock/mudslide causing much devastation (Fig. 1). Damage to buildings and infrastructure due to landslides dominated those due to direct ground shaking in some regions. Landslides cut off the severely affected areas from the rest and hampered the rescue and relief work in this difficult terrain.

Fig. 1 Rockslide at Lachung

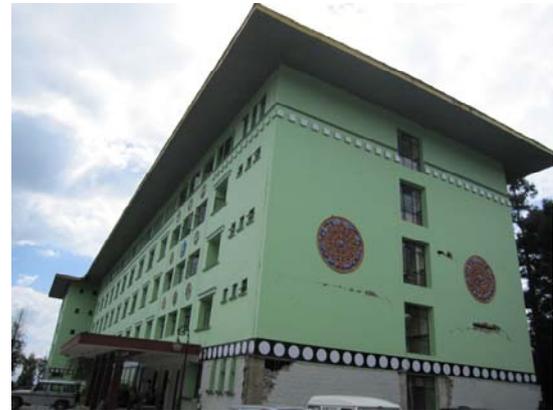
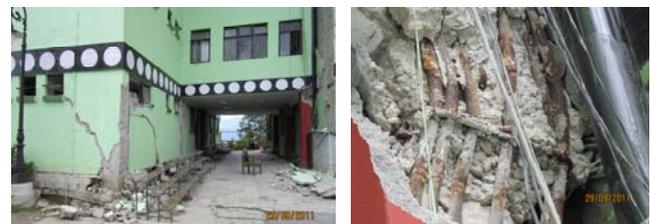
General damage to buildings and other structures agreed well with the intensity of ground shaking observed at various places, with the maximum of VIII at Chungthang and Lachung, VI in and around Gangtok and Mangan on MSK scale. However, unexpected severe damage at an intensity of VI in Gangtok was observed in buildings such as the Secretariat building (Fig. 2), two multistorey buildings in Balwakhani, and 5-storey building in Lumshey Basty. Similar damages were also reported from other towns such as Dikchu, Nayabazar, Singtam, etc.

Fig. 2 Damages observed in state secretariat building

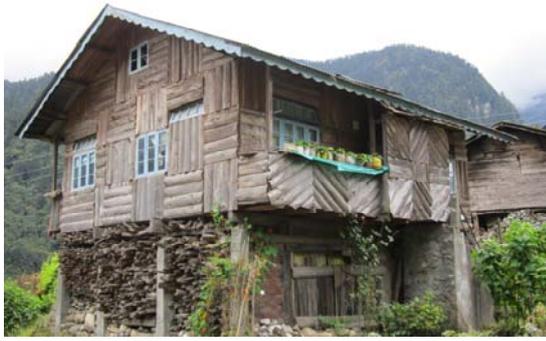
The wrath of this earthquake was witnessed by both urban and rural communities but much of the damage was observed in the areas closer to the epicenter. Three major building typologies prevalent in the state are RC/ masonry buildings, and traditional *Ikra* type and *Shee-khim* houses (Fig. 3). Traditional constructions are built using locally available materials and have performed well because of their inherent earthquake resistance abilities.

Fig. 3 Traditional *Shee-khim* house which suffered negligible damage

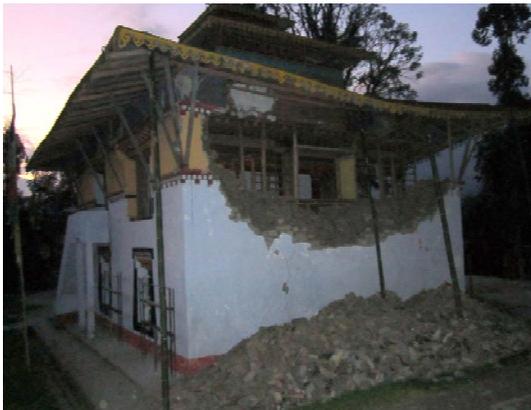
The poor earthquake performance of cultural heritage such as monasteries is a source of concern as almost all historic religious structures suffered varying degree of damages in this earthquake. Heavy damages have been observed to exterior walls at several monastery temples (Fig. 4).

Fig. 4 Partial collapse of stone masonry walls of a monastery temple at Mangan

Monasteries which are important historic structure and adds to the cultural heritage of the state should be considered for retrofitting as well. Important structures such as schools and hospitals which are vital in the post-earthquake relief and rescue efforts must be built earthquake-resistant on a high-priority.

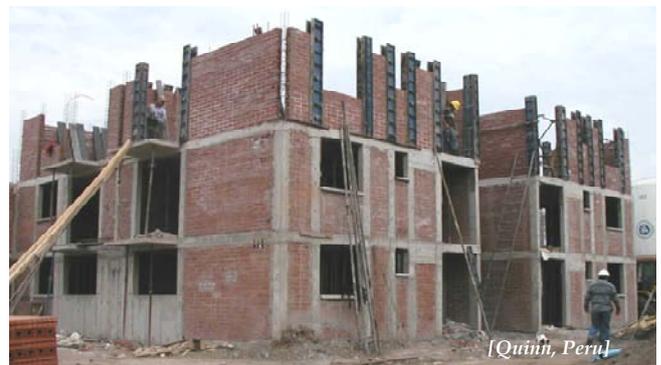
Fig. 5. A building in construction using confined masonry

Rough terrain, complex topography and remote locations pose serious challenge for sound and quality construction in hilly areas. Lack of awareness in the general public about the seismic vulnerability of the area have led to haphazard planning of towns and construction on sites prone to landslides and sinking (ground settlement). Unavailability of raw building materials and the expensive transportation cost have caused use of various substandard construction materials. It is critical to promote good concrete and masonry construction practice and suitable material for light or strong partition walls. For low rise buildings, new building typologies of proven earthquake performance, such as confined masonry needs to be introduced (Fig. 5).
