**PRELIMINARY REPORT ON THE IIT KANPUR RECONNAISSANCE SURVEY OF
THE SIKKIM (INDIA-NEPAL BORDER REGION) EARTHQUAKE OF SEPTEMBER 18, 2011**

Department of Civil Engineering
Indian Institute of Technology Kanpur, India

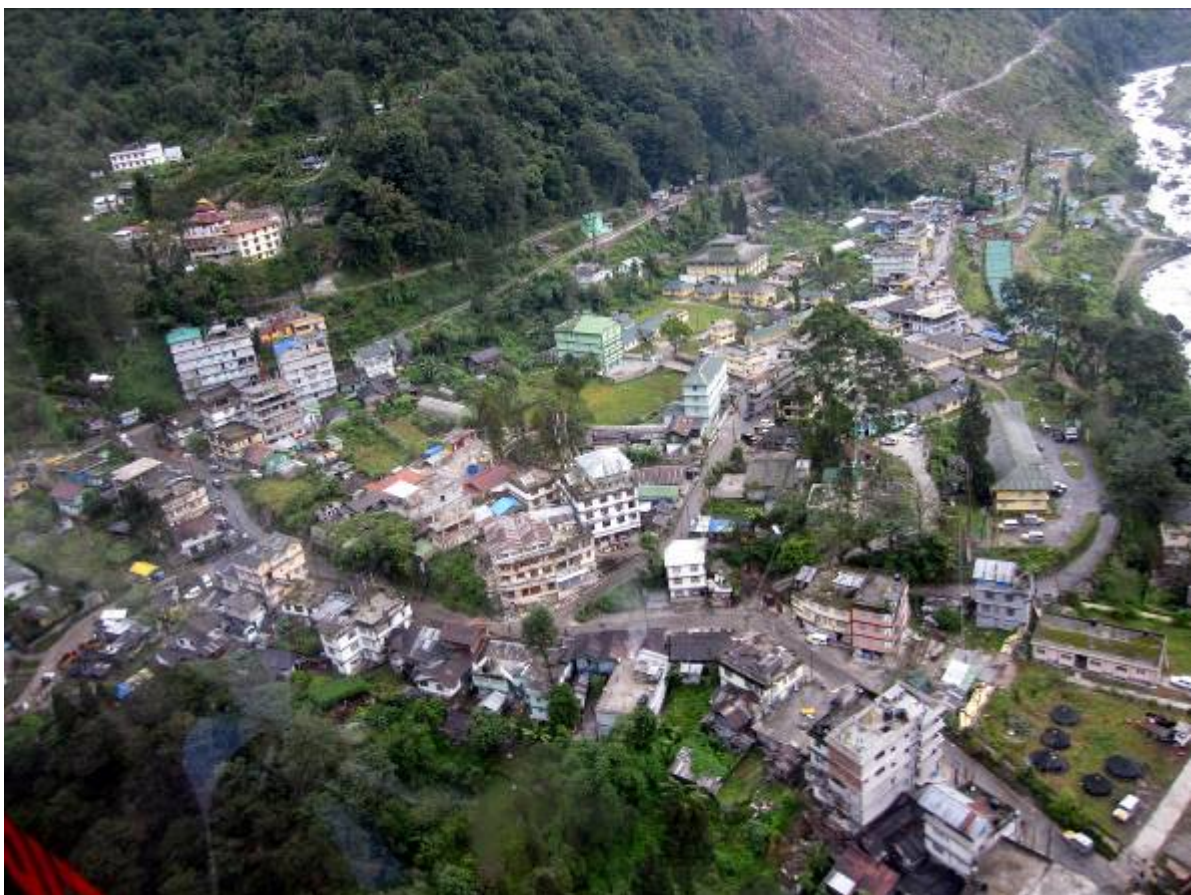
Fig. 3. Aerial photograph of Chungthang showing damages (Photo: Durgesh Rai)

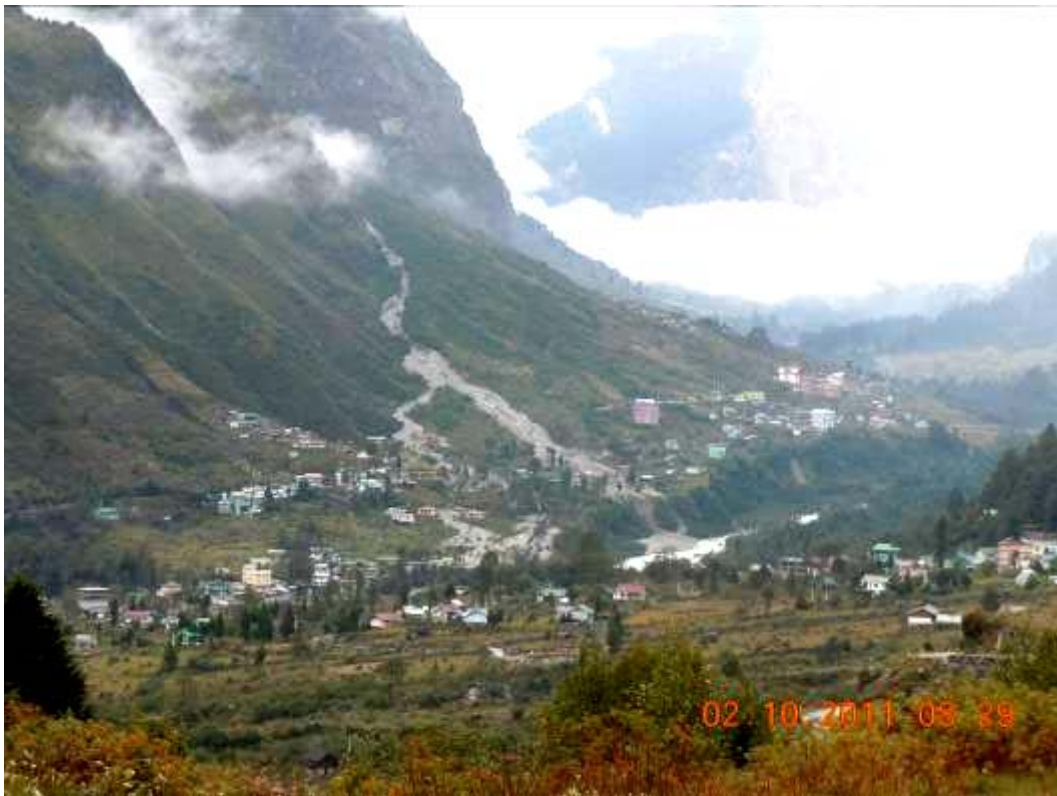
Fig. 4. Photograph of town Lachung showing massive rockslides (Photo: Vaibhav Singhal)

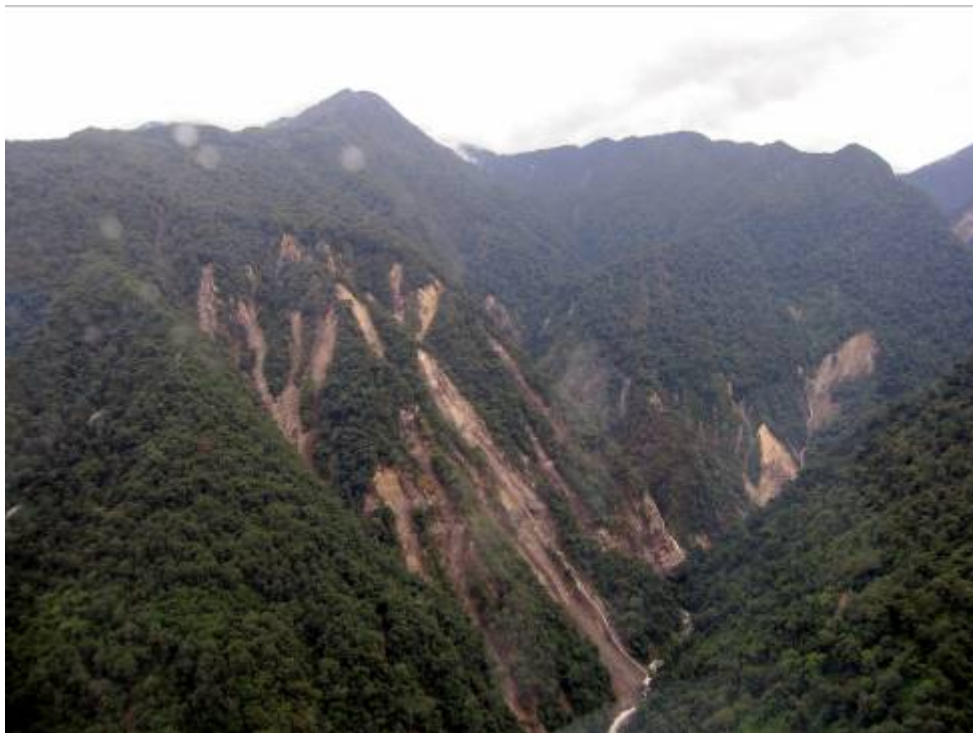
The earthquake followed by heavy seasonal rains triggered more than 300 landslides, rock/mudslide causing much devastation (Fig. 5). Damage to buildings and infrastructure due to landslides dominated those due to direct ground shaking in some regions (Fig. 6). Landslides cut off the severely affected areas from the rest and hampered the rescue and relief work in this difficult terrain. The immediate requirement was to provide temporary shelter along with medicine, food, blankets, etc. for survivors, before these areas become further inaccessible due to approaching winter.

Fig. 5. Aerial photograph showing typical landslides enroute from Mangan to Chungthang and Lachung (Photo: Durgesh Rai)

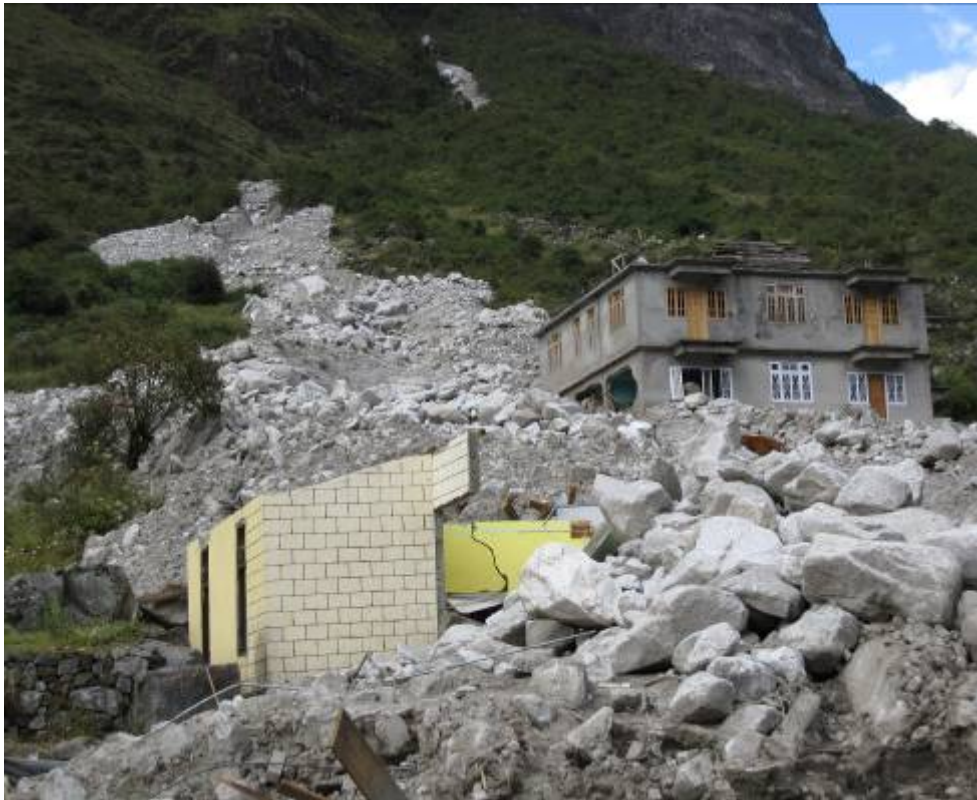
Fig. 6. Damage due to rock slide after two days of the event in Lachung (Photo: Neha Parool)

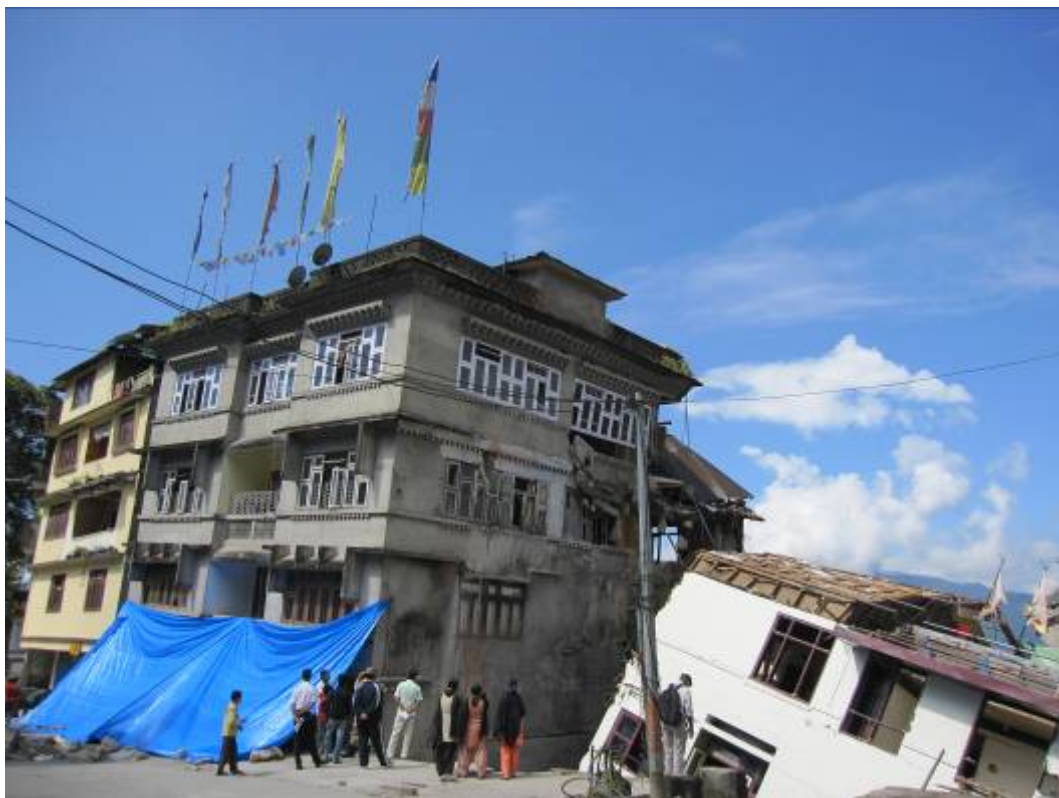
General damage to buildings and other structures agreed well with the intensity of ground shaking observed at various places, with the maximum of VIII at Chungthang and Lachung, VI in and around Gangtok and Mangan on MSK scale. However, unexpected severe damage at an intensity of VI in Gangtok was observed in buildings such as the secretariat building, two multistorey buildings in Balwakhani, 5-storey building in Lumshey Basti and 4-storey building in Dikchu Bazaar (Fig. 7 and 8).

Fig. 7. Collapse of two multistory RC frame buildings at Balwakhani, Gangtok (Photo: Tripti Pradhan)

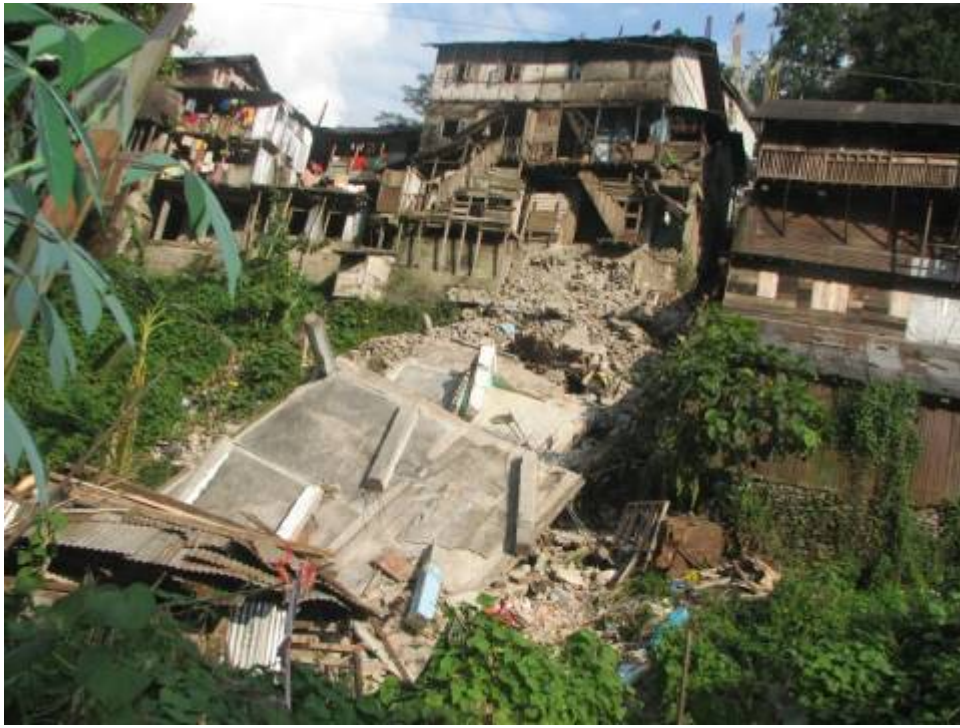
Fig. 8. Collapsed four story reinforced concrete building at Dikchu Bazaar (Photo: Hemant Kaushik)

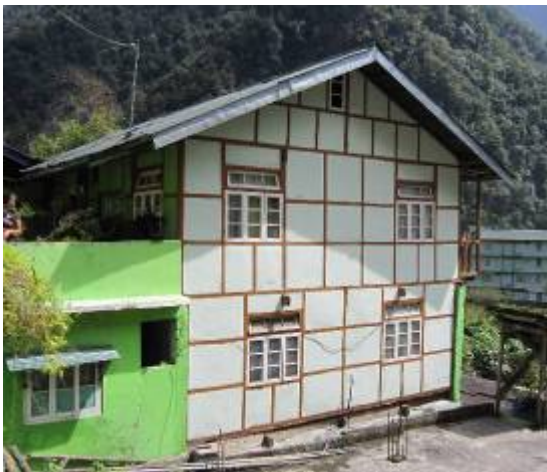
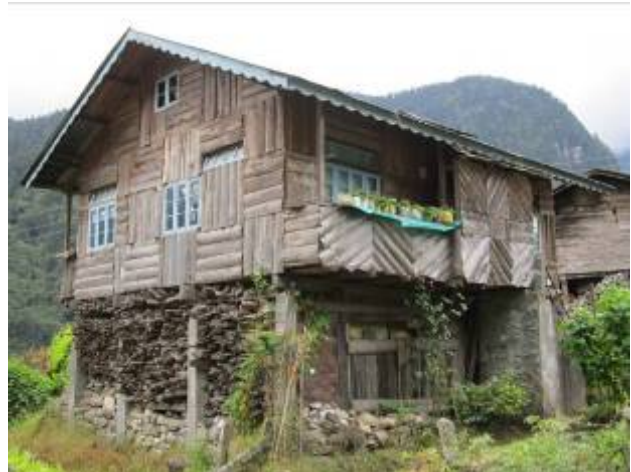
It was common practice in Sikkim to construct residential buildings using bamboo/wood, until the economic development aided by tourism industry got boosted in early nineties. These traditional constructions (*Shee-khim* and *Ikra* type) have better earthquake resistance as observed in the present and past earthquakes (Fig. 9).

Fig. 9. Traditional construction type (a) Ikra house (Photo: Vaibhav Singhal) (b) Shee-Khim house (Photo: Neha Parool)

Traditional construction like *Shee-khim* and *Ikra* type performed well as expected and needs to be reinstated. Buddhist temples being old and weak were deficient in strength and needs to be safeguarded against future tremors. Despite the available knowledge base, the communities are not adequately prepared. Ever increasing inventory of seismically deficient constructions causing the seismic risk in the region to rise to unacceptable levels which may lead to a large-scale disaster, if the risk is not mitigated.

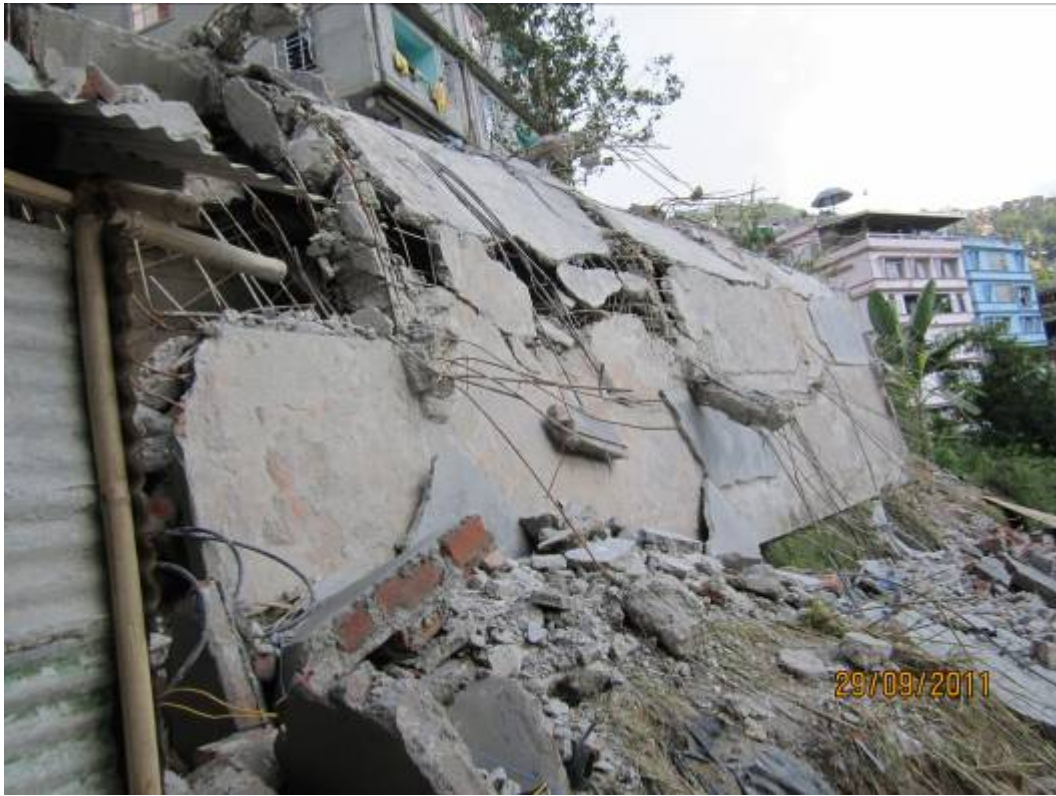
Fig. 10. Complete collapse of newly constructed RC building at Lumshey Basti, Gangtok (photo: Neha Parool)

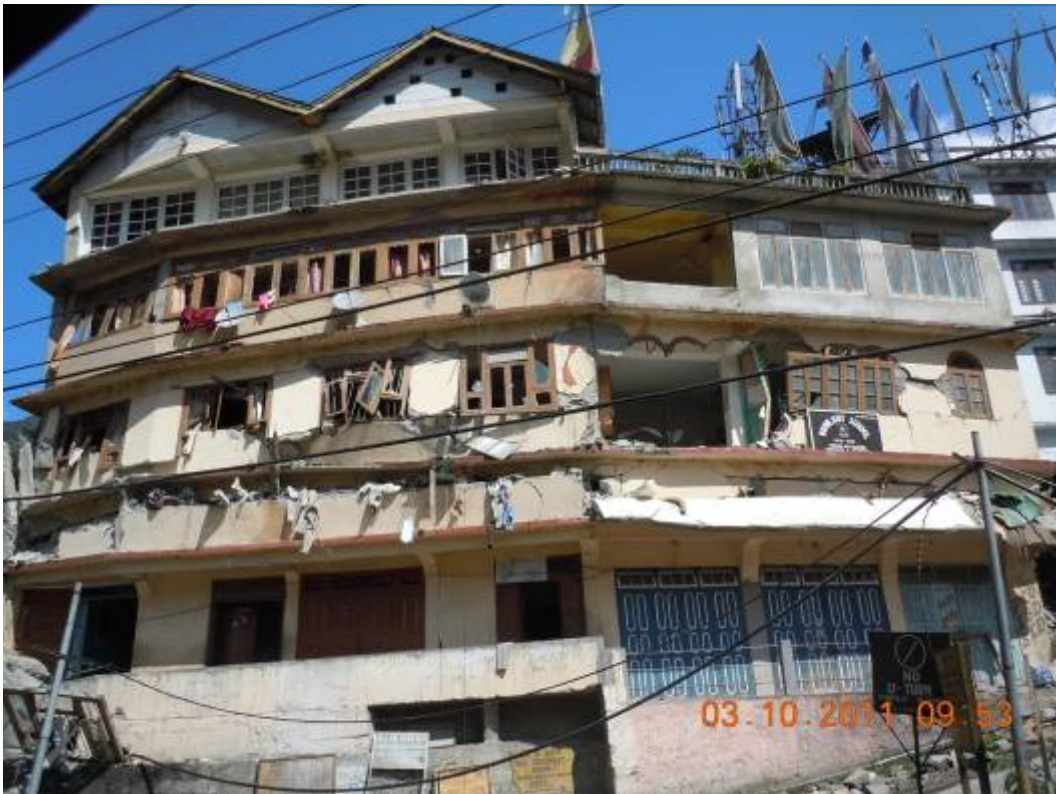
Fig. 11. Pancake collapse of the third storey of the five storey school cum residential building in Chungtang (Photo: Goutam Mondal)

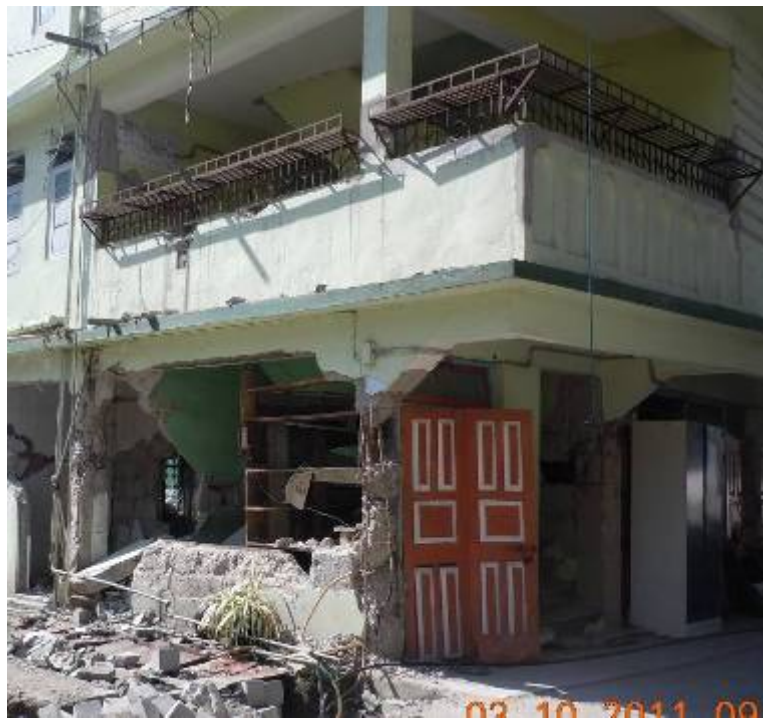
Fig. 12. Complete damage of columns and exterior wall in a building at Chungthang due to poor detailing of column reinforcement, lack of confining reinforcement, improper splicing of rebars, inferior detailing of columns with corbel (Photo: Tripti Pradhan)

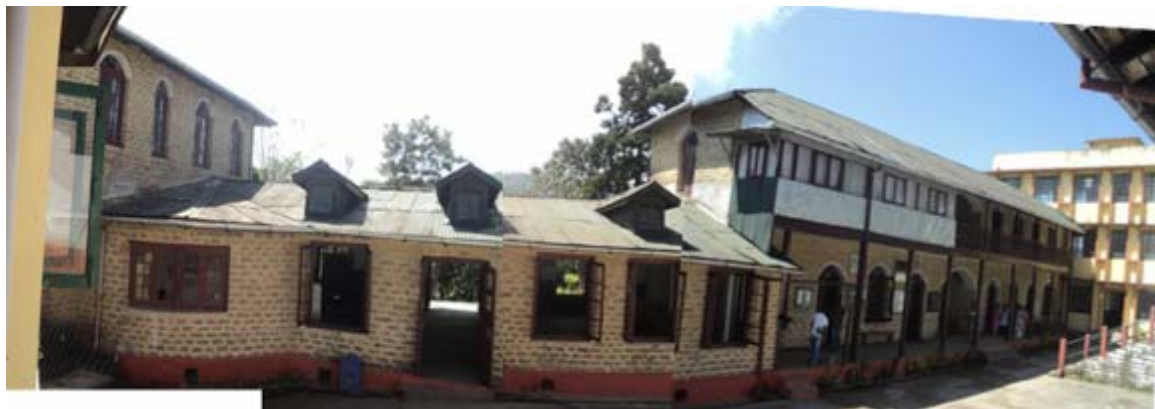
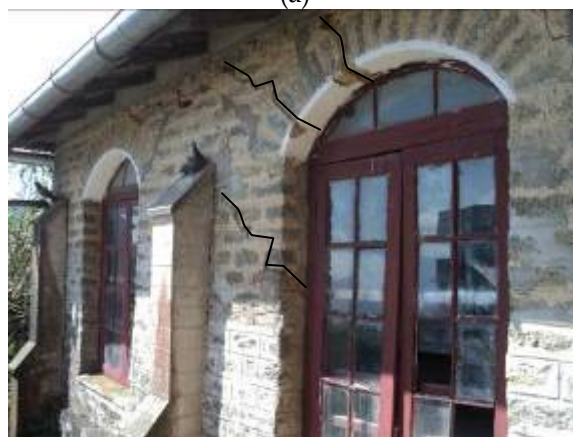
Fig. 13. (a) Damage reported at Kalimpong Girl's High School (b) Damage to semi-circular arches, diagonal cracks in masonry pier (Photo: Keya Mitra)

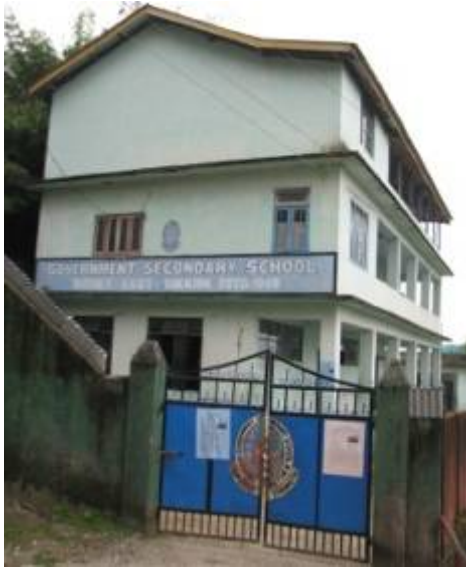
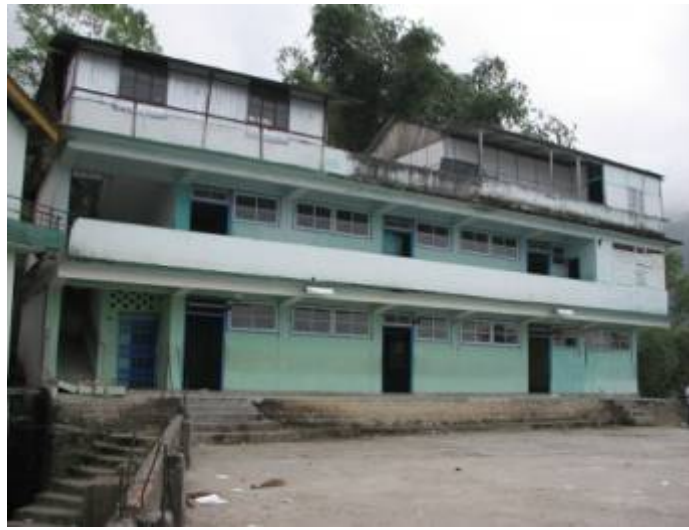
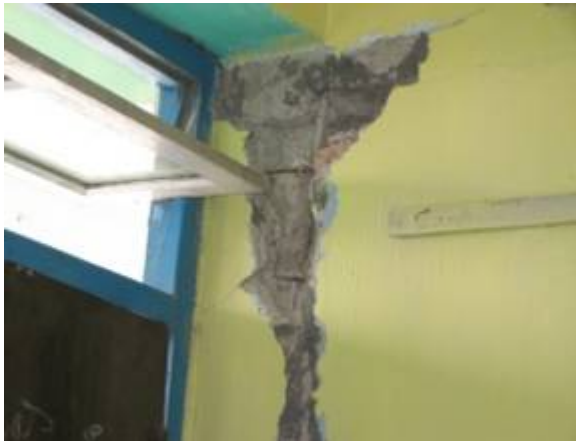
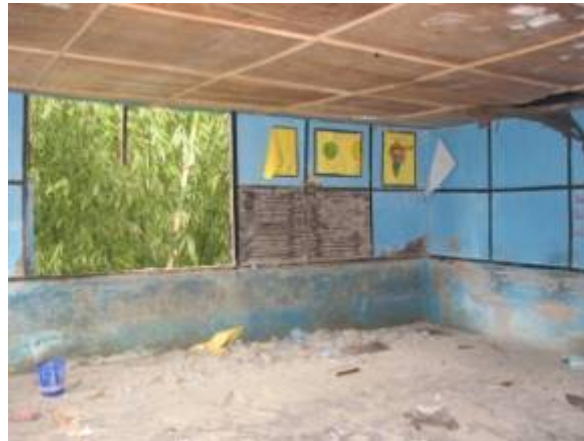
Fig. 14. Damage observed at Government Secondary School at Sichey (a) old school building, (b) additional school building, (c) damage to RC columns, and (d) damage to Ikra walls on top floor (Photo: Hemant Kaushik)

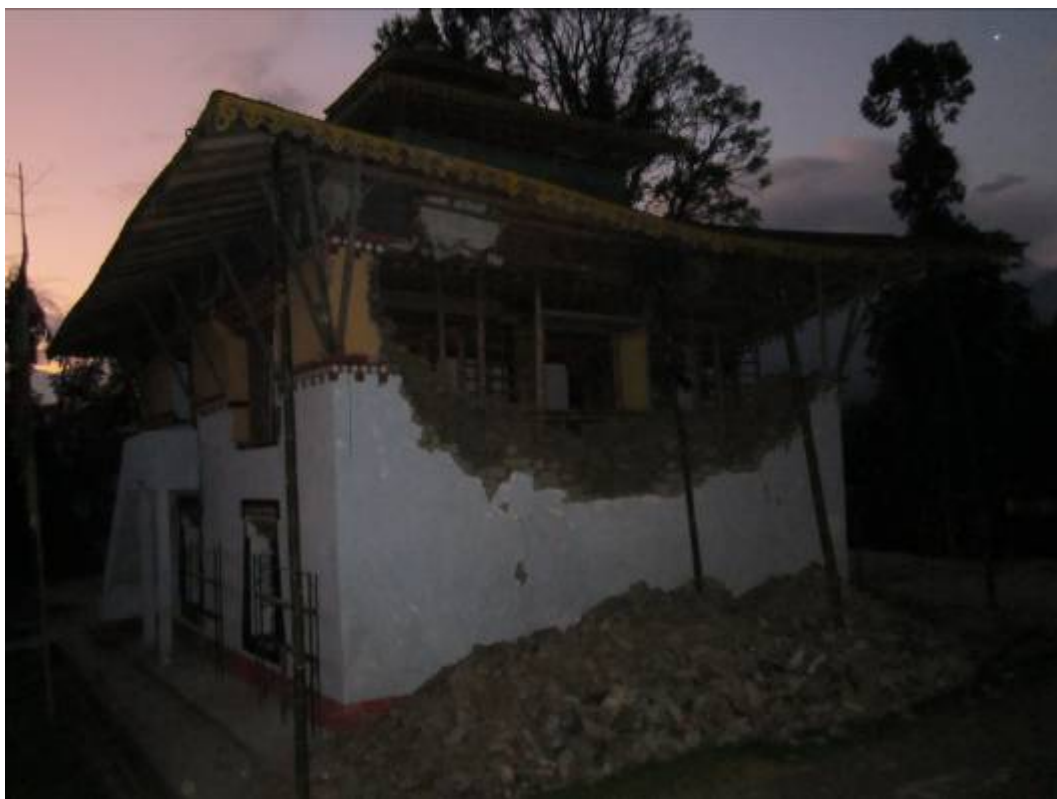
The poor earthquake performance of cultural heritage such as monasteries is a source of concern as almost all historic religious structures suffered varying degree of damages in this earthquake. The exterior walls of monastery temples are constructed of stone masonry mostly random rubble while the interior building frame is constructed of timber using single post beam system. Heavy damages have been observed to exterior walls at several monastery temples at Mangan and Lachung (Fig. 18). In Kalimpong, in West Bengal, two brick spires of the historic Mac Farlane Church have collapsed and the tall load bearing walls at the gable end of the building have numerous cracks (Fig. 19).

Fig. 18. Partial collapse of stone masonry walls of a Monastery temple at Mangan (Photo: Goutam Mondal)

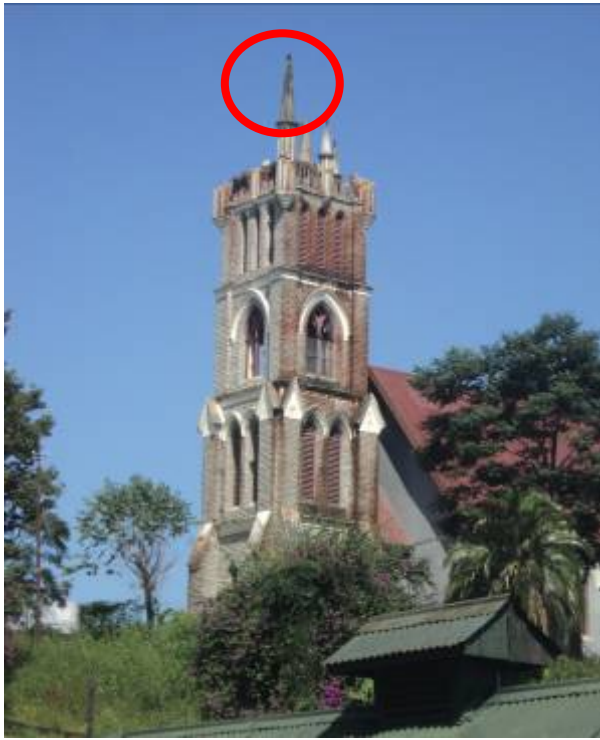
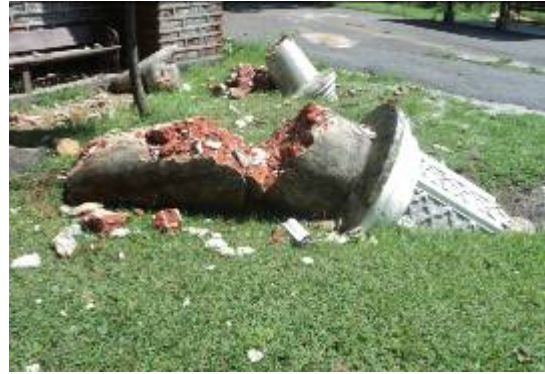
Fig. 19. Collapse of brick spires of Mac Farlene Church at Kalimpong (Photo: Keya Mitra)

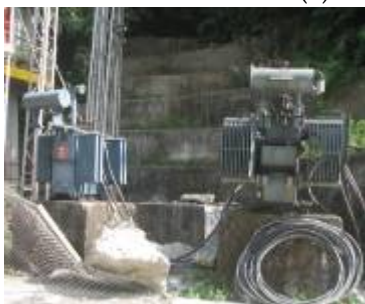
Fig. 20. Concrete gravity dams in operation at (a) Project Teesta-V, and (b) Project Rangit, (c) damaged electrical transformer at Teesta-V dam site, (d) ground deformation at Teesta-V dam site, and (e) accumulation of excessive debris and silt in reservoirs due to landslides (Photo: Kaustubh Dasgupta)

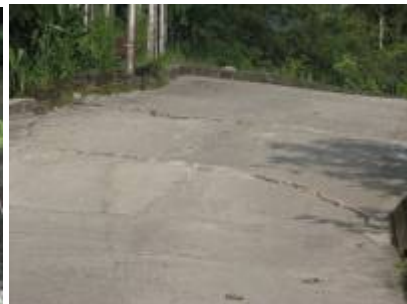
(d)

National Hydroelectric Power Corporation (NHPC) has constructed concrete gravity dams over Teesta River near Dikchu (Project Teesta-V: 513 Mega Watt) and Rangit River near Rangit Nagar (Project Rangit: 60 Mega Watt). Project Rangit is in operation since last 10 years and Project Teesta-V was completed recently and is in operation since last two years (Fig. 20). No damage due to earthquake shaking or landslide was observed in the body of any of these dams. The hydroelectric power stations performed extremely well; the only visible damage was minor cracking in masonry infill walls at various locations in the power stations. Severe landslides and ground deformations were observed near both the dam sites that resulted in accumulation of excessive debris and silt in the reservoir and on the downstream of the dam (Fig. 20d and 20e).
