# QUICK REPORT ON THE IIT KANPUR RECONNAISSANCE SURVEY OF THE SIKKIM (INDIA-NEPAL BORDER REGION) EARTHQUAKE OF SEPTEMBER 18, 2011

Department of Civil Engineering  
Indian Institute of Technology Kanpur, India

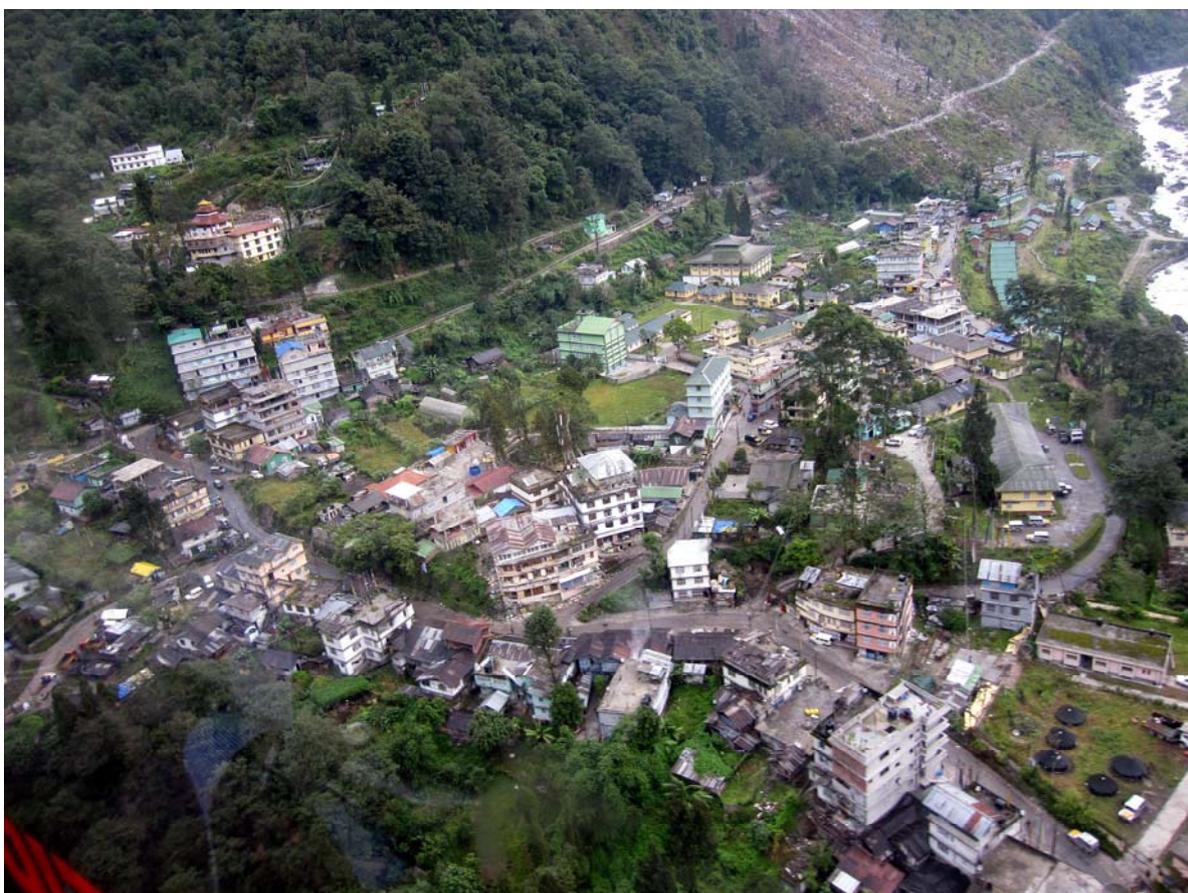
**Fig. 3.** Aerial photograph of Chungthang showing damages (Photo: Durgesh Rai)

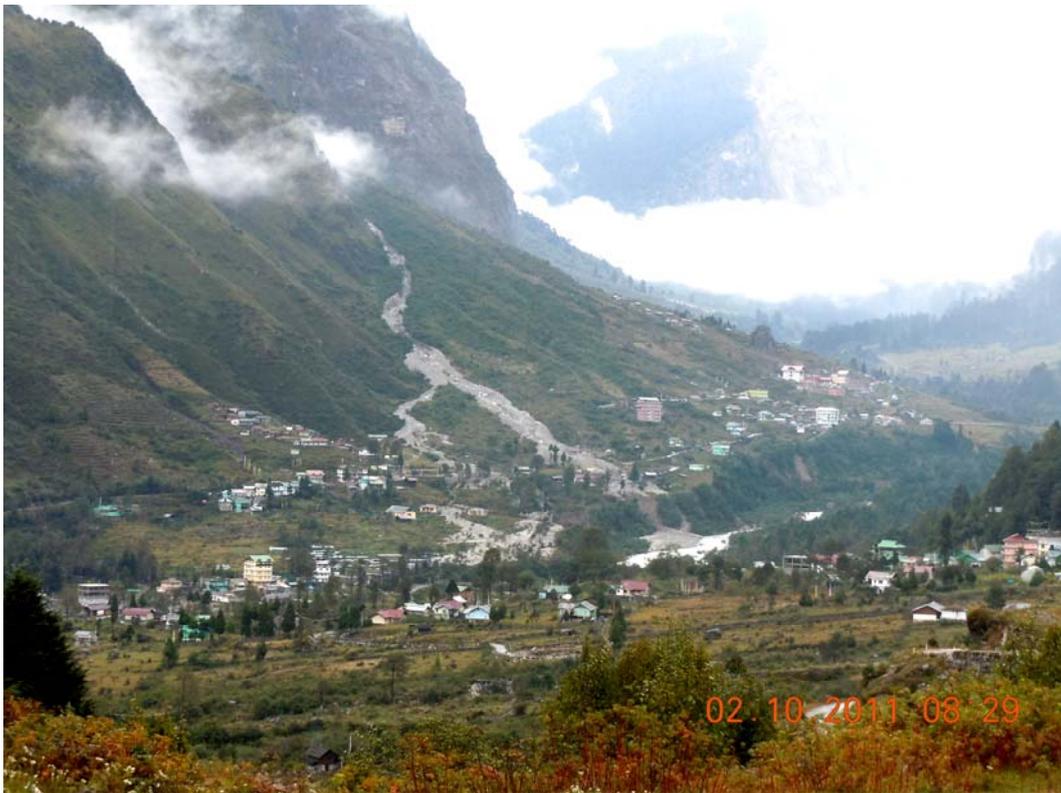
**Fig. 4.** Photograph of town Lachung showing massive rockslides (Photo: Vaibhav Singhal)

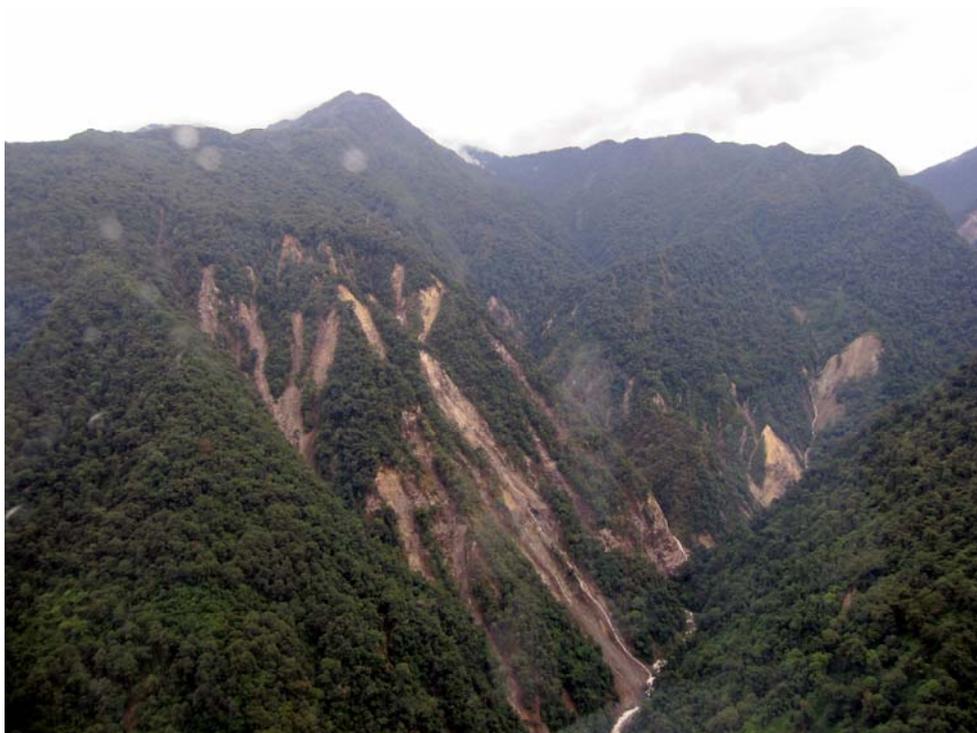
The earthquake followed by heavy seasonal rains triggered more than 300 landslides, rock/mudslide causing much devastation (Fig. 5). Damage to buildings and infrastructure due to landslides dominated those due to direct ground shaking in some regions (Fig. 6). Landslides cut off the severely affected areas from the rest and hampered the rescue and relief work in this difficult terrain. The immediate requirement was to provide temporary shelter along with medicine, food, blankets, etc. for survivors, before these areas become further inaccessible due to approaching winter.

**Fig. 5.** Aerial photograph showing typical landslides enroute from Mangan to Chungthang and Lachung (Photo: Durgesh Rai)

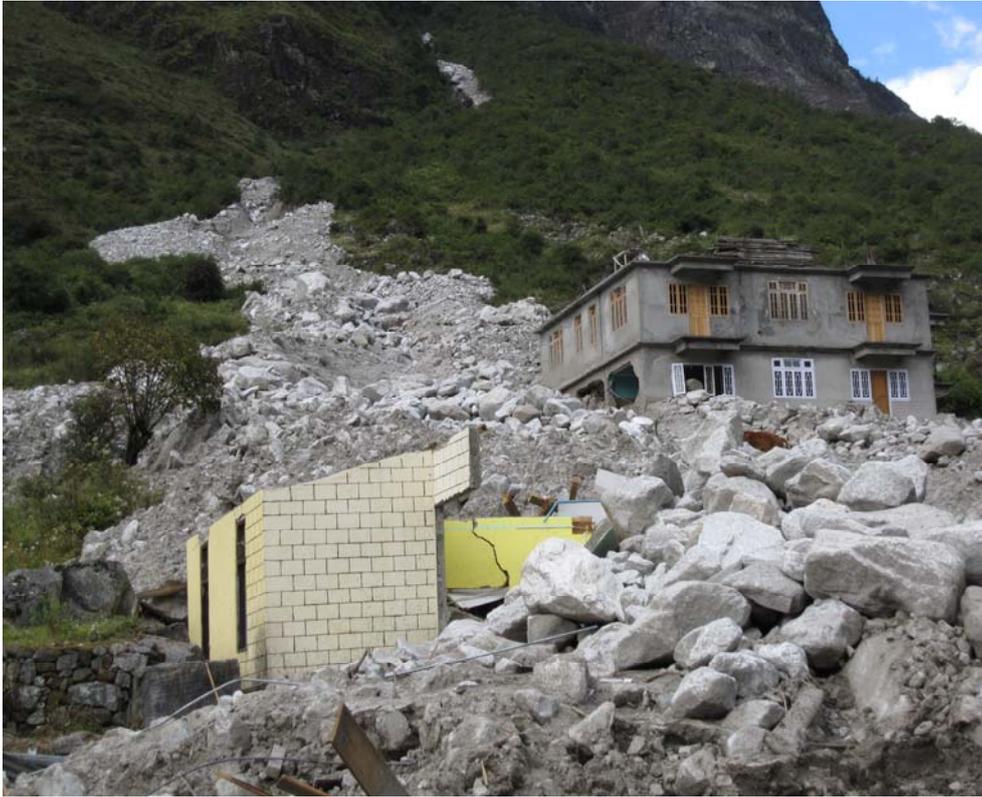
**Fig. 6.** Damage due to rock slide after two days of the event in Lachung (Photo: Neha Parool)

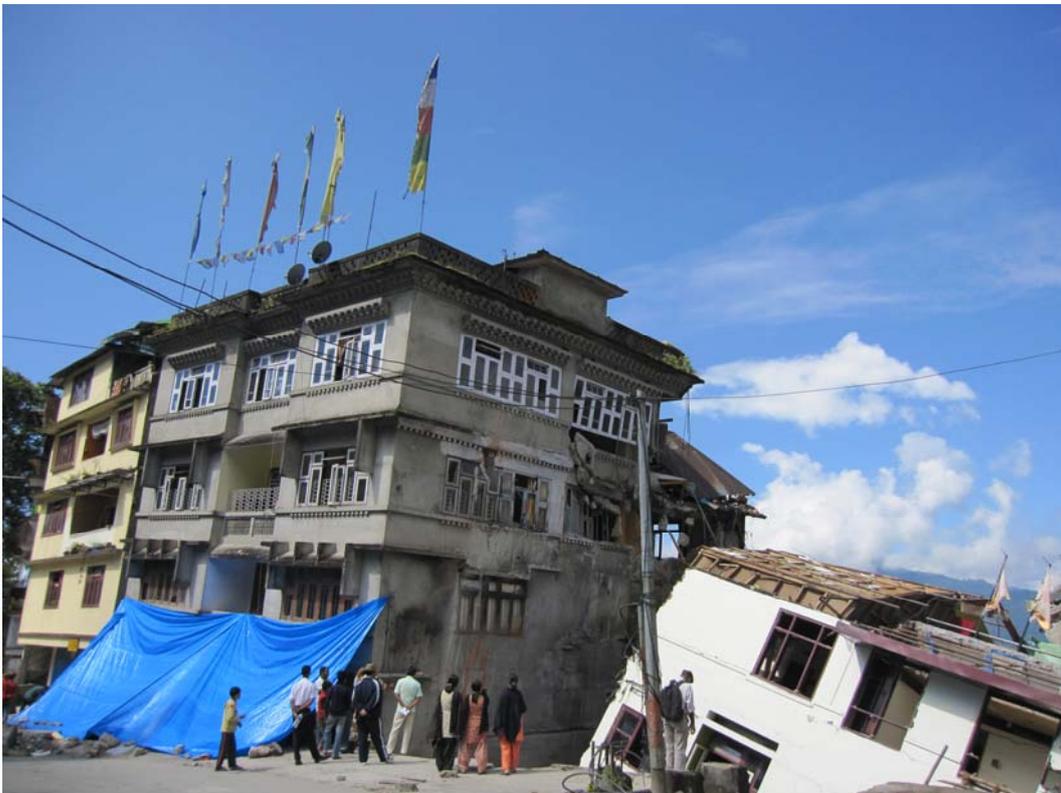
General damage to buildings and other structures agreed well with the intensity of ground shaking observed at various places, with the maximum of VIII at Lachung and Chungthang, VI in and around Gangtok and Mangan on MSK scale. However, unexpected severe damage at an intensity of VI in Gangtok was observed in buildings such as the secretariat building, two multistorey buildings in Balwakhani, 5-storey building in Lumshey Basti and 4-storey building in Dikchu Bazaar (Figs. 7 and 8).

**Fig. 7.** Collapse of two multistory RC frame buildings at Balwakhani, Gangtok (Photo: Tripti Pradhan)

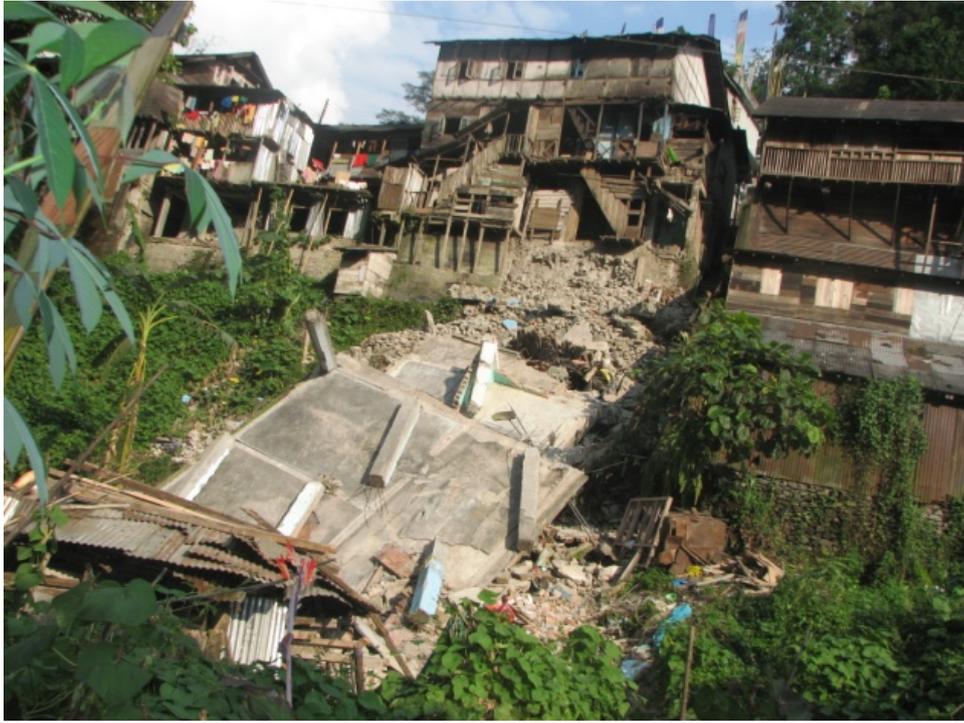
**Fig. 8.** Collapsed four story reinforced concrete building at Dikchu Bazaar (Photo: Hemant Kaushik)

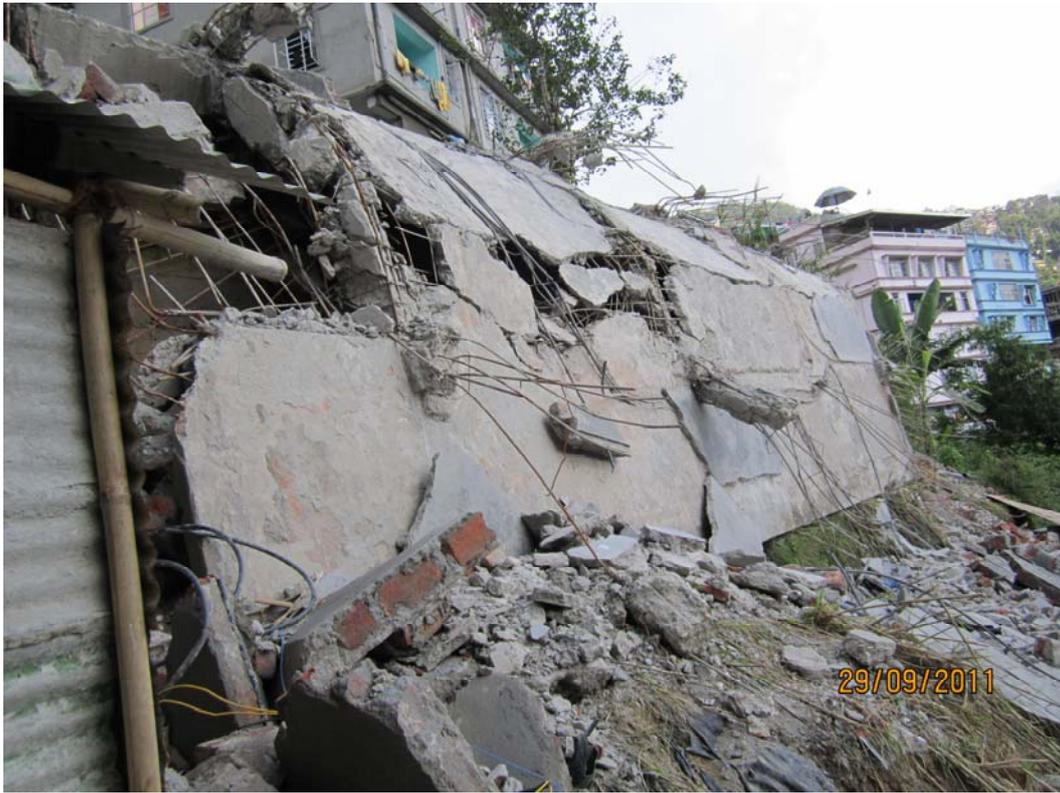
**Fig. 10.** Complete collapse of newly constructed RC building at Lumshey Basti, Gangtok (photo: Neha Parool)

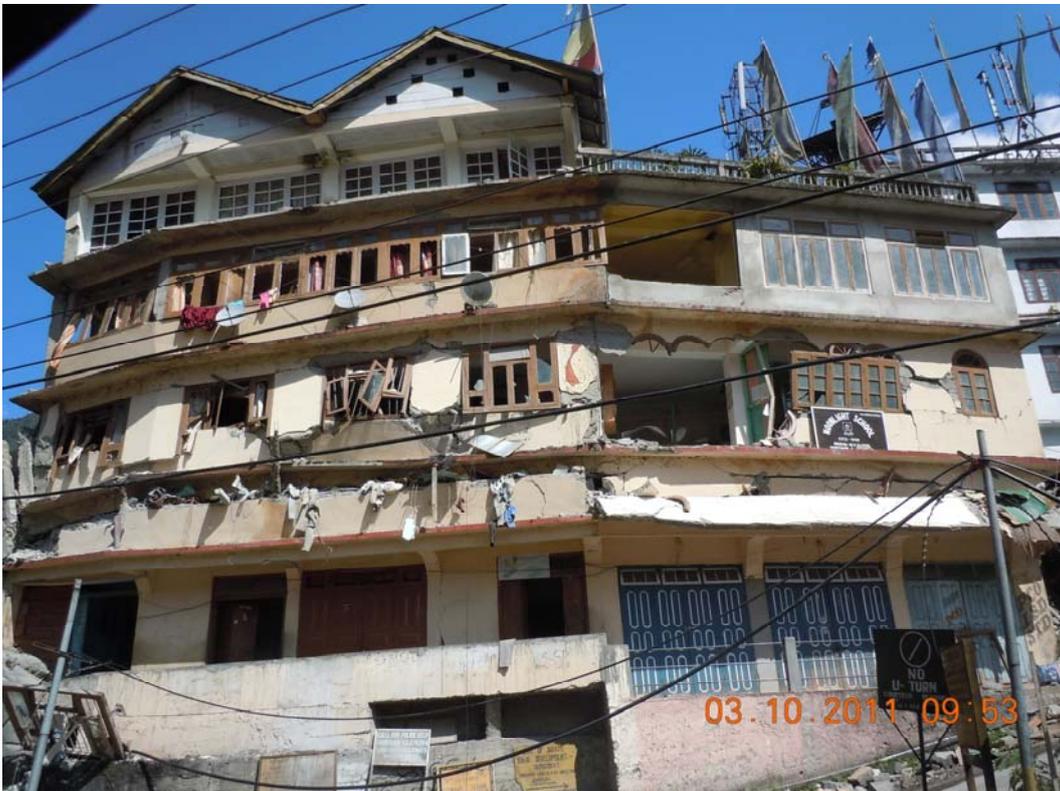
**Fig. 11.** Pancake collapse of the third storey of the five storey school cum residential building in Chungtang (Photo: Goutam Mondal)

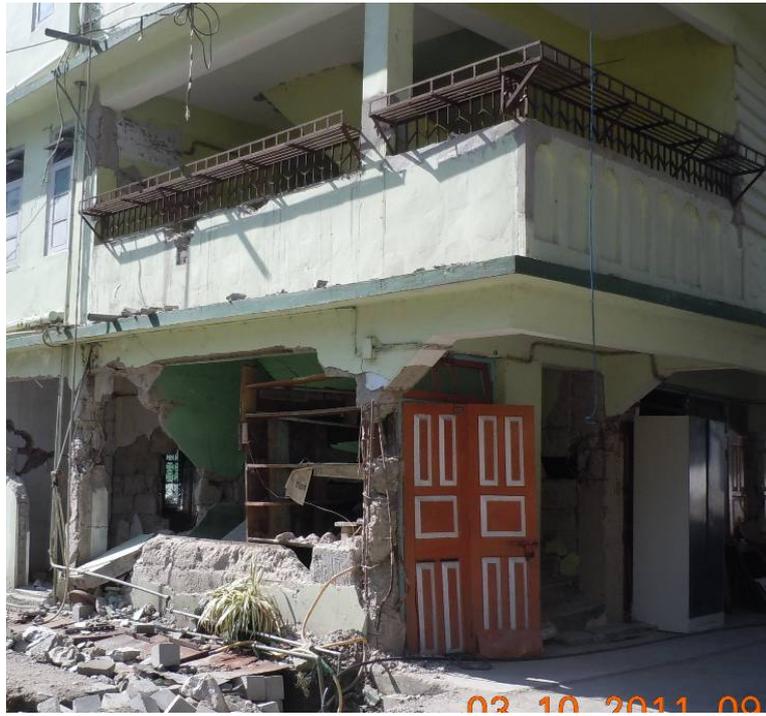
**Fig. 12.** Complete damage of columns and exterior wall in a building at Chungthang due to poor detailing of column reinforcement, lack of confining reinforcement, improper splicing of rebars, inferior detailing of columns with corbel (Photo: Tripti Pradhan)

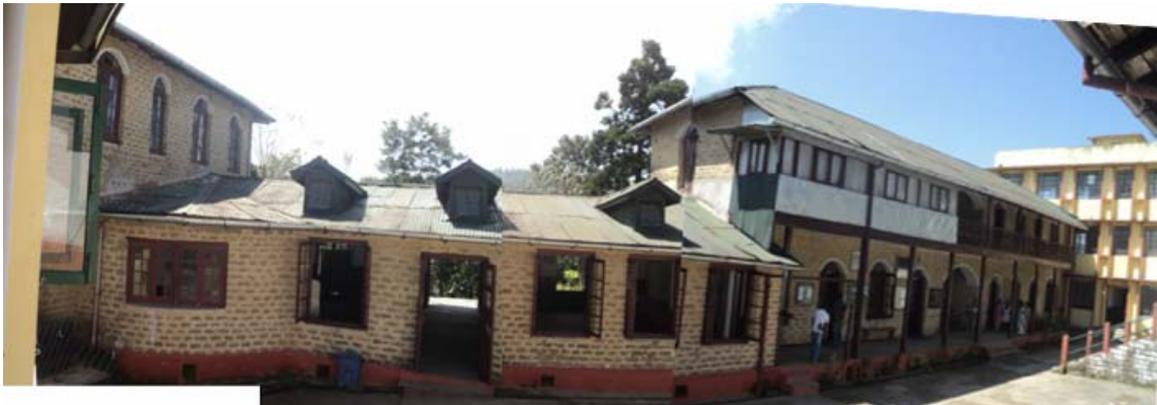
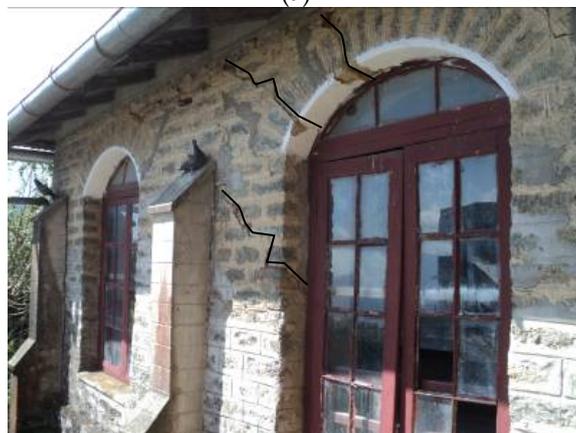
**Fig. 13.** (a) Damage reported at Kalimpong Girl's High School (b) Damage to semi-circular arches, diagonal cracks in masonry pier (Photo: Keya Mitra)

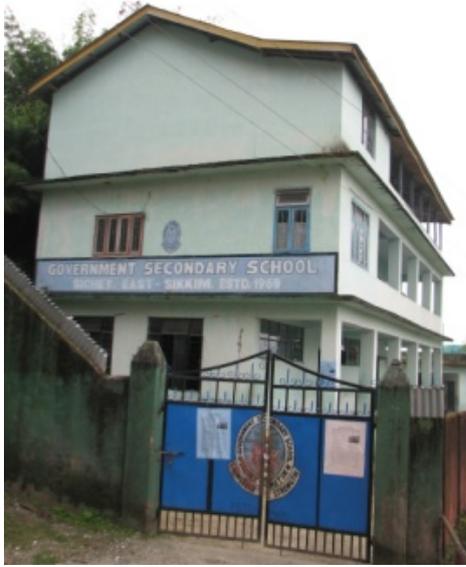
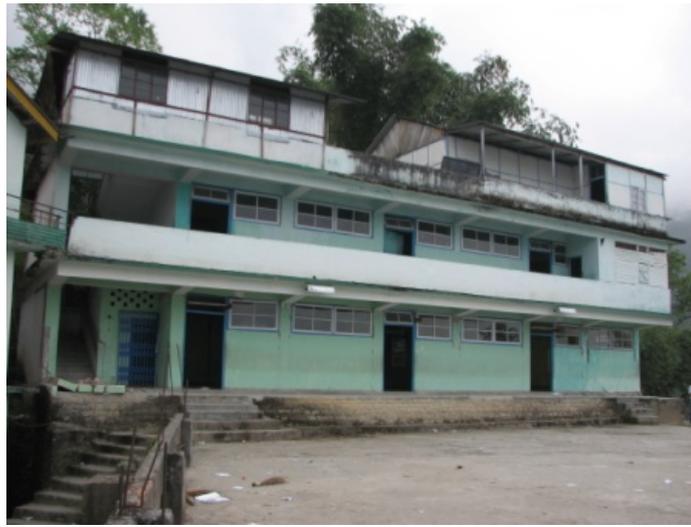
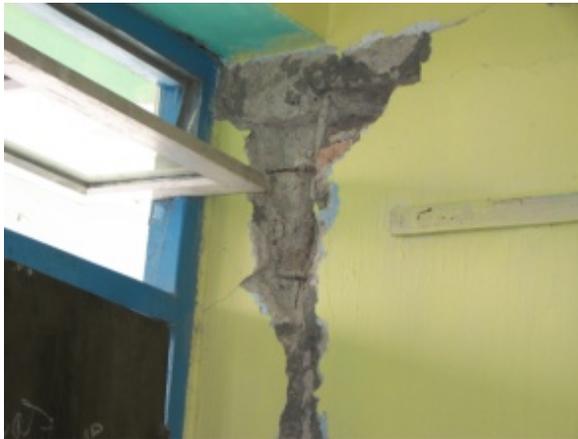
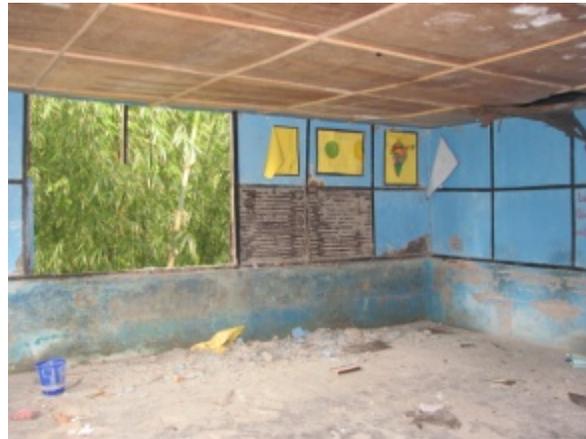
**Fig. 14.** Damage observed at Government Secondary School at Sichey (a) old school building, (b) additional school building, (c) damage to RC columns, and (d) damage to Ikra walls on top floor (Photo: Hemant Kaushik)

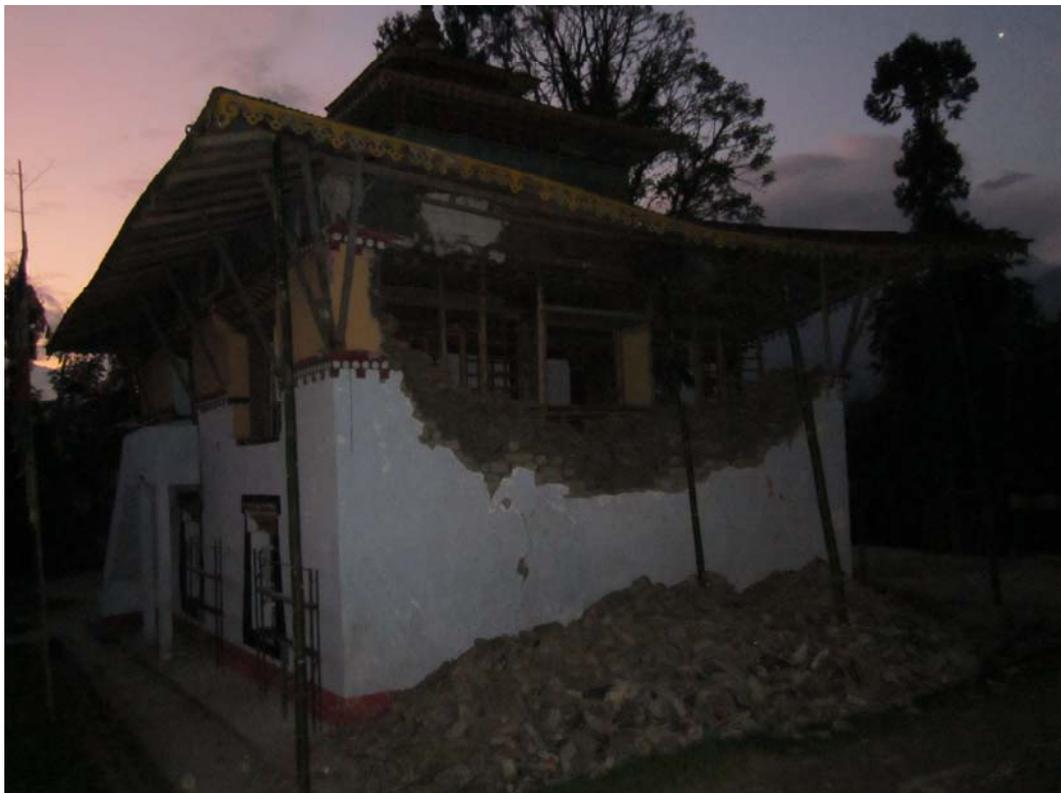
The poor earthquake performance of cultural heritage such as monasteries is a source of concern as almost all historic religious structures suffered varying degree of damages in this earthquake. The exterior walls of monastery temples are constructed of stone masonry mostly random rubble while the interior building frame is constructed of timber using single post beam system. Heavy damages have been observed to exterior walls at several monastery temples at Mangan and Lachung (Fig. 18). In Kalimpong, in West Bengal, two brick spires of the historic Mac Farlane Church have collapsed and the tall load bearing walls at the gable end of the building have numerous cracks (Fig. 19).

**Fig. 18.** Partial collapse of stone masonry walls of a Monastery temple at Mangan (Photo: Goutam Mondal)

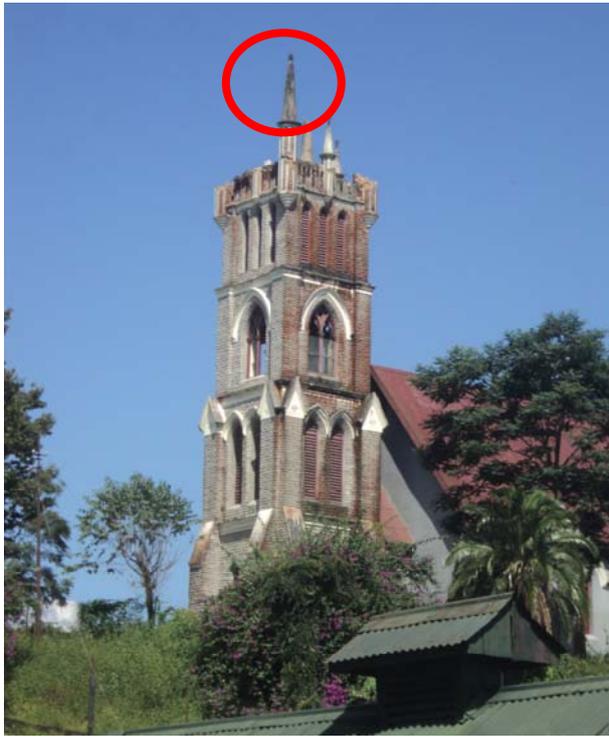
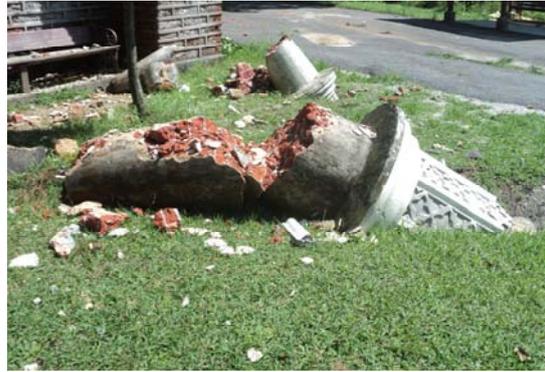
**Fig. 19.** Collapse of brick spires of Mac Farlene Church at Kalimpong (Photo: Keya Mitra)

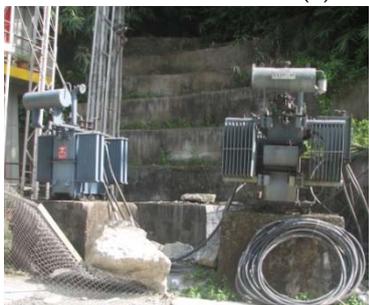
**Fig. 20.** Concrete gravity dams in operation at (a) Project Teesta-V, and (b) Project Rangit, (c) damaged electrical transformer at Teesta-V dam site, (d) ground deformation at Teesta-V dam site, and (e) accumulation of excessive debris and silt in reservoirs due to landslides (Photo: Kaustubh Dasgupta)

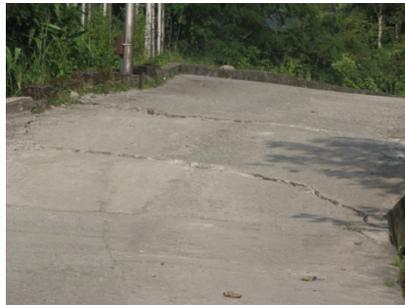
(d)

National Hydroelectric Power Corporation (NHPC) has constructed concrete gravity dams over Teesta River near Dikchu (Project Teesta-V: 513 Mega Watt) and Rangit River near Rangit Nagar (Project Rangit: 60 Mega Watt). Project Rangit is in operation since last 10 years and Project Teesta-V was completed recently and is in operation since last two years (Fig. 20). No damage due to earthquake shaking or landslide was observed in the body of any of these dams. The hydroelectric power stations performed extremely well; the only visible damage was minor cracking in masonry infill walls at various locations in the power stations. Severe landslides and ground deformations were observed near both the dam sites that resulted in accumulation of excessive debris and silt in the reservoir and on the downstream of the dam (Figs. 20d and 20e).
