Quick Report on the Study of the 2004 Sumatra Earthquake and Tsunami Effects

*Department of Civil Engineering
Indian Institute of Technology Kanpur*

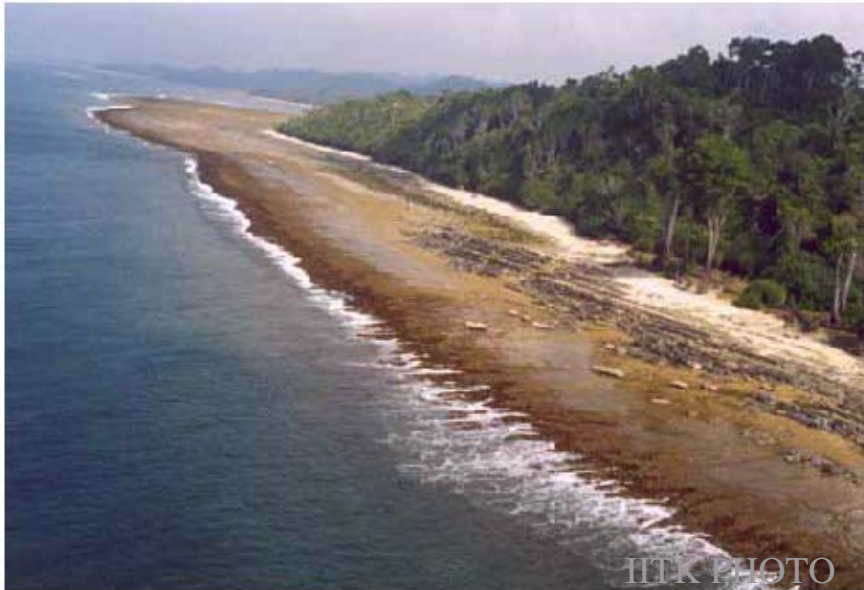
Figure 1: Up-throw of coral beds and rock strata due to uplift on the western coast of middle Andaman Island near Flat Island. (Photo: Javed Malik)

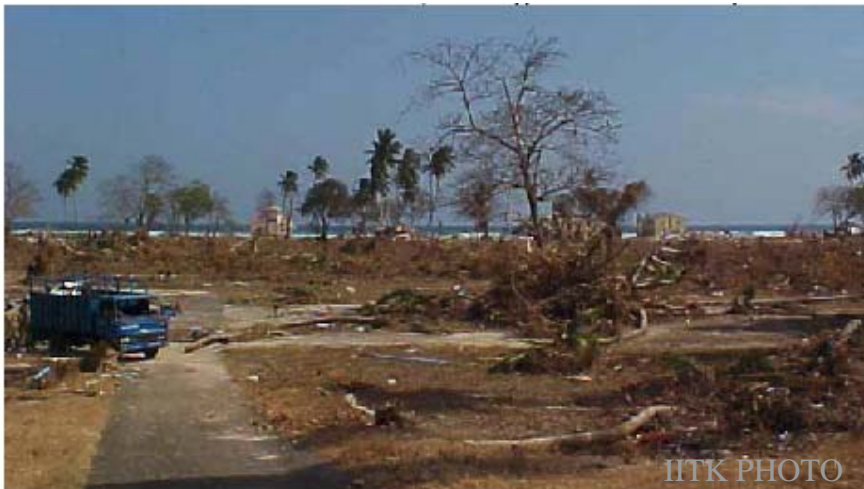
Figure 2: Barren look with an occasional partially collapsed structure of an erstwhile-full military residential colony south of Malacca on the east coast of Car Nicobar Island. (Photo: CVR Murty)

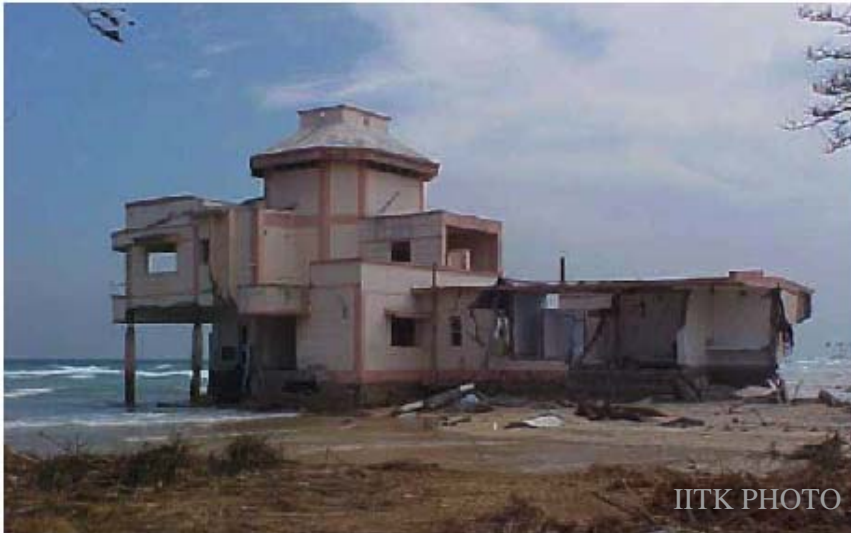
Figure 3: RC frame building (MES Inspection Bungalow) now stands in waters at the Military Residential Colony south of Malacca on the east coast of Car Nicobar Island. (Photo: CVR Murty)

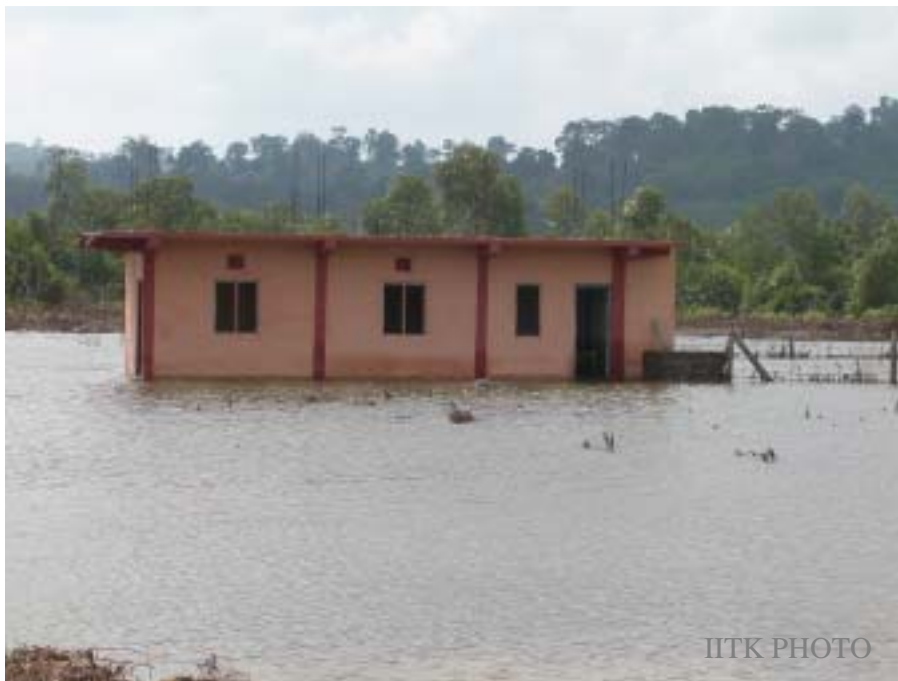
Figure 4: Sea water level at Port Blair with respect to land has gone up by about 1.0m. Hence, many areas are now flooded during high tide (Photo: Sudhir K Jain)

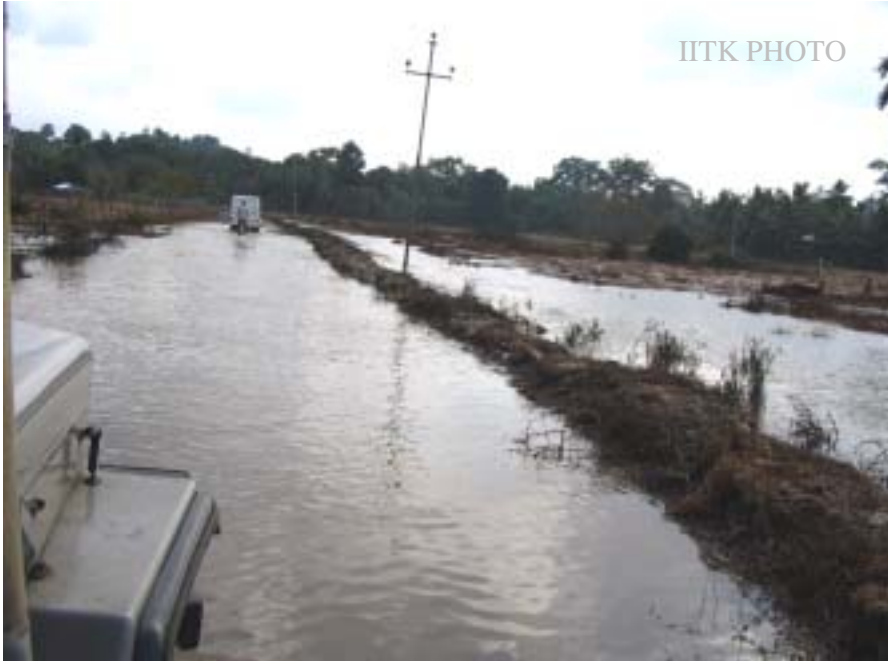
Figure 5: Sea water flooded ATR at Sipi Ghat area near Port Blair during high tide. (Photo: Goutam Mondal)

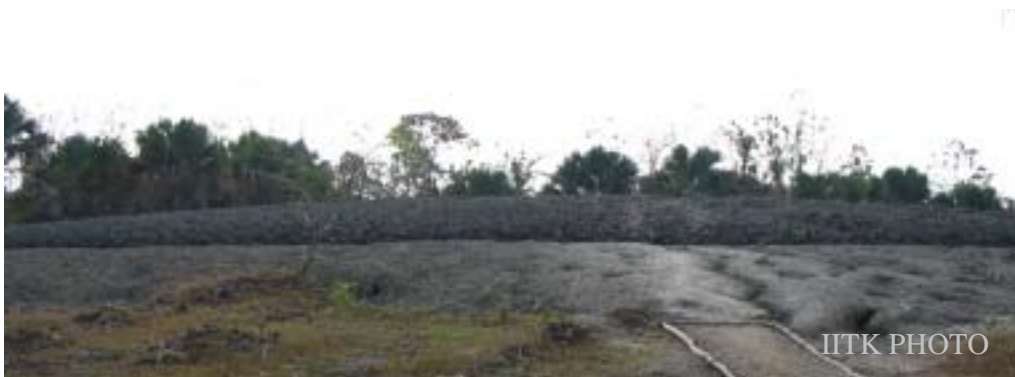
Figure 6: Eruption of a mud volcano near Jarawa Creek at Baratang Island in Middle Andaman, 105 km north of Port Blair (Photo: Durgesh C Rai)

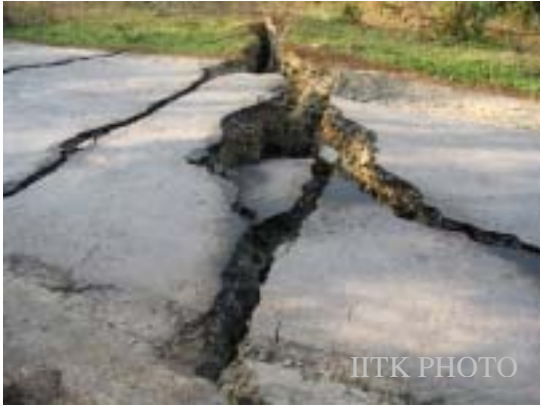
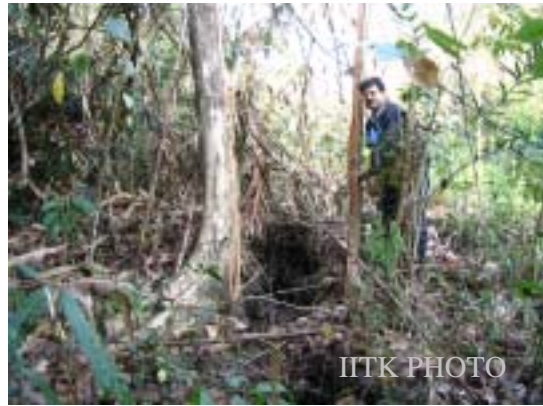
Figure 7: Ground deformation at Jarawa Creek, Baratang Island, Middle Andaman, (a) Damage to road connecting Baratang and Baludera Beach, (b) Splitting of a tree trunk due to ground rupture (≈ 1.2 m wide). (Photo: Goutam Mondal)

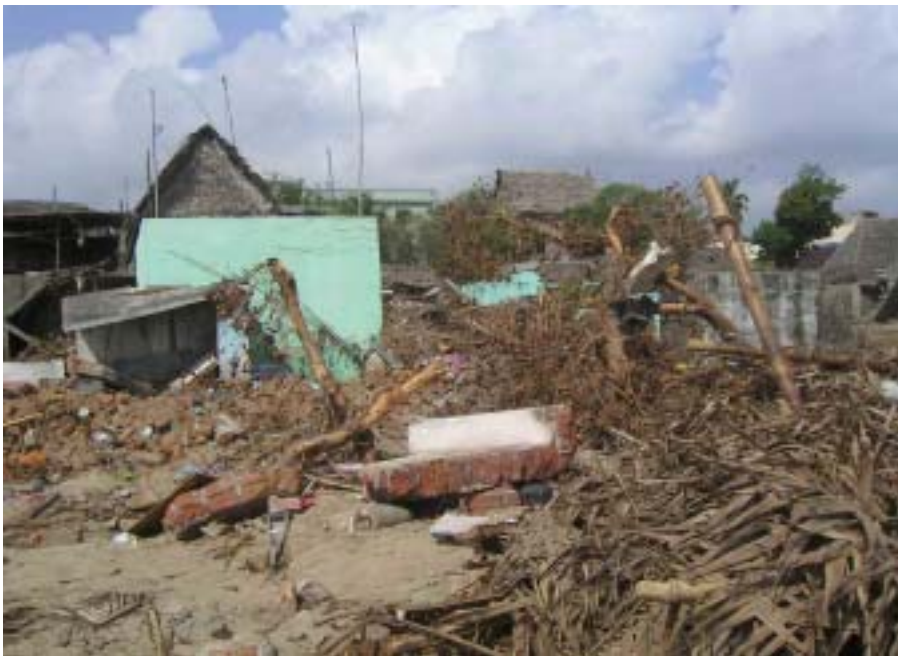
Figure 8: Ravaged houses at Nagapattinam due to poor constructions. (Photo: Alpa Sheth)

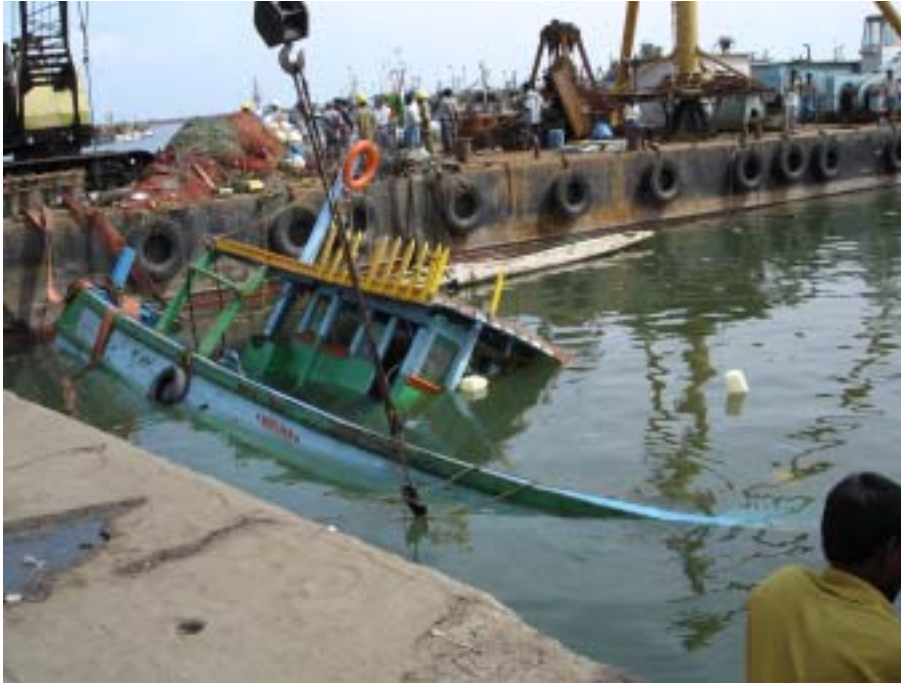
Figure 9: Small mechanized boat sunk into the harbour basin being pulled out of water at the Fisherman's Wharf at the city of Chennai. (Photo: Arvind Jaiswal)

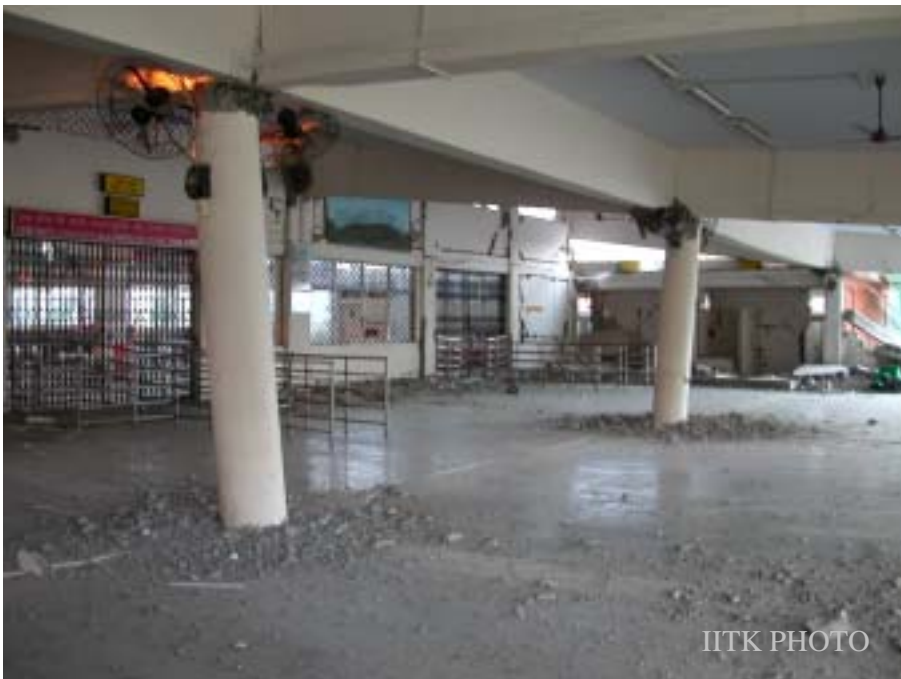
Due to the ground shaking, the wooden buildings have performed very well as compared to the more modern RC frame and concrete block masonry buildings. The latter sustained large damage when the seismic codes were not complied with. For instance, the Passenger Terminal Building at the Phoenix Bay in Port Blair was recently constructed but did not comply with the seismic codes. This rather expensive building has been irreparably damaged. A number of houses built by local people using reinforced concrete but without proper engineering supervision and seismic detailing collapsed. A three-storey apartment building in Port Blair on stilt columns, not complying with the codal requirements, collapsed. Similar damages were also observed in Rangat, and Mayabandar in northern islands as well.

Figure 10: Severe damage to Passenger Terminal Building at Port Blair. (Photo: Sudhir K Jain)

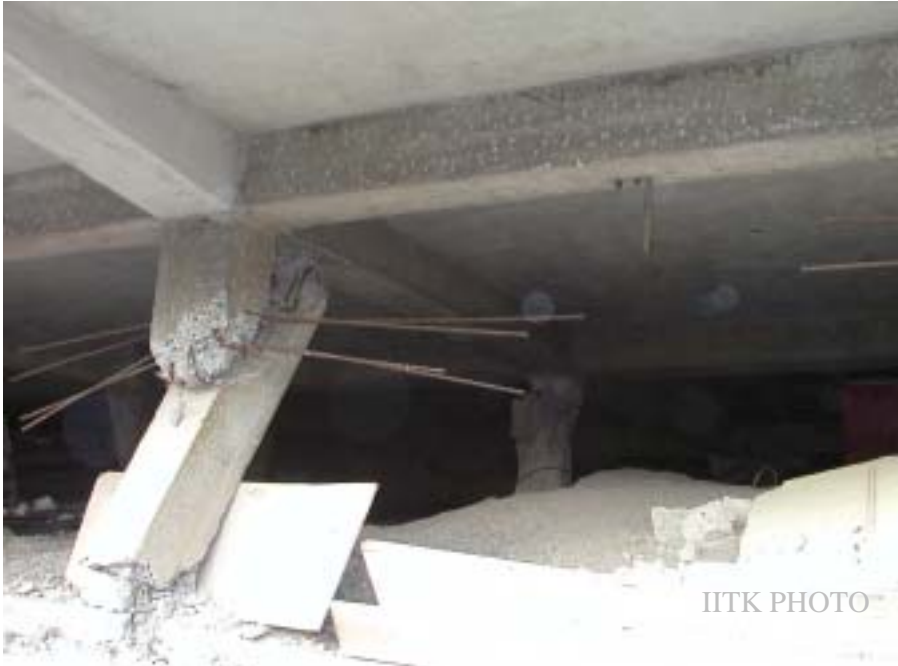
Figure 11: Collapse of a three storey reinforced concrete frame building at Port Blair (Photo: Sudhir K Jain)

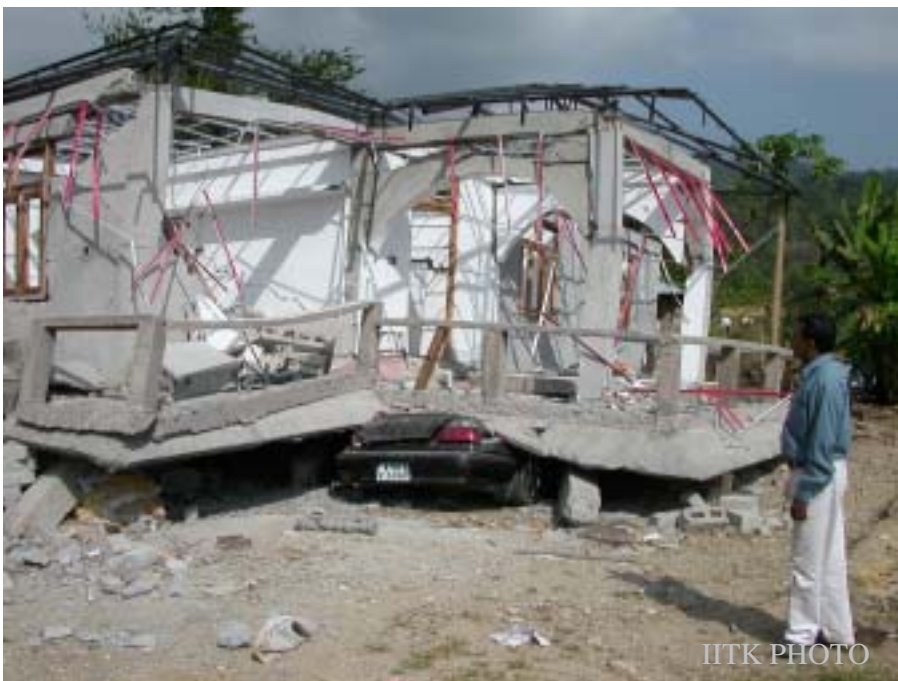
Figure 12: Collapse of a stilt Plus one storey house in reinforced concrete near Port Blair. (Photo: Sudhir K Jain)

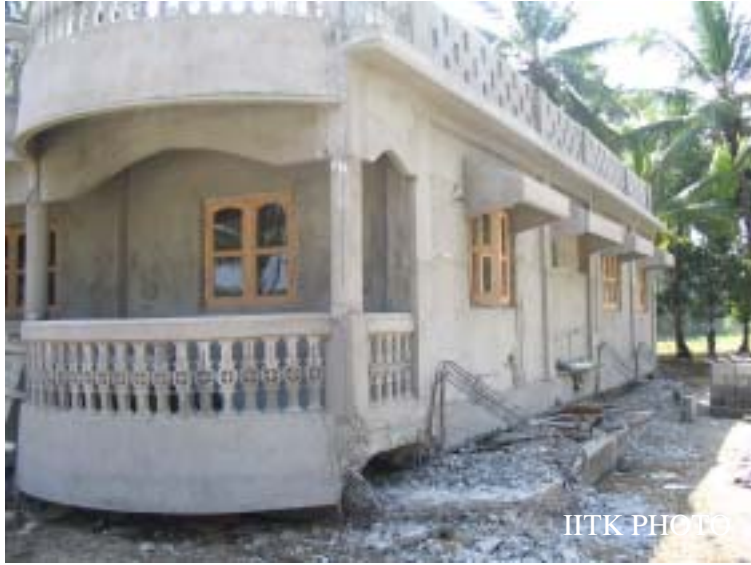
Figure 13: Collapse of an open storey reinforced concrete house at Rampur, near Mayabunder. (Photo: Durgesh C Rai)

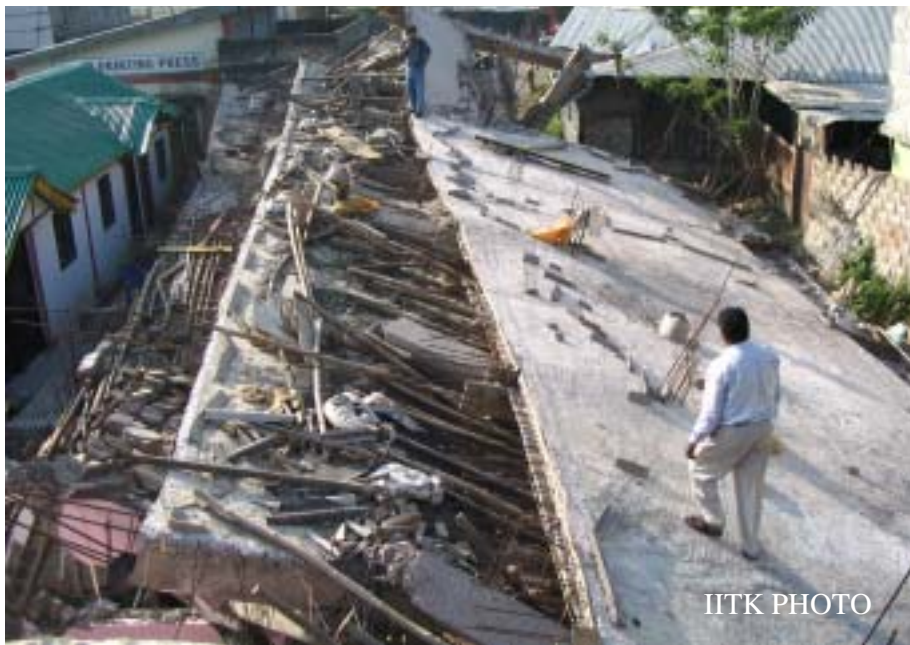
Figure 14: Collapse of RC bare frame of three storey building under construction at Rangat, Middle Andaman Islands. (Photo: Durgesh C Rai)

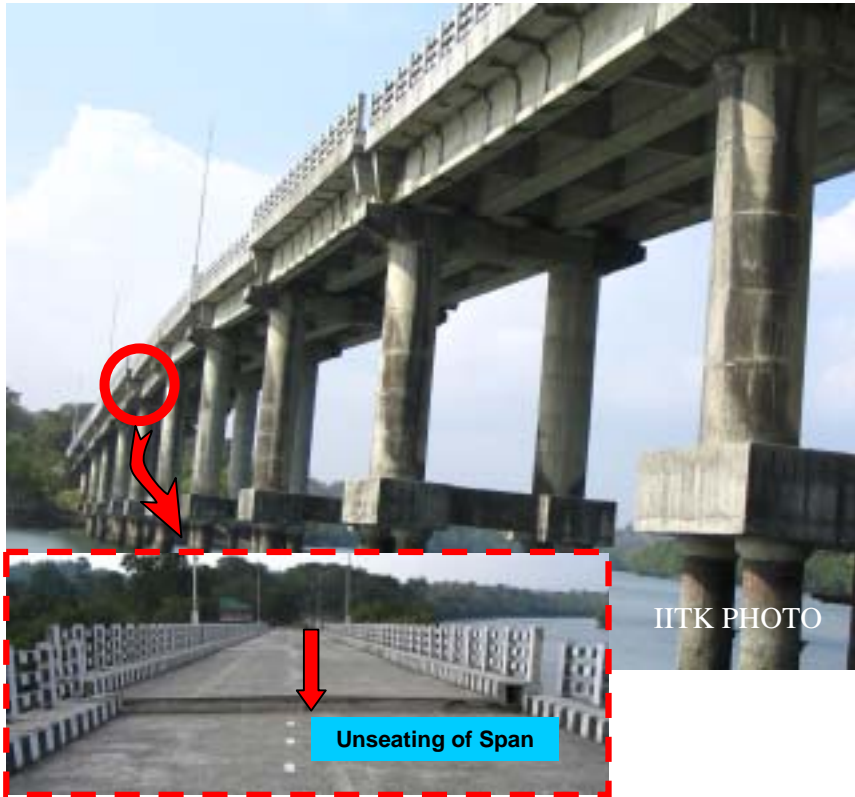
A new 268m long bridge between North Andaman and Middle Andaman at Austen Strait had to be closed to even the light vehicles. The superstructure has moved on the substructure by a substantial amount and middle three spans fell off from the bearing. Dr CVR Murty and Dr Durgesh C Rai of IIT Kanpur had visited this region two years back after a moderate earthquake on 14 September 2002 and in their published report had expressed concerns about this very bridge as follows:

“Inadequate seating of bridge deck over piers and abutments is a serious concern for its safely during a stronger earthquake in future. The bearings are simple neoprene pads which are far from satisfactory for a bridge located in seismic zone V. Bridge deck restrainers are the minimum that need to be provided to ensure that the spans are not dislodged from the piers in future earthquakes.”

Figure 15: Chengappa Bridge over Austen Strait connecting Middle Andaman and North Andaman Islands, 230 km north of Port Blair. (Photo: Durgesh C Rai)

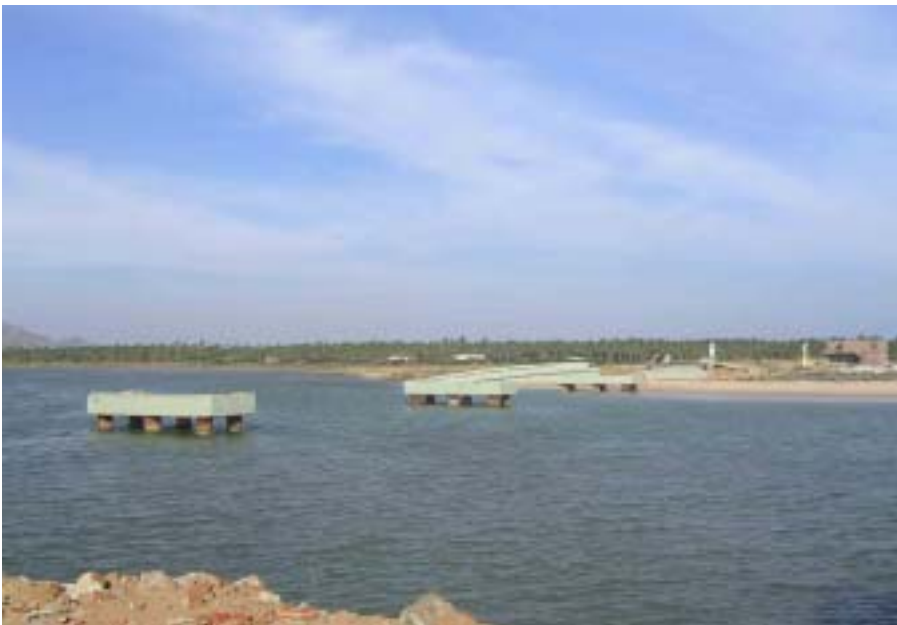
Figure 16: Complete loss of spans of the four span RC bridge at Melmannakudi. (Photo: Alpa Sheth)

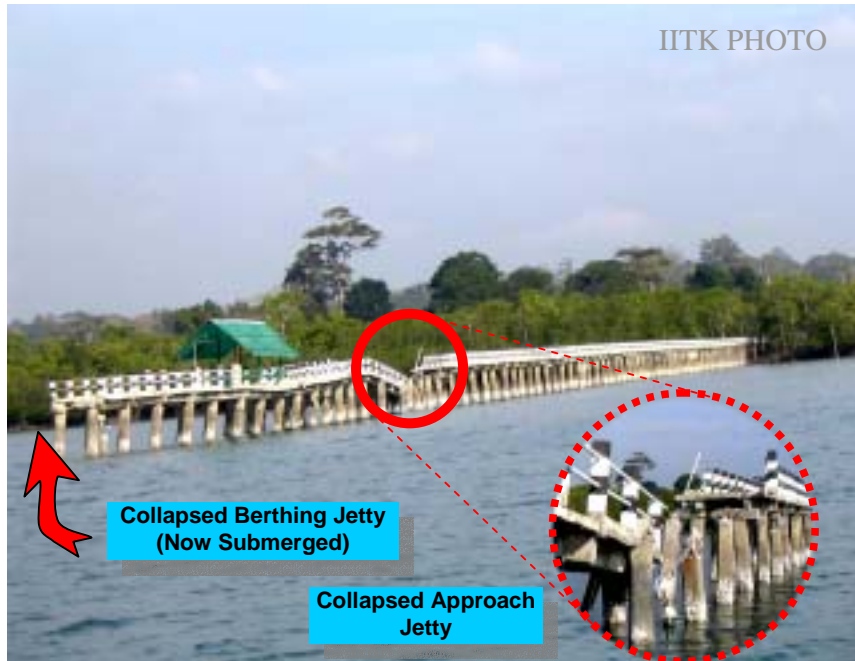
Figure 17: Gandhinagar Jetty in North Andaman: Total collapse of the berthing Jetty and partial collapse of the approach jetty. (Photo: Durgesh C Rai)

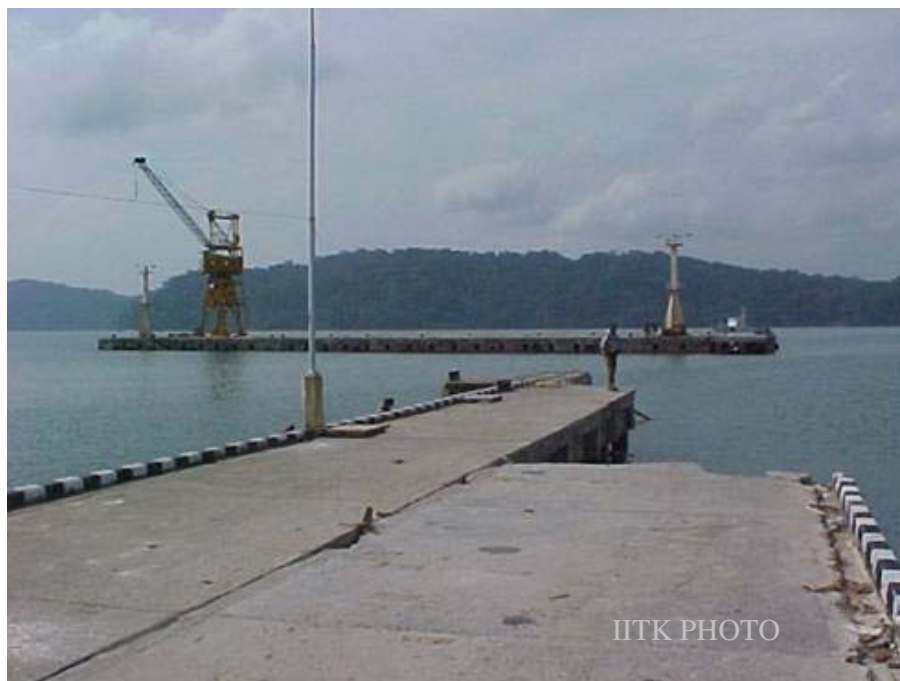
Figure 18: Collapse of the 80m segment of approach in Great Nicobar Island jetty at Campbell Bay This has adversely affected the relief work. (Photo: CVR Murty)

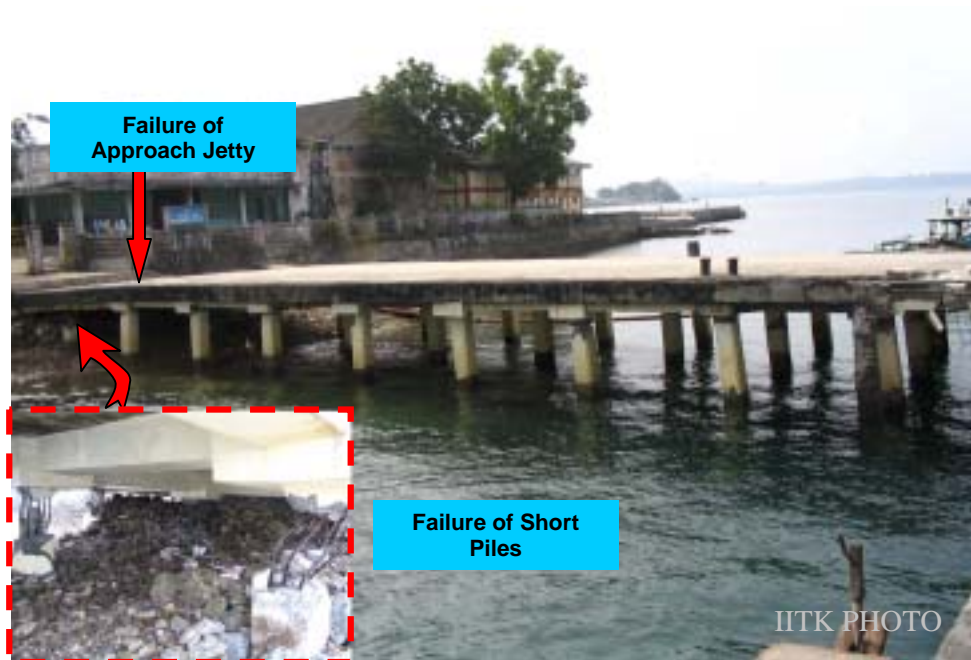
Figure 19: Shear failure of short piles of the approach jetty at Mayabandar in Middle Andaman Island (Photo: Durgesh C Rai)

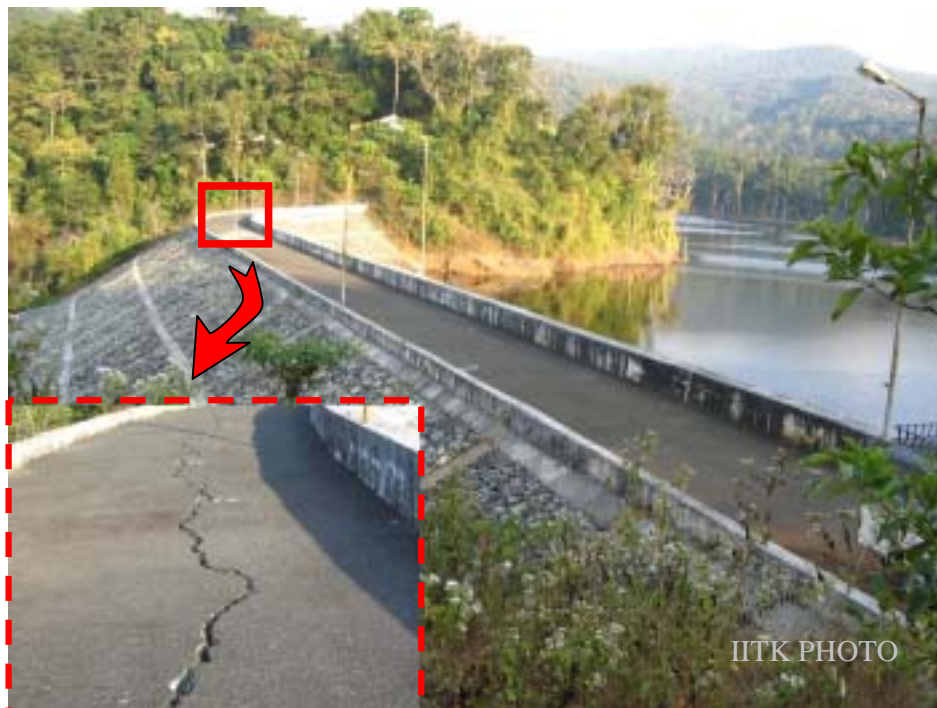
Figure 20: Longitudinal cracks at the crest of rockfill dam of the Kalpong hydro-electric project near Diglipur (Photo: Goutam Mondal).

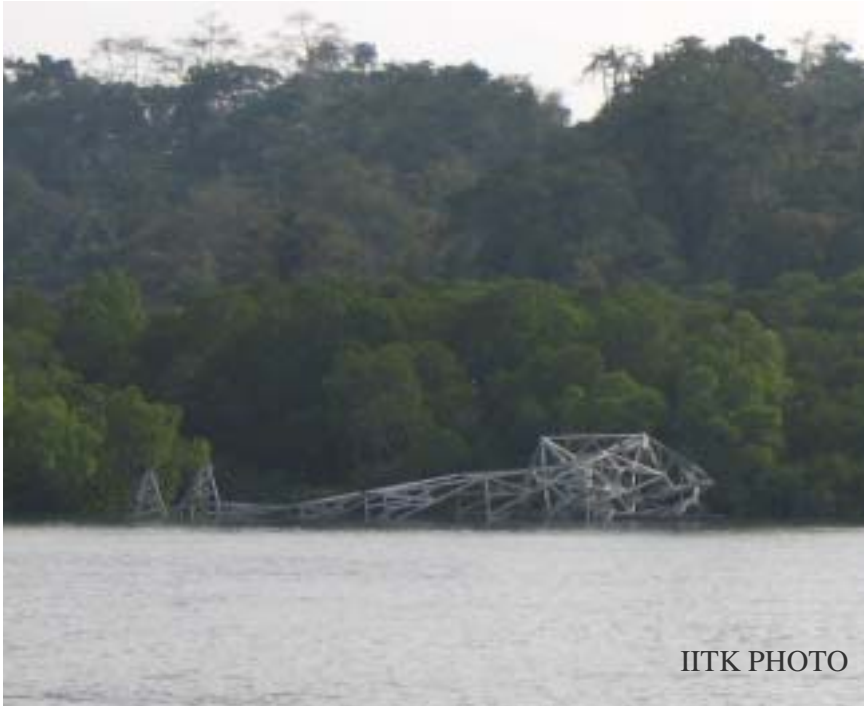
Figure 21: Collapse of electric power transmission tower at Middle Strait (between South and Middle Andaman Islands), disrupting the power supply from Kalpong Hydroelectric Project to Baratang island (Photo: Durgesh C Rai).
