## The *M* 6.9 Sikkim (India–Nepal Border) earthquake of 18 September 2011

**The *M* 6.9 Sikkim earthquake of 18 September 2011 was a remarkable event in the long history of the Himalayan earthquakes which presented a unique opportunity to reflect on the unacceptable rising trend of the seismic risk in the hilly regions. Many dramatic collapses and damages were disproportionate to the observed intensity of shaking and can be attributed to poor construction material, deficient workmanship and lack of compliance with seismic codes and earthquake-resistant construction practices. Many private and governmental buildings were constructed neglecting the seismic design and detailing requirements necessary in the Zone IV of the Indian seismic code IS 1893. The traditional construction practices prevalent in the area performed rather satisfactorily due to their inherent earthquake-resistant features. Old monastery temple structures of distinctive construction in stone masonry and timber suffered varying degree of damage to masonry walls ranging from minor damages to partial collapse. This event should be regarded as a preview of what is likely to happen in the event of a greater shaking ex

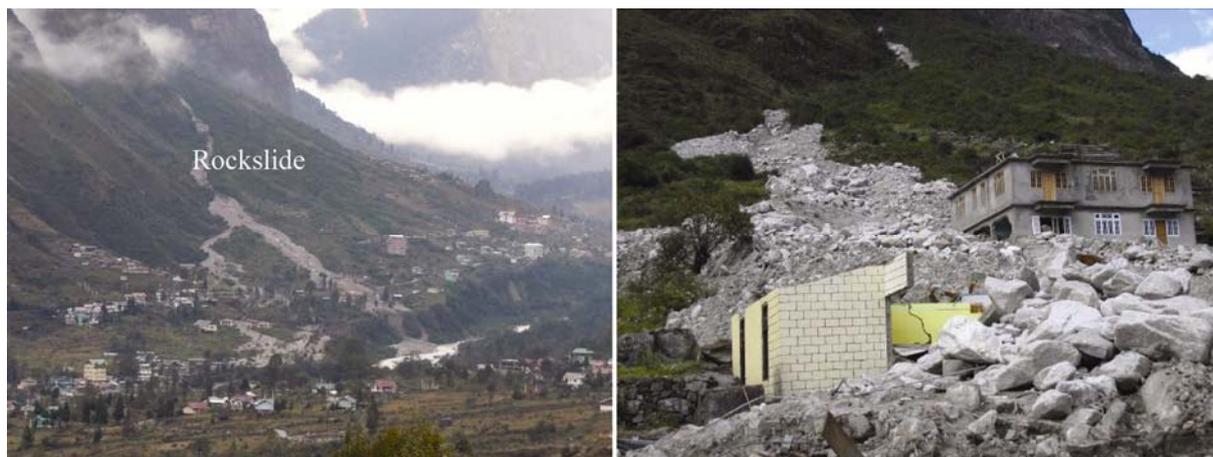
**Figure 5.** Damage due to rockslide and mudslide at Lachung.

Chunghang and Lachung in North Sikkim are two major towns which have suffered maximum damage caused by landslides and poor construction of buildings combined with intense shaking. The aerial photograph in Figure 4 shows the location of Chunghang town surrounded by mountainous terrain and river valley. The maximum intensity of shaking was observed to be VIII. In Lachung, rockslides and mudslides after two days of

the main event caused extensive damage, as shown in Figure 5. Intensity of shaking was VI in and around the state capital, Gangtok (e.g. Singtam, Dikchu, Mangan, etc). The general intensity of shaking assigned to a region is based on the observed overall effect of the earthquake on the structures. General damage to buildings was in accordance with the assigned intensity of shaking, except a few, such as the Secretariat building, two multistorey buildings in Balwakhani, and another five-storey building in Lumshey Bastey (Figure 6), all of which suffered either complete collapse or partial collapse due to faulty

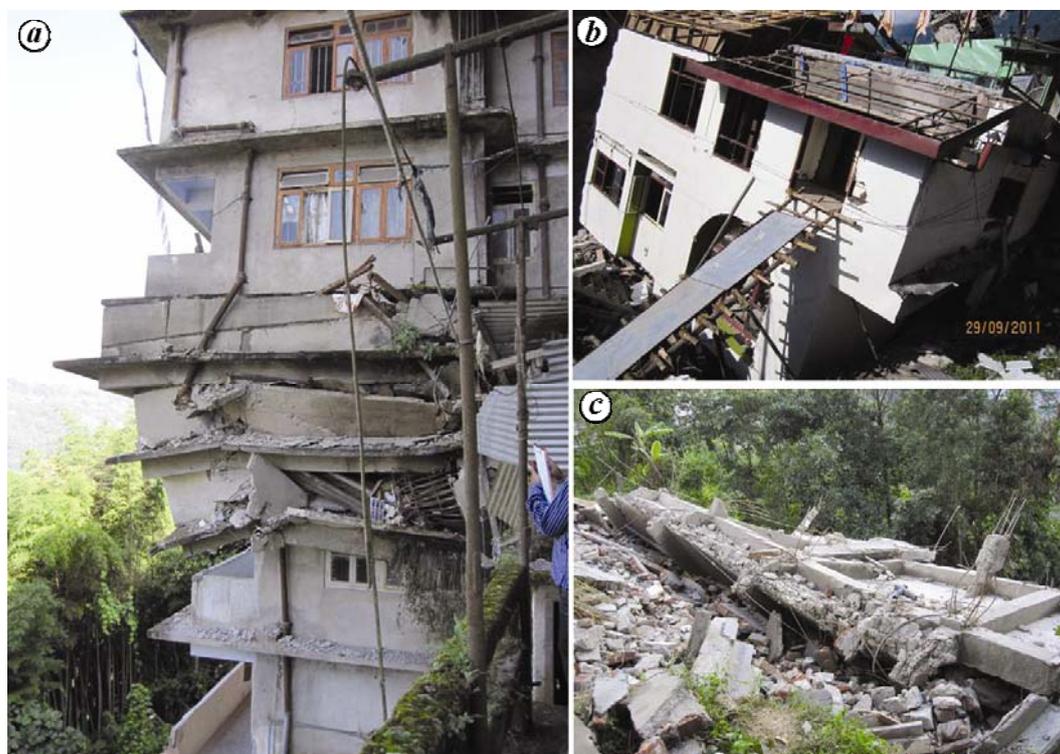
**Figure 6.** *a*, Pan-caking of the middle two storeys in a 9-storey building at Gangtok. *b*, Collapse of a building near Balwakhani at Gangtok. *c*, Complete collapse of a newly constructed 5-storey RC building at Lumshey Basti, Gangtok.

construction practices and poor workmanship. Kalimpong and Darjeeling in the northern part of West Bengal suffered moderate damages to building stock primarily constructed with stone masonry dating back to the colonial period and maximum intensity of shaking was observed to be V on the MSK scale (Figure 7). Extensive damage to school and hospital buildings was reported in the worst-affected regions of Sikkim and West Bengal.

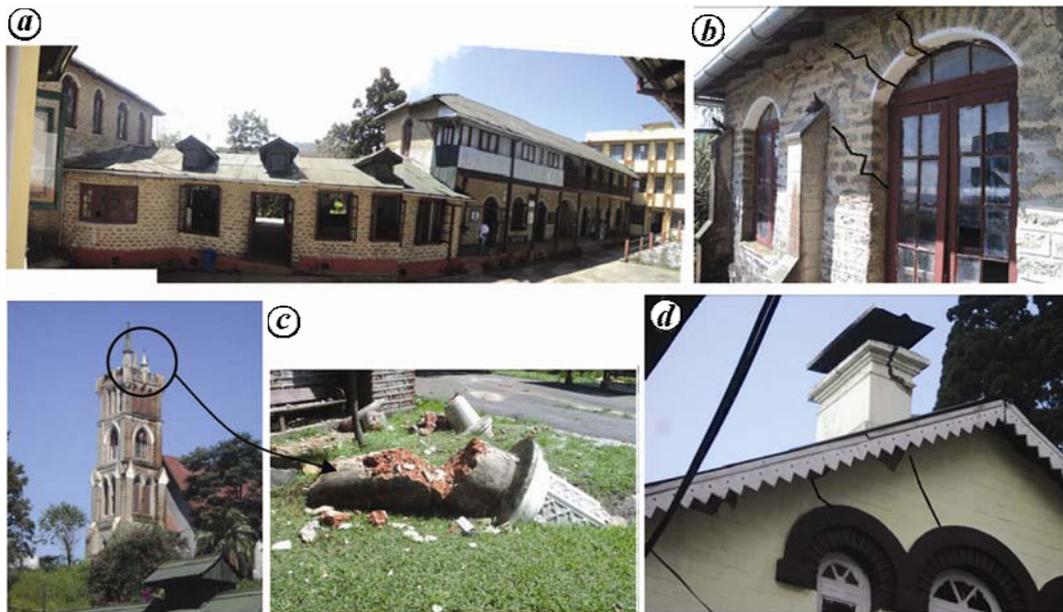
**Figure 7.** *a*, Damage reported at Kalimpong Girl's High School. *b*, Damage to semi-circular arches, diagonal cracks in masonry pier. *c*, Collapse of brick spires of Mac Farlene Church at Kalimpong. *d*, Damaged chimney and cracks in the wall above the arched openings at District Magistrate Office in Darjeeling.

in Lachung (Figure 13 *a*). Heavy damages were observed to the exterior walls at several monasteries, e.g. partial collapse at Ringhem Choling monastery in Mangan, and delamination of walls and cracks in Samten Choling monastery in Lachung (Figure 13 *b* and *c*). King's monastery at Gangtok built in dressed stone masonry suffered no significant damage. Many of the monasteries have recent additions to their structures, such as pavilions, and prayer halls constructed in RC-frame with infills, which performed satisfactorily. In Kalimpong, West Bengal, two brick spires of the historic Mac Farlene Church collapsed and the tall load-bearing walls at the gable end of the building developed numerous cracks (Figure 7 *c*).

Schools and educational buildings also suffered extensive damage, with the partial/complete collapse of around 23 school buildings reported in Sikkim alone. Moderate damages to some schools were observed in Kalimpong District, West Bengal. Schools built during the colonial period, constructed using stone masonry, had damaged to arches, diagonal cracks in walls and separation at roof-wall intersection (Figure 7 *a* and *b*). Some of the structures, including the medical centre and a dormitory of a residential school suffered severe damage, such as in-plane shear cracking and out-of-plane bending of walls, damage to arch abutments and the dislocation of the keystone.

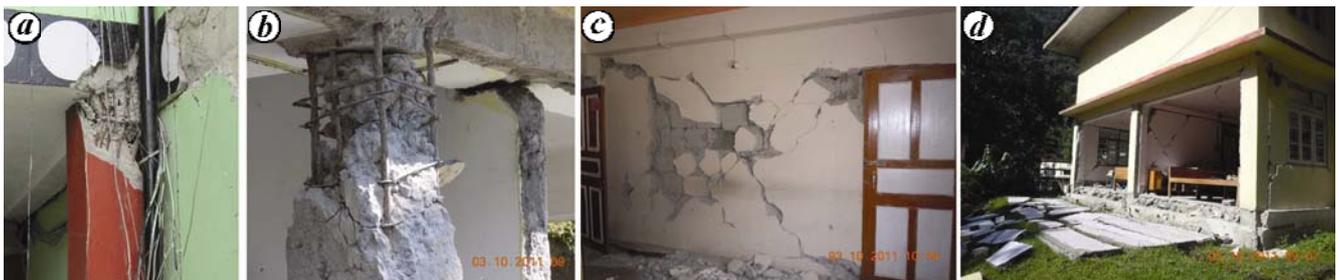
**Figure 8.** *a, b*, Typical failure at column ends (widely spaced stirrups with 90° hooks, cold junction at the column top, poor concrete quality). *c*, In-plane failure of weak infill masonry. *d*, Out-of-plane collapse of concrete block masonry walls.

Many RC buildings in Gangtok and most of them in Chungthang suffered damages of some form or the other: the most common being shear and/or flexure failure at column ends, failure of beam-column joints, in-plane failure of weak infills and out-of-plane failure of slender walls (Figure 8). The traditional houses like Ikra and Shing-Khim (meaning wooden house); Figure 9 *a* and *b* respectively performed significantly better compared to RC-frame buildings and suffered only minor damages at the basement level. Various monasteries all over Sikkim suffered damages to their thick exterior walls constructed

- Poor quality of construction and workmanship, e.g. hand-mixing of concrete, inferior quality of aggregates, no control on water/cement ratio, volume batching, improper consolidation of concrete, etc.
- Inadequate seismic detailing, e.g. no ductile detailing in RC beams and columns (lack of confining reinforcement and stirrups with inadequate hook length not bent at  $135^\circ$ ), improper splicing of bars and lapping near the beam-column joint, relatively smaller-sized columns even for buildings as tall as seven stories, cold joints in column below beam, extended floor plans in upper stories over cantilevered beams and columns with corbels, etc. (Figures 8, 11 and 12).

- Good construction practice and quality material: Rough terrain, complex topography and remote locations pose serious challenges for sound and quality construction in the hilly areas. Many unique and inherently poor construction features which significantly add to the seismic vulnerability of structures, are: weak and slender partition walls in brick/block masonry or in lightly reinforced/plain concrete; extended floor plans in upper stories supported on cantilevered beams and slabs, enclosed with slender and inadequately supported masonry walls; columns with corbels; construction on sloped ground; unstable slopes; weak retaining walls, etc. Lack of building materials and expensive transportation cost have led to the usage of various substandard construction materials. It is critical to promote good concrete and masonry construction practice and suitable alternative materials for light and strong partition walls.

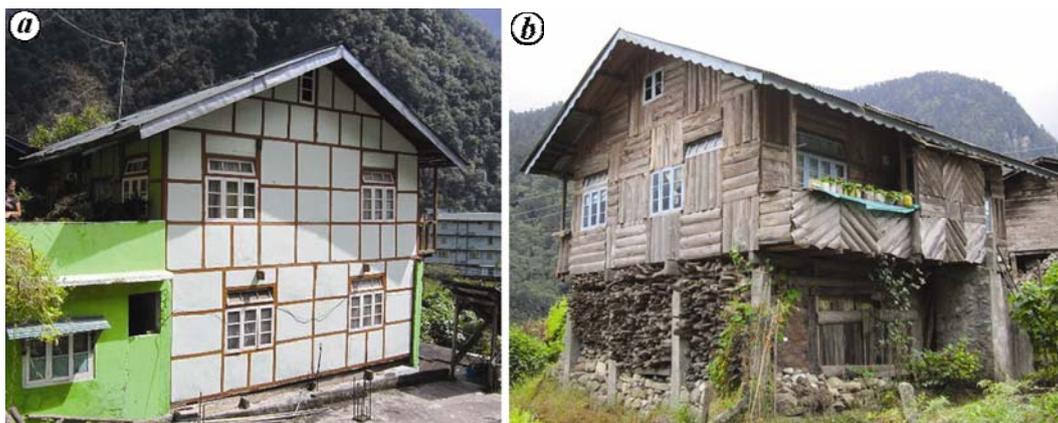
**Figure 9.** Satisfactory seismic performance of traditional construction typologies: (a) Ikra; (b) Shing-Khim house.

Traditional construction in Sikkim mostly consists of Shing-Khim and Ikra houses (Figure 9). Such houses were constructed using locally available materials and has performed well during past/recent earthquakes. These practices were observed throughout the affected area and were more in number in the upper reaches like Lachung. Shing-Khim houses are single-storey structures consisting of wooden planks connected by steel flats with bolts and nails. However, Ikra houses are 1–2-storey, timber-framed structures filled with infill panels which are

prepared by bamboo splints woven together with wooden frame and finished with cement/mud mortar plaster on both faces. In Shing-Khim and Ikra construction, the superstructure is supported on a wooden post and an exterior basement wall of R/R masonry is provided for thermal insulation. In the present earthquake no major damage was observed and reported in such houses. Damage was only observed at the foundation level to the R/R masonry in most of these buildings. Presence of wooden frame at close intervals resulted in an excellent earthquake-resistant feature that performed well. Moreover, the closely spaced vertical members prevent the propaga-

tion of diagonal shear cracks within any single panel and reduce the possibility of the out-of-plane failure of panels.

- Promotion of earthquake-resistant building typologies: The traditional houses like Shing-Khim and Ikra performed well as expected, as they evenly distribute the deformation which adds to energy dissipation capacity of the system. Locally available materials (such as bamboo and other sustainable timber alternatives) and traditional technologies which have proven their ability to resist earthquake loads should be reinstated and integrated with modern construction practices to have an appropriate design for strong and safe housing. For low-rise buildings, new building typologies of proven earthquake performance, such as confined masonry need to be introduced.

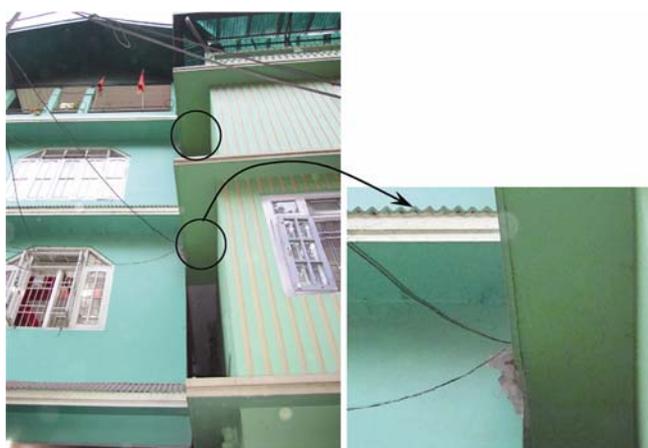
**Figure 10.** Pounding damage in two adjacent buildings at Gangtok.

to each other, sometimes with no gap at all between adjacent buildings and this resulted in damage due to pounding of the buildings (Figure 10).

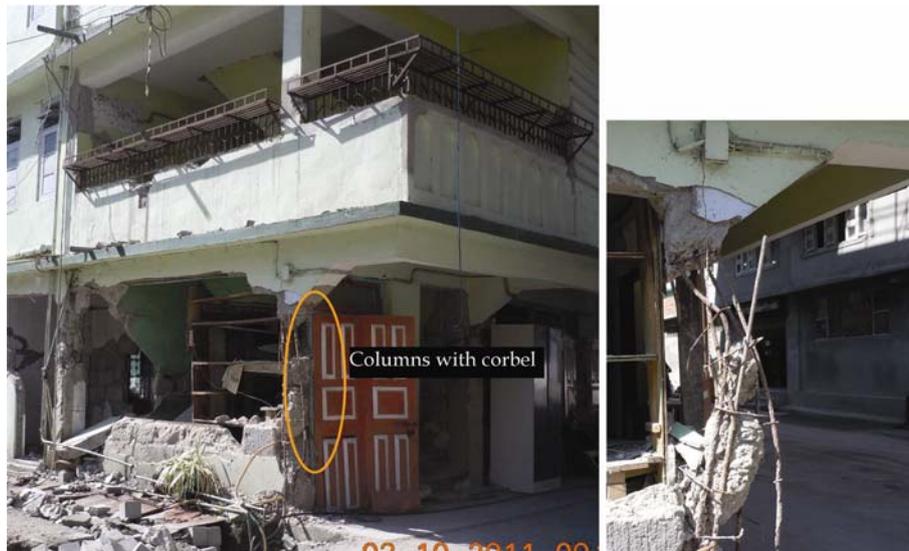
**Figure 11.** Complete damage of columns and exterior wall in a building at Chungthang due to poor detailing of column reinforcement, lack of confining reinforcement, improper splicing of rebars and inferior detailing of columns with corbel.

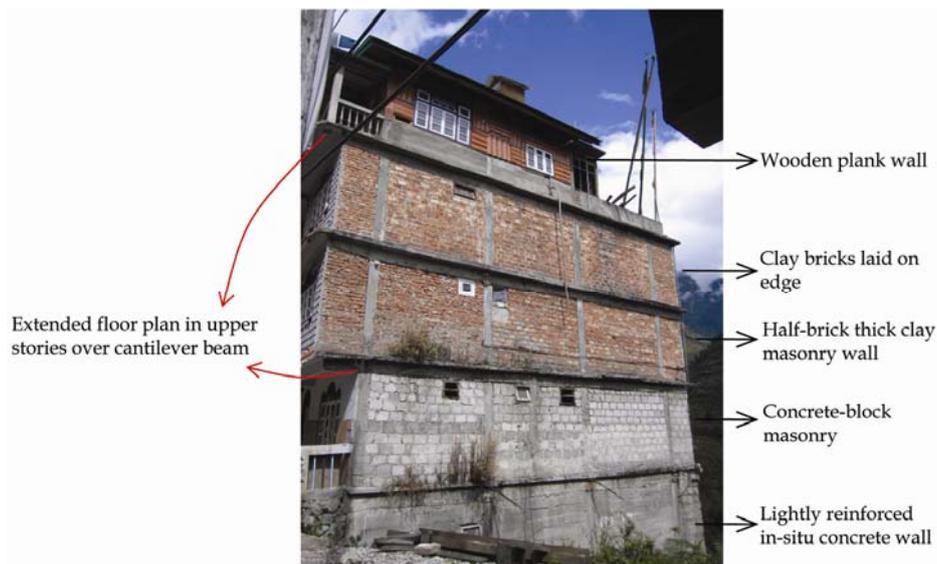
Failure of infill walls in RC-frame structure was commonly observed due to poor quality of infill material (low density/strength concrete blocks), and poor connection between walls and the supporting frame element. Most of these infill walls failed in the out-of-plane direction due to their higher slenderness ratio; as thin concrete blocks (80–100 mm), half-brick thick wall and even bricks ‘on edge’ were used (Figure 12).

**Figure 12.** Different infill materials used in different storeys in a building at Lachung.

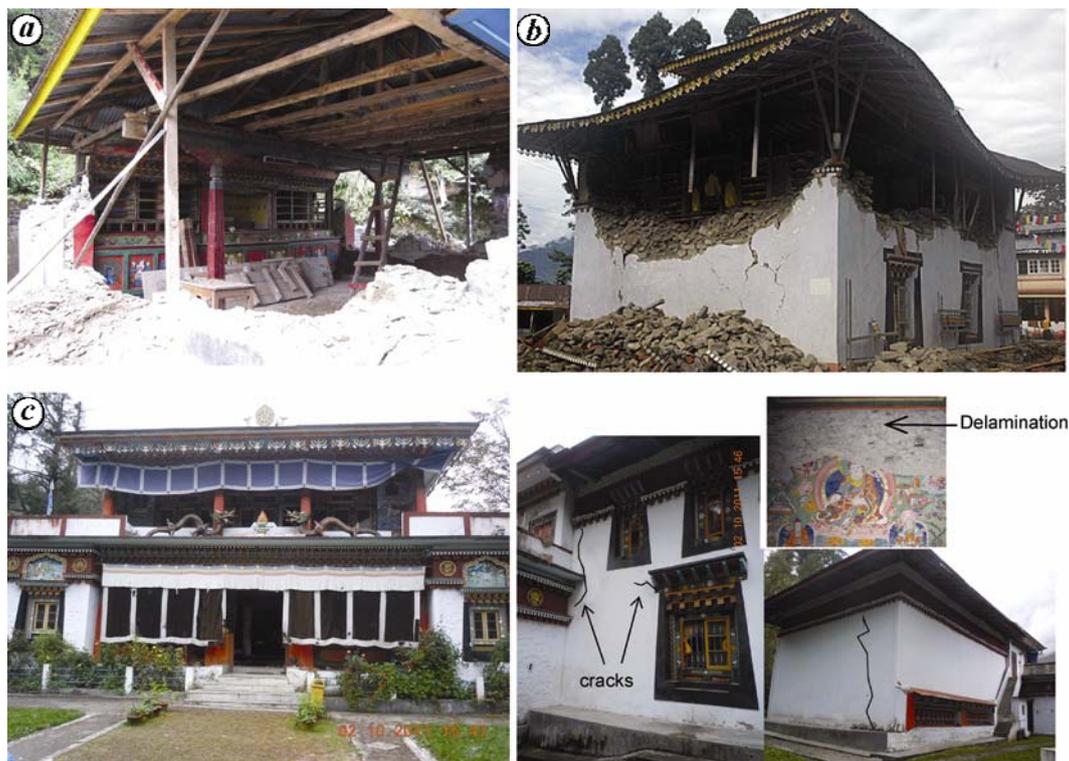
The poor seismic performance of cultural heritage structures such as monasteries is a source of concern, as it was found that almost all historic, religious structures suffered varying degrees of damage due to this earthquake. The temples (shrine hall) in monasteries are simple 1–3-tiered structures on a rectangular plan with reduced floor area for the upper stories. The exterior walls are in stone masonry, mostly R/R, while the floors and double-pitched roof are made of timber, using single post and beam system, as seen from a damaged monastery

**Figure 13.** *a*, Damaged Buddhist temple at Lachung illustrates typical construction features, with exterior walls in stone masonry and doubled-pitched roof timber construction. *b*, Partial collapse of exterior masonry walls and timber floors on simple beam-post system holding up for Ringhem Choling Monastic temple at Mangan. *c*, Damages seen in the historic portion of Samten Choling monastic temple at Lachung (right), while there were no damages to the new addition of RC-framed pavilion at the front entrance (left).

- Heritage and important buildings: Monasteries which are important historic structures and add to the cultural heritage of the state suffered varying degrees of damage. These structures being old and weak could not resist the seismic loads and thus need to be effectively strengthened to safeguard against future tremors. Important buildings, such as schools and hospitals which are vital in the post-earthquake relief and rescue efforts must be built earthquake-resistant on a high-priority.
