## M 6.7, 4 January 2016 Imphal earthquake: dismal performance of publicly-funded buildings

Durgesh C. Rai<sup>1,\*</sup>, Hemant B. Kaushik<sup>2</sup> and Vaibhav Singh<sup>3</sup>

**Keywords:** Earthquake effects, reinforced concrete frame, seismic vulnerability.

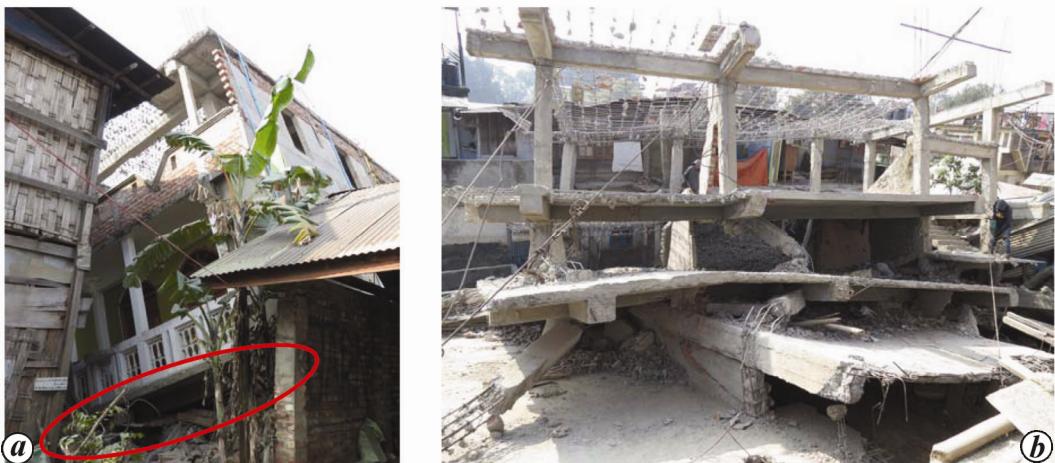
**Figure 2.** *a*, Collapse of a 3-storey building in Keishampat, Imphal; *b*, Collapse of a 4-storey building in Dewlahland, Imphal.

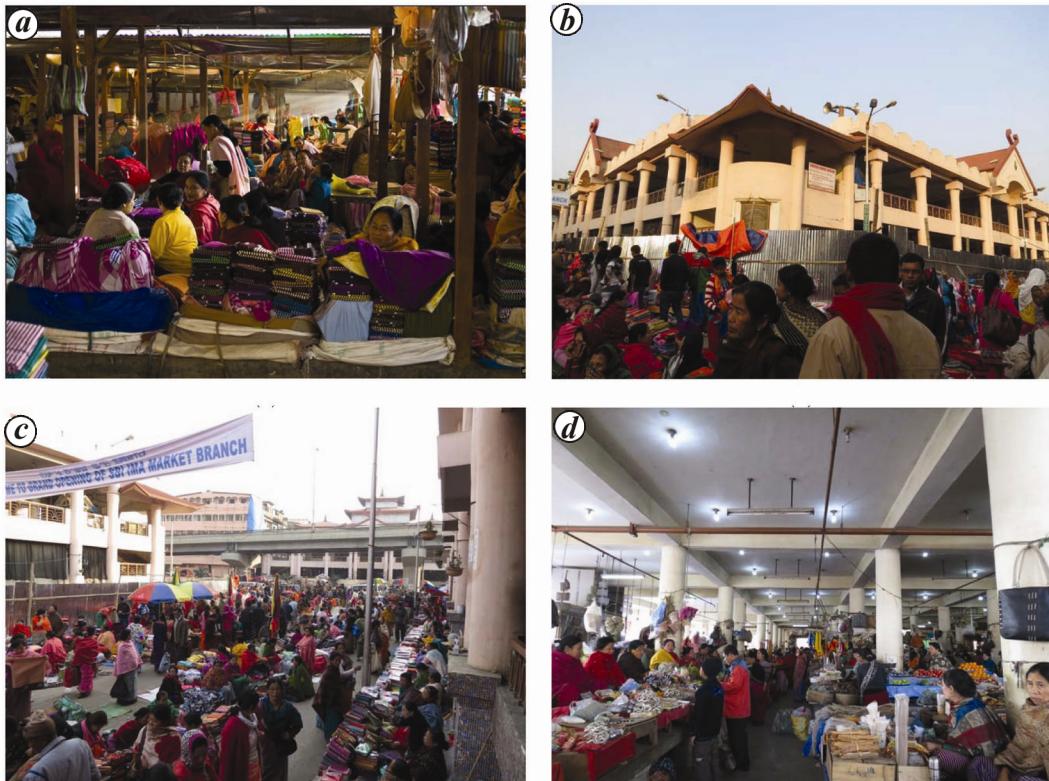
**Figure 4.** *a*, Old buildings in Ima Keithel complex were primarily steel truss sheds supported over steel or bamboo posts (<http://www.trekhub.in/blog/a-trek-through-old-bazaars-of-india/>); *b*, Newly constructed RC building in Ima Keithel complex (Keithel-1 or Ima Market is shown here); *c*, Vendors doing routine business outside the damaged building of New Market; *d*, Vendors doing routine business inside the undamaged Ima Market.

market operated their business inside the building as usual (Figure 4 *d*).

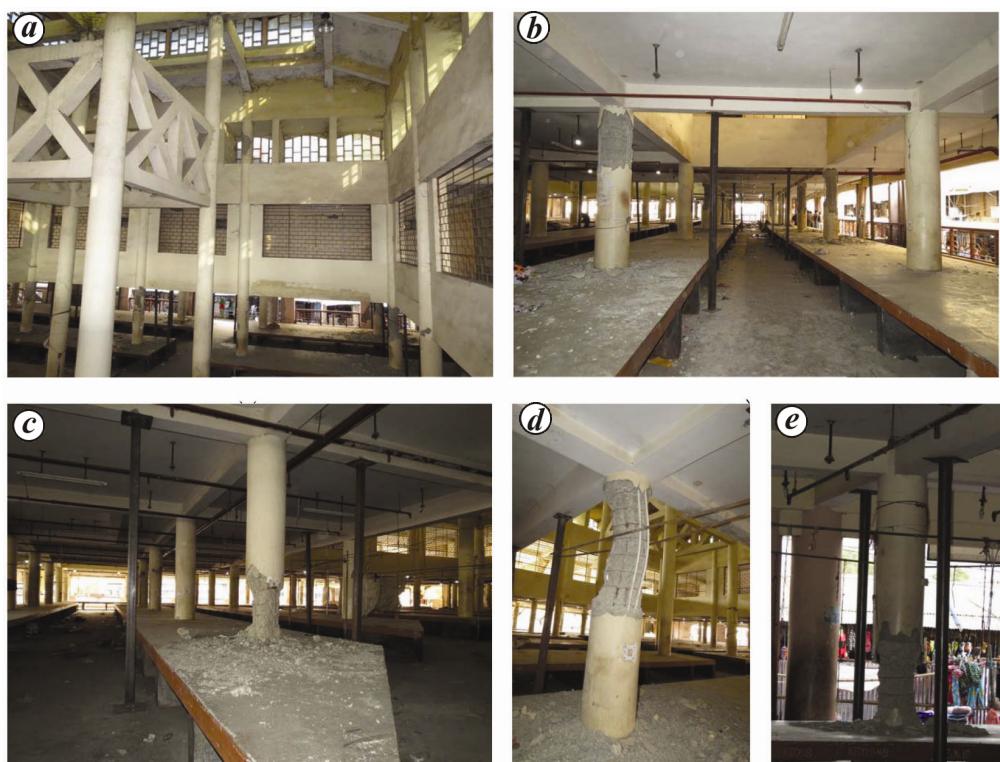
**Figure 5.** *a*, Soft first storey in Laxmi Market; *b–e*, severe damage to the RC columns of Laxmi and New Market.

Though the structural plan of all three buildings was more or less symmetric and regular, the masonry infill walls were placed un-symmetrically in the upper floors (other than the basement and the first floor). The concrete and workmanship used in the buildings appeared to be of poor quality. RC retaining walls were provided at the periphery in the basement of all the three buildings. All three buildings were supported on RC raft foundation. The presence of RC walls in the basement and masonry infill walls in the second and third storey resulted in the formation of a soft first storey (Figure 5 *a*). Moreover, since the infills in the second and third storeys were pro-

vided un-symmetrically, the heavier and stiffer side of the buildings attracted more lateral force. Hence, the columns in the eastern side of the first floor of the two buildings suffered more damage during the earthquake (Figure 5 *b*). Some columns were so badly damaged that the longitudinal bars underwent buckling, resulting in large axial deformation (Figure 5 *c–e*).

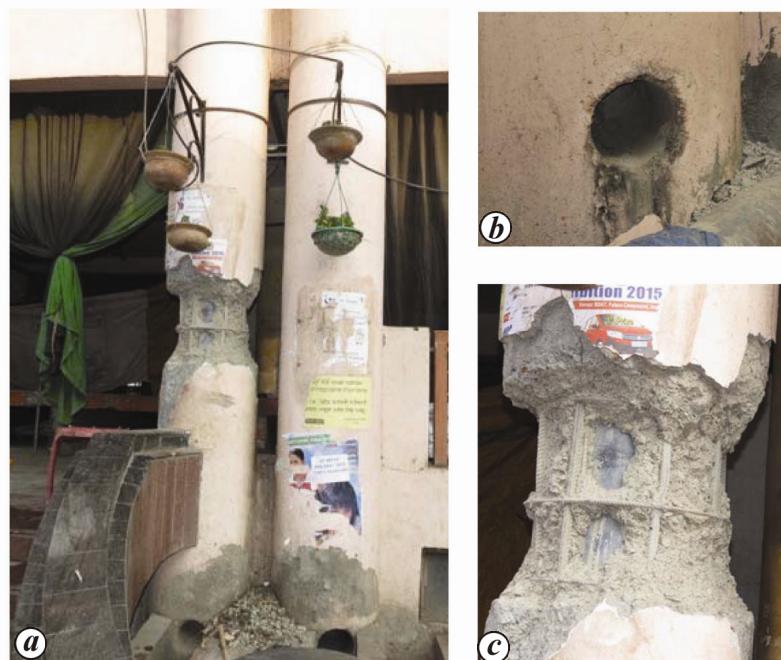
**Figure 6 a–c.** Concealed drain water pipes inside the exterior columns further compromised the confinement of core concrete in the circular columns of the buildings.

All columns in the buildings have circular cross-section. Thicker columns were provided on the periphery to conceal PVC rain water pipes (RWP) of 150 mm diameter inside the columns. This further compromised the confinement of core concrete in these columns (Figure 6). In most exterior columns, the RWP were provided along the periphery of the circular hoops (Figure 6 *a*). In

some locations, where two adjacent columns were closely constructed, the RWP were provided at the centre of one of the columns and along the periphery of hoop reinforcement in the other column.

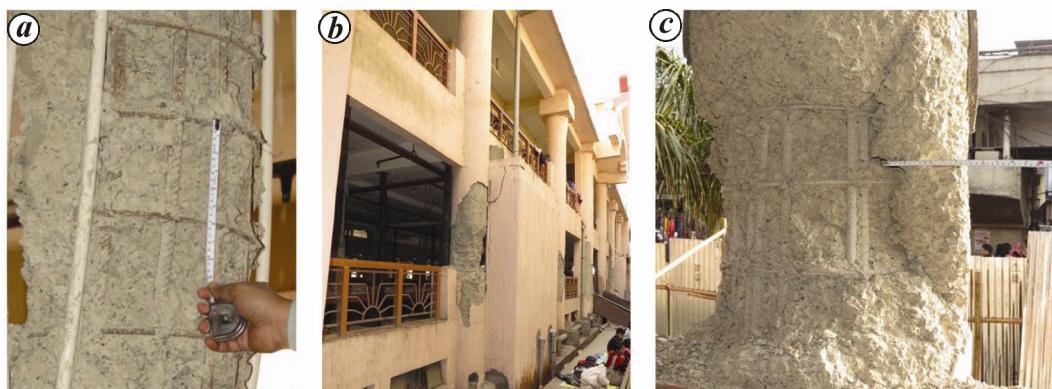
**Figure 7.** *a*, Non-ductile detailing in columns of the buildings; *b*, Short column effect in columns due to presence of parapet walls; *c*, Irregular concrete cover in columns.

In addition to poor material quality used in the building, it was observed from the damaged regions of the columns that, the reinforcement details did not comply with the ductile detailing provisions of IS 13920 (ref. 10). The spacing of circular stirrups was as high as 200 mm in some locations and 135° hooks were not provided in the stirrups (Figure 7 *a*). Vertical alignment of longitudinal steel bars was not maintained at several places, which resulted in unequal stress distribution in the stirrups. All longitudinal reinforcing bars were spliced at the same

level in the columns, resulting in a weaker section where most damage took place. Short column effect was observed in several first storey columns due to the presence of RC slab at 450 mm height (provided for displaying items for sale in the market) and also due to the provision of parapet walls along the periphery between the columns in the first storey (Figures 5 *c* and 7 *b*). Short column effect damaged several columns in the first storey of the buildings. Provision of irregular cover to concrete (as thick as 150 mm in some cases) resulted in spalling of cover concrete in several columns (Figure 7 *c*). In addition to the columns, severe damage was observed in staircases and several masonry infill walls of both buildings (Figure 8 *a* and *b*). The staircase and masonry

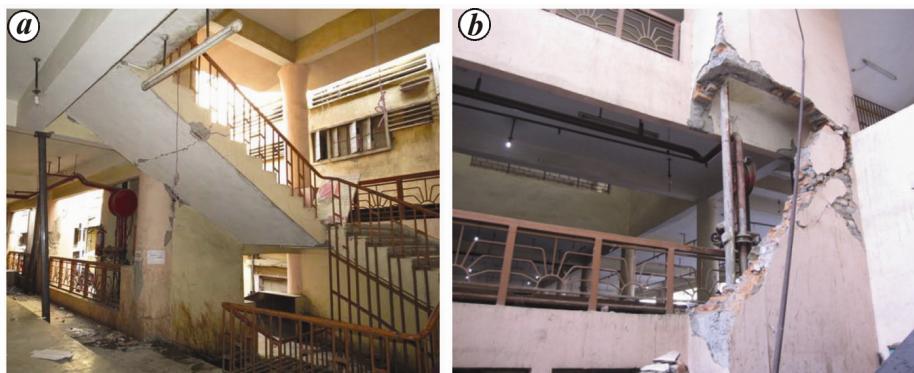
**Figure 8.** *a*, Severe damage to waist slab of RC staircase in Laxmi market; *b*, severe damage to masonry infill walls.

infill walls were in fact hanging precariously during our visit.

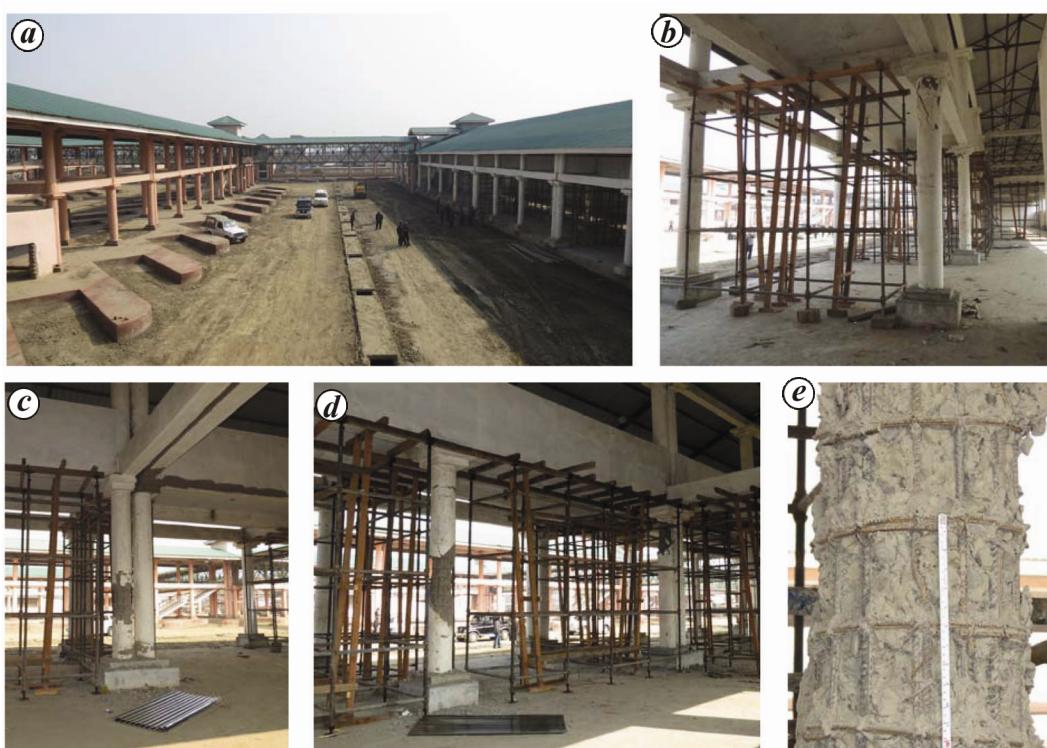
**Figure 9.** *a*, A view of Inter-State Bus Terminal at Imphal; *b-d*, severe damage to RC columns; *e*, non-ductile detailing in columns.

The Inter-State Bus Terminus (ISBT) built with the North Eastern Council (NEC) funding for the benefit of not only Manipur but also people of other north-eastern states, experienced major damage in many RC columns during the earthquake. ISBT was one of the many projects inaugurated in December 2011. However, even after 5 years, the ISBT complex was not fully functional (Figure 9 *a* shows the current status of ISBT). The RC columns in the buildings also have circular cross-section and consist of similar design and detailing defects as observed in Laxmi and New markets. Thus, many of these columns suffered severe damage during the earthquake as shown in Figure 9 *b–e*. It was surprising to notice that such an important publicly-funded building with simple and regular structural configuration had experienced this intensity of damage during a moderate level shaking. This level of shaking is significantly less than what is expected in the design level earthquake in highest seismic zone V of the Indian code.

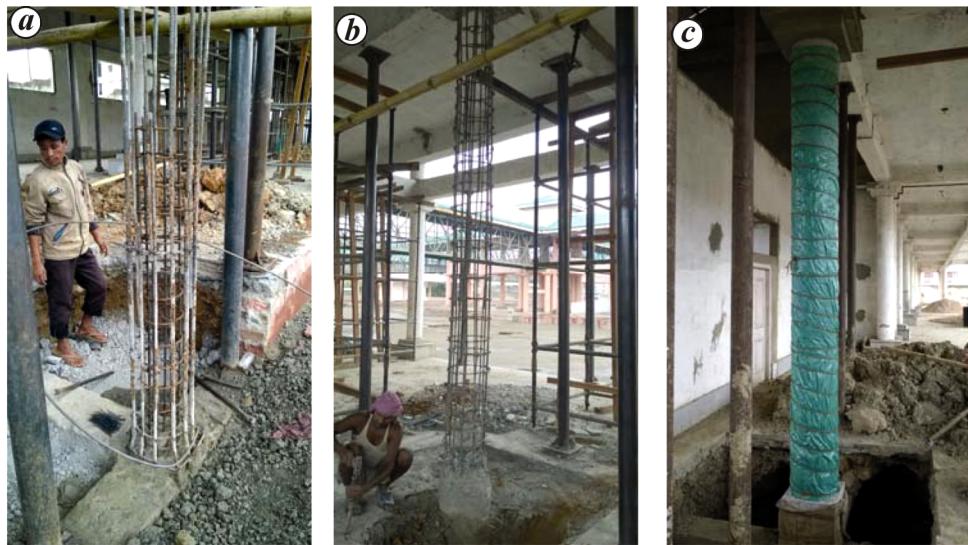
**Figure 10 a, b.** Retrofitting of RC column by replacing circular ties with helical reinforcement and addition of longitudinal bars along with ties in the existing concrete core; **c**, view of retrofitted column wrapped with plastic sheet for curing.

During the next visit to ISBT after three months, we observed that the retrofitting of the damaged RC columns was in progress (Figure 10). The retrofitting work involved replacing of circular ties with helical reinforcement and adding another layer of longitudinal reinforcement along with ties inside the original concrete column core. Though some steps were taken by the state PWD for restoring the structure from its damaged state, the effectiveness of this retrofitting technique is suspect and open to discussion. First, proper assessment is required to determine the performance level of the damaged building. Then an appropriate strengthening scheme should be developed, provided that the building achieves an adequate level of performance related to life-safety of occupants. The concerned authorities should follow the Indian code IS 15988 (ref. 11) and IS 13935 (ref. 12) for seismic evaluation and strengthening of buildings.

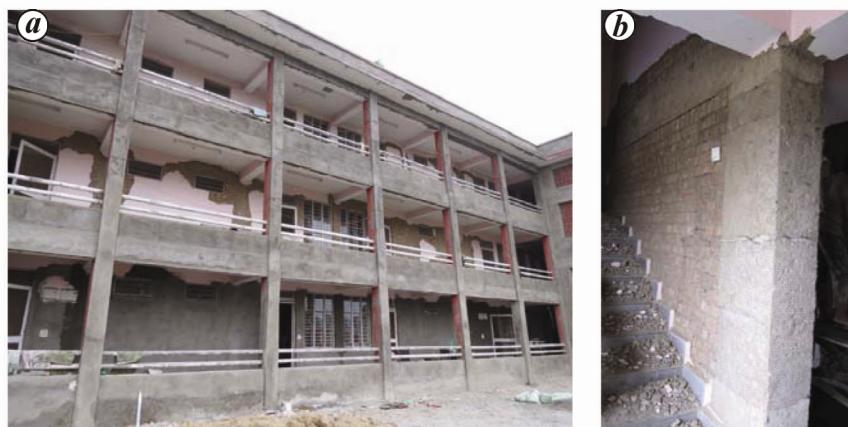
**Figure 11.** **a**, Damage experienced by hostel building in SAI complex; **b**, repairing of crack with plaster reinforced with steel wire mesh.

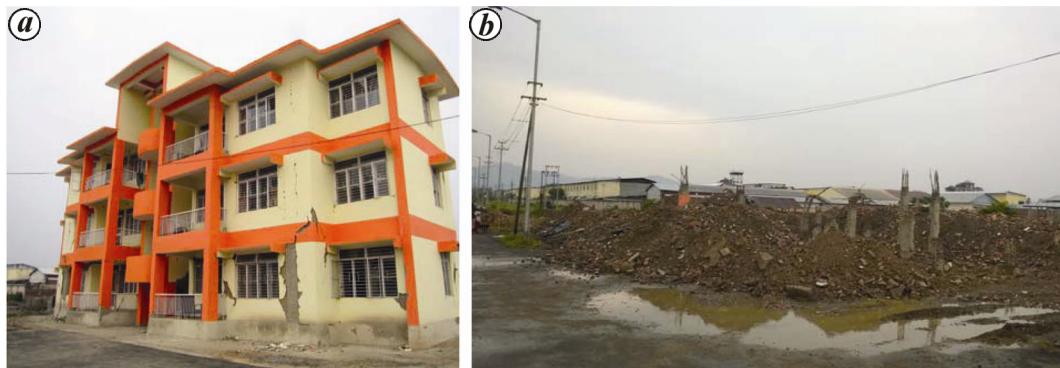
**Figure 12.** *a*, Minor to moderate damage experienced by staff/coach quarters in SAI complex; *b*, View of demolished quarters after three months.

part of SAI complex at Imphal was constructed in 2010, ahead of the Commonwealth Games in New Delhi. However, few buildings such as residential quarters for coaches and staff were recently constructed, which are yet to be handed over to SAI. The SAI complex hostels and newly built staff quarters that suffered cracks during the 4 January earthquake were deemed unsafe and forced most hostellers and staff to leave for their homes (Figures 11 *a* and 12 *a*). The authorities, however, started repairing the damaged portions within a week after the earthquake. The repair work only included covering of cracks with plaster, reinforced with steel wire mesh (Figure 11 *b*). This impromptu restoration work cannot ensure acceptable performance of the structure in case of another earthquake. However, no such repair work was taken up for the newly constructed three storey quarters built for the accommodation of staff coaches (Figure 12 *a*).

It was rather disturbing to see during the next visit, that the three storey building (Figure 12 *a*) which experienced minor to moderate damage was completely demolished (Figure 12 *b*). The visible details of RC columns in Figure 13 clearly indicate that the columns were unnecessarily over/heavily reinforced. For the sake of ductile detailing, huge amount of confining and longitudinal reinforcement was provided in column. Generally such large amount of reinforcement in small size columns is not recommended to achieve good compacted concrete. The column sizes for the demolished building vary from 230 mm × 300 mm to 230 mm × 500 mm and longitudinal bar of 25 mm diameter was used in these columns. The percentage of longitudinal reinforcement appears to vary from 4.5 to 5.8, which is higher than the recommended limit of 4% prescribed in the Indian code IS 456 (ref. 13).

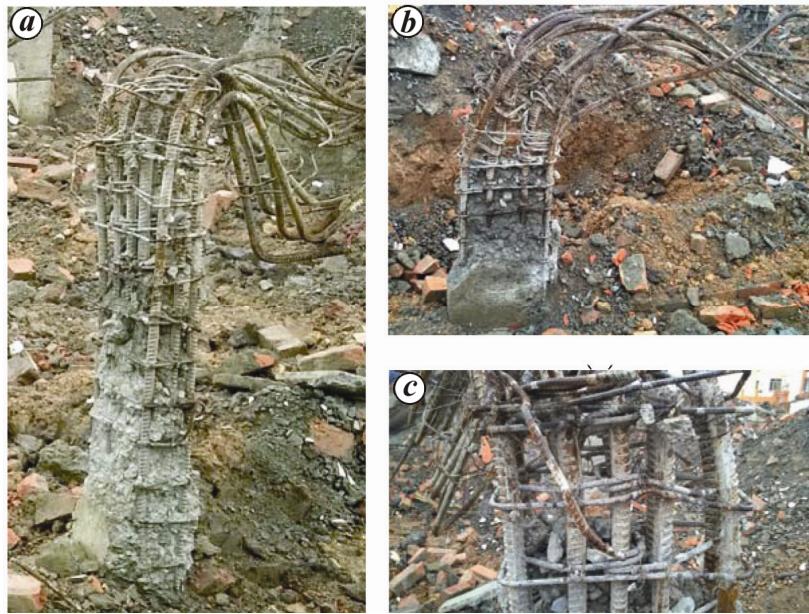
**Figure 13 a–c.** Huge amount of reinforcement provided in concrete columns of staff quarter building at SAI, Imphal.
