# The Republic Day Earthquake in the land of M. K. Gandhi, The Father of the Nation

**Learning from Earthquakes ::** A field report on structural and geotechnical damages sustained during the 26 January 2001 M7.9 Bhuj Earthquake in Western India

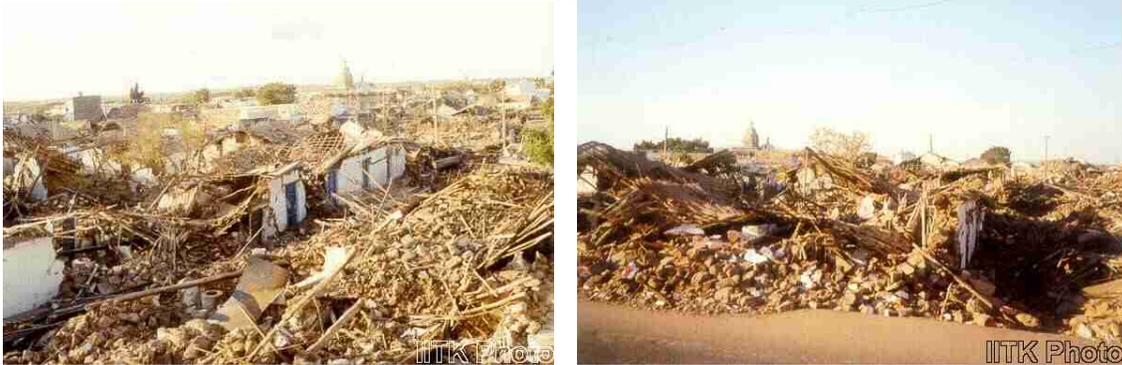
A common site of destruction of the villages in the meizoseismal area.

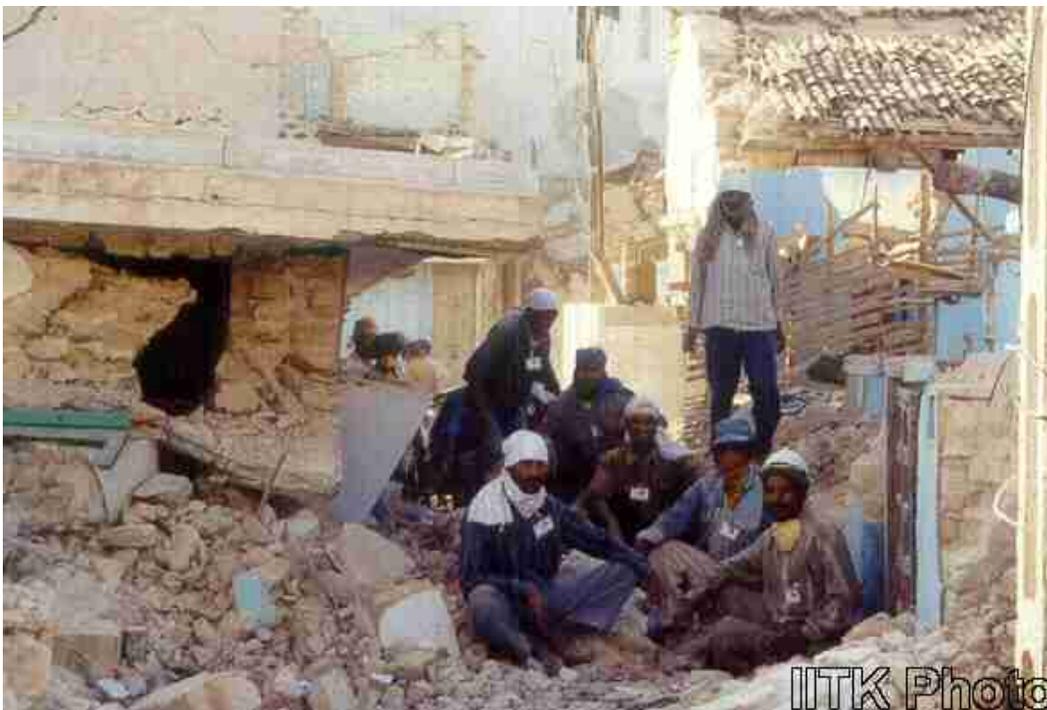
Common man learns: even RC frame buildings can break apart!!

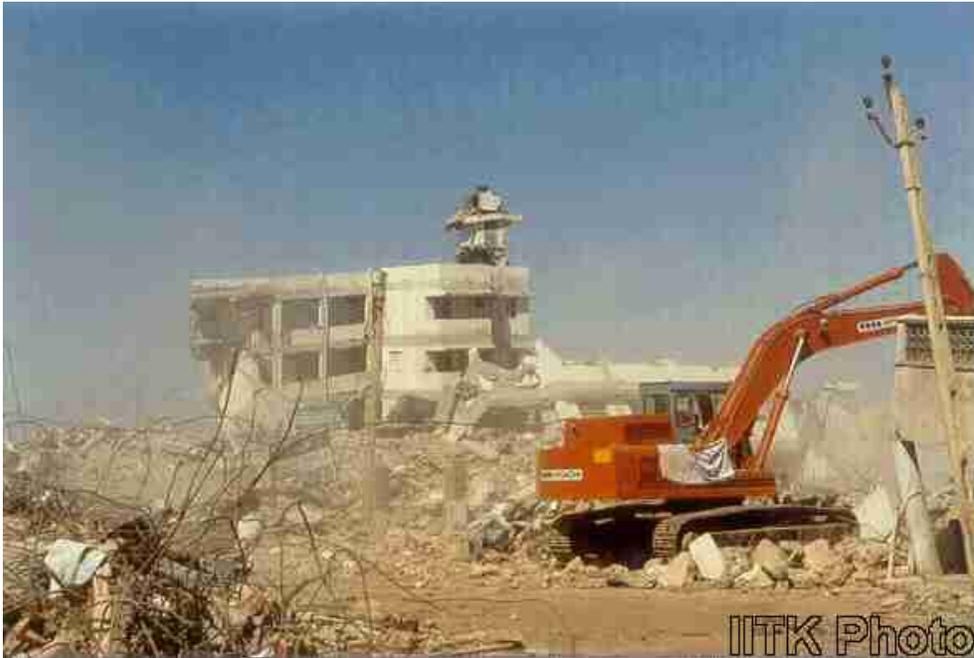
Virtually nothing could be recovered from most RC frame buildings that collapsed. Clearing of debris from collapse of numerous multistorey RC frame buildings was an even bigger challenge.

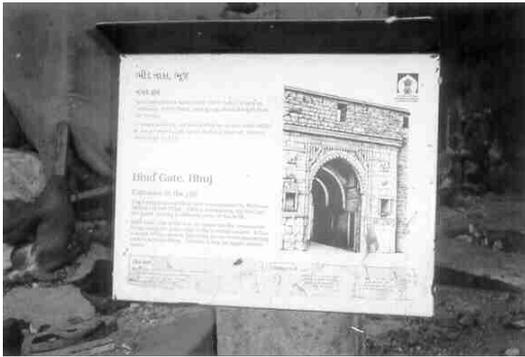
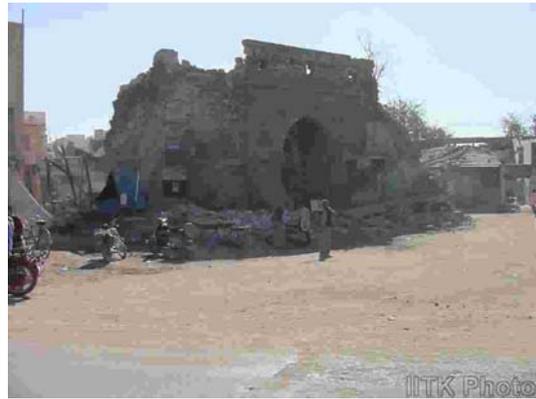
Damage to the Bhid gate at Bhuj. This gate seems to have been rehabilitated earlier also.

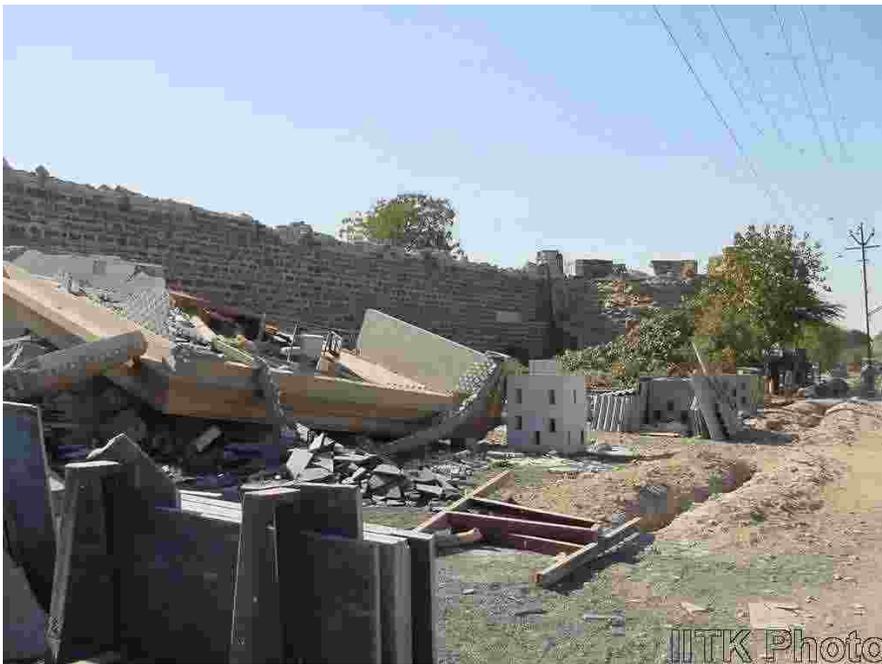
Partial collapse of the walls of the historic fort at Bhuj.

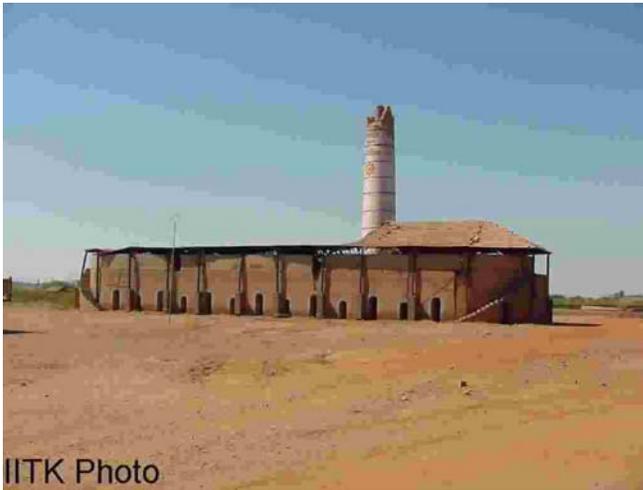
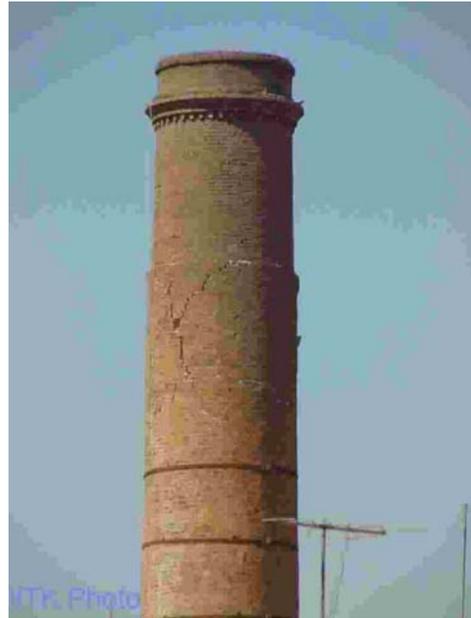
Partial collapse of the roof and brick chimney at the Mangalore roof tile factory near Morbi. Close-up view shows the cyclic shear cracks in the upper portion of another precariously balanced brick chimney near Morbi.

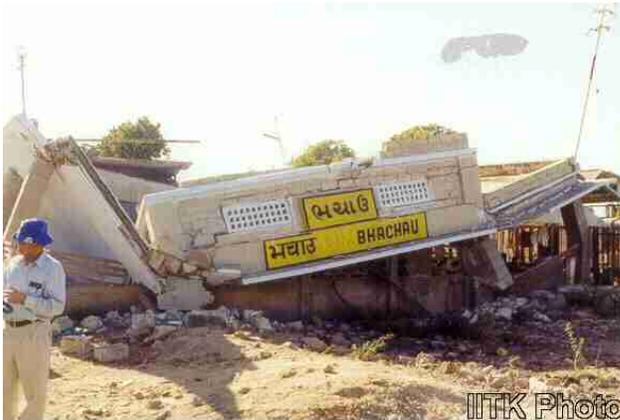
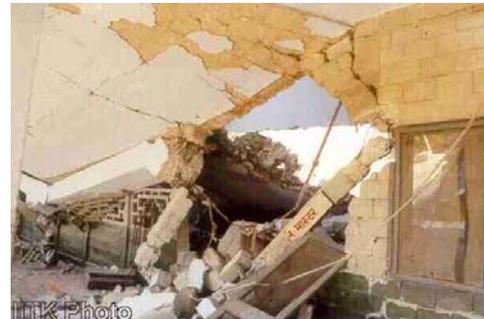
A number of railway stations suffered extensive damages. Fortunately, at this location, no one was killed since at the time all the railway staff had gathered elsewhere for the Republic day flag hoisting ceremony.

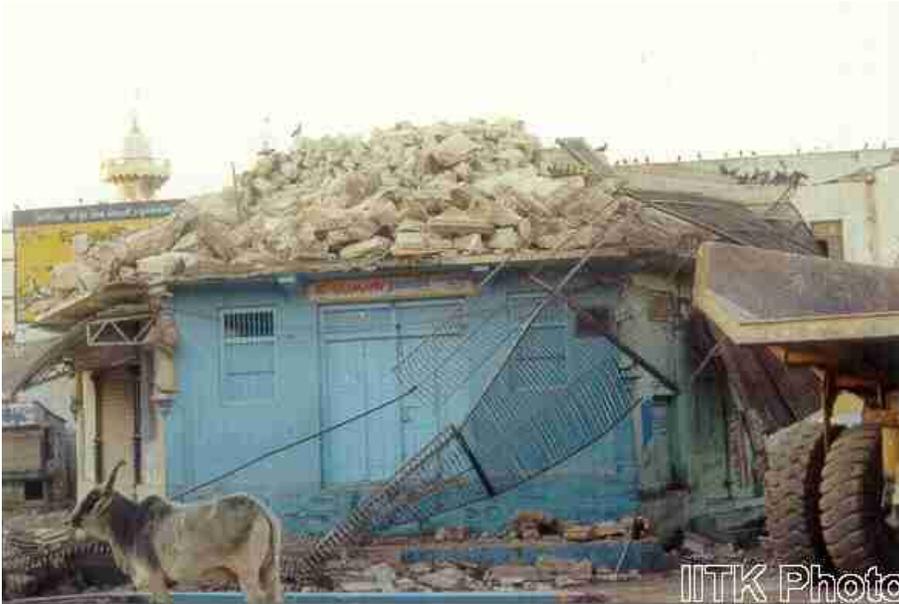
Collapse of upper storey of a commercial building in old Bhuj.

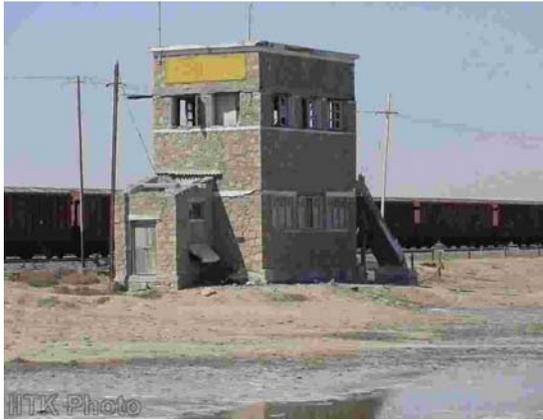
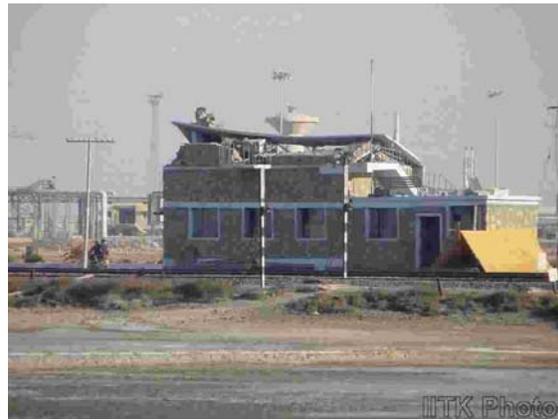
One two-storey random rubble stone masonry rail road signaling cabin with lintel band at Kandla port sustained minor damage, while another in the same area had a collapse of the upper storey.

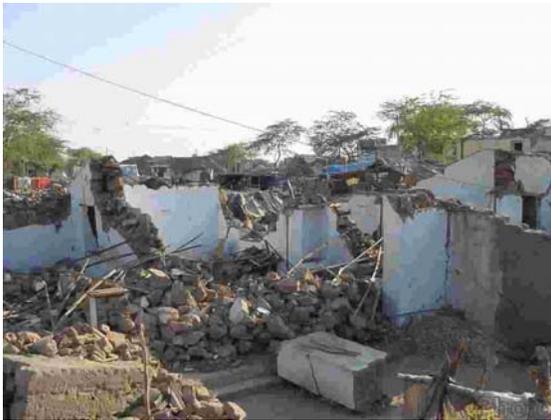
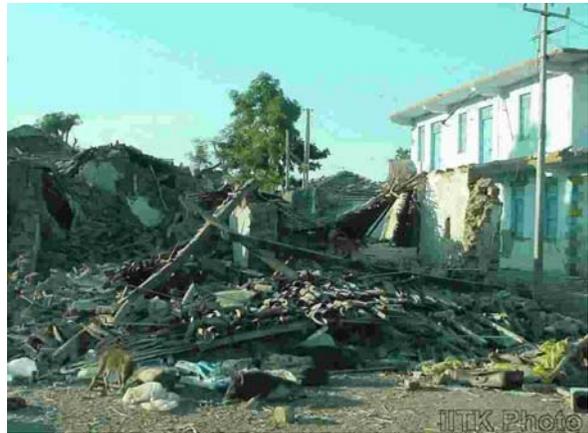
Total collapse of traditional houses in random rubble stone masonry with mud mortar at Maliya and Samakhyali villages.

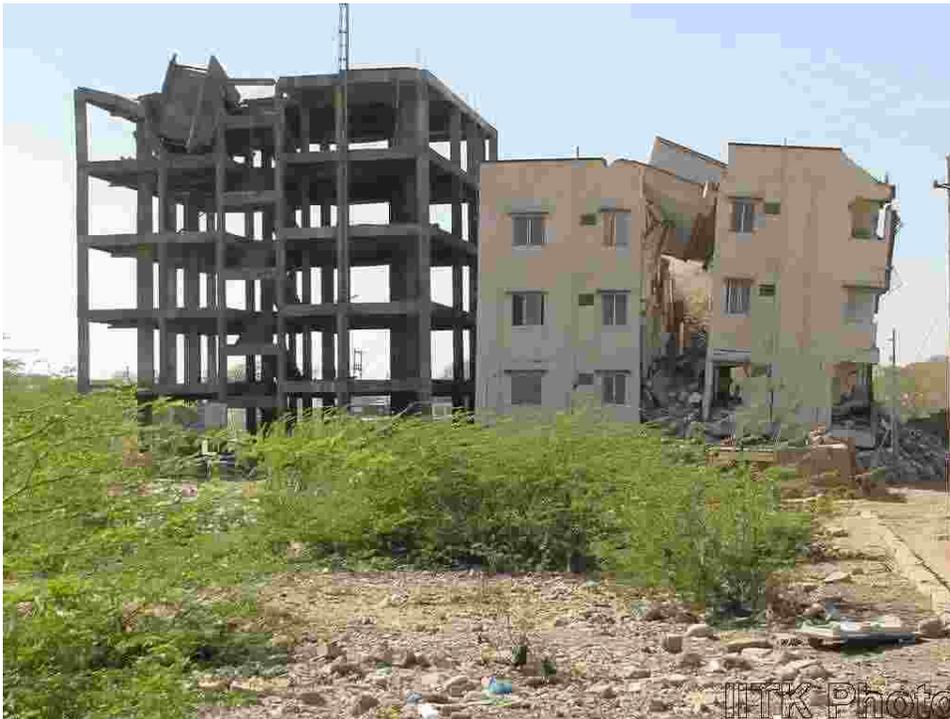
Numerous cases of dislodging of the weakly connected overhead storage water tanks were observed in the entire earthquake affected area. Picture shows dislodging of water tank appendages from atop unfinished and finished RC frame buildings in Bhuj.

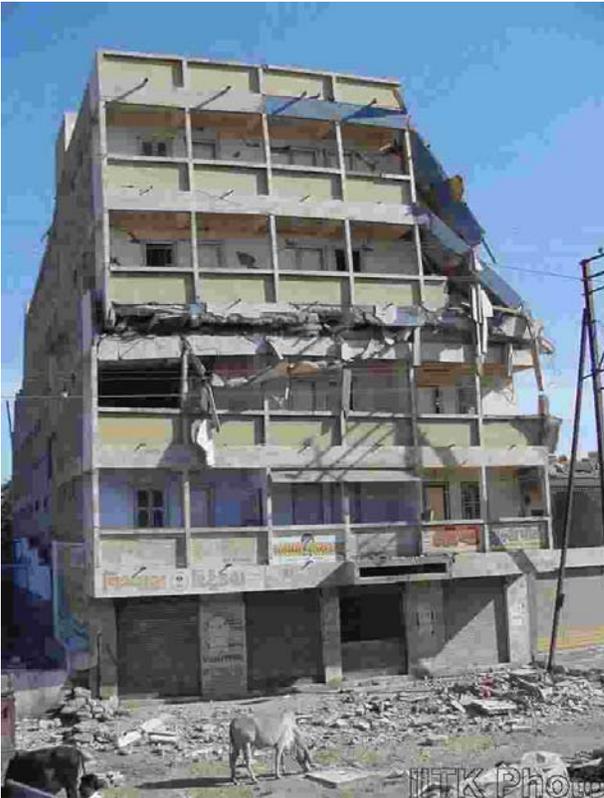
Collapse of intermediate storey in a 6-storey RC frame commercial building at Bhuj.

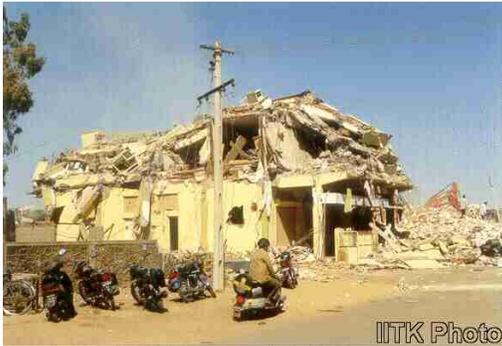
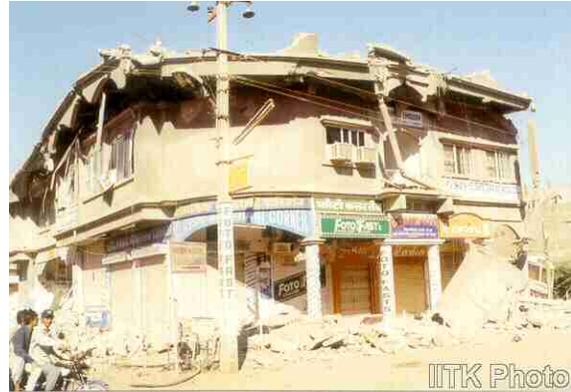
Collapse of upper storey of buildings at Gandhidham. It is suspected that this may have been caused by inadequate lap lengths in the column reinforcement.

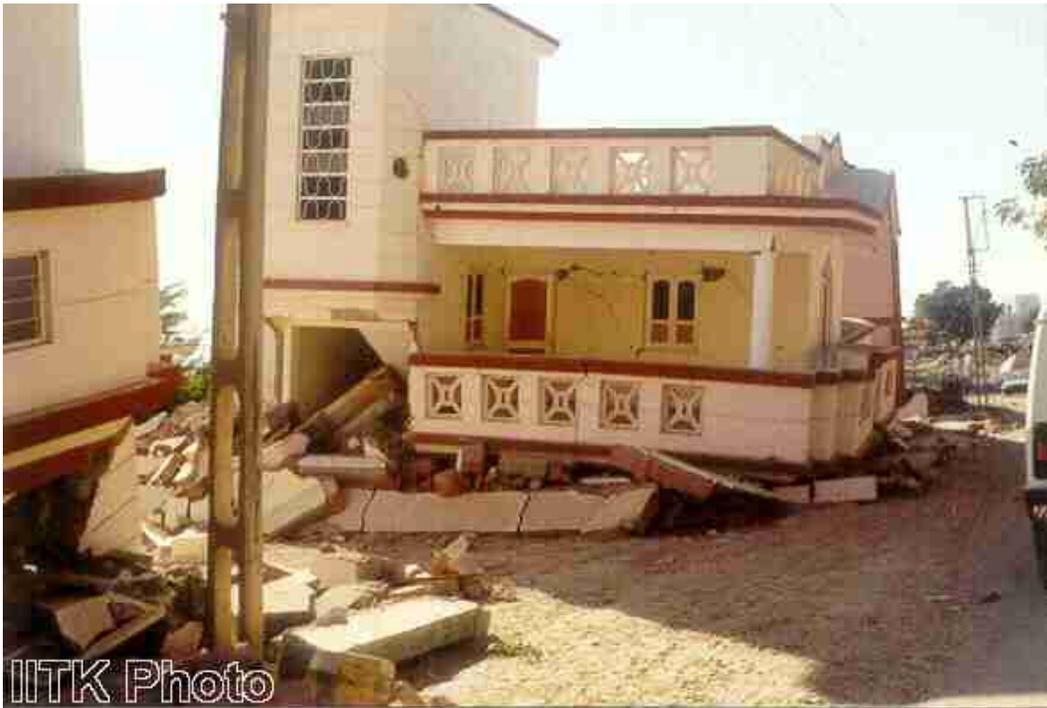
Collapse of ground storey of a two-storey RC frame building in Manfara village.

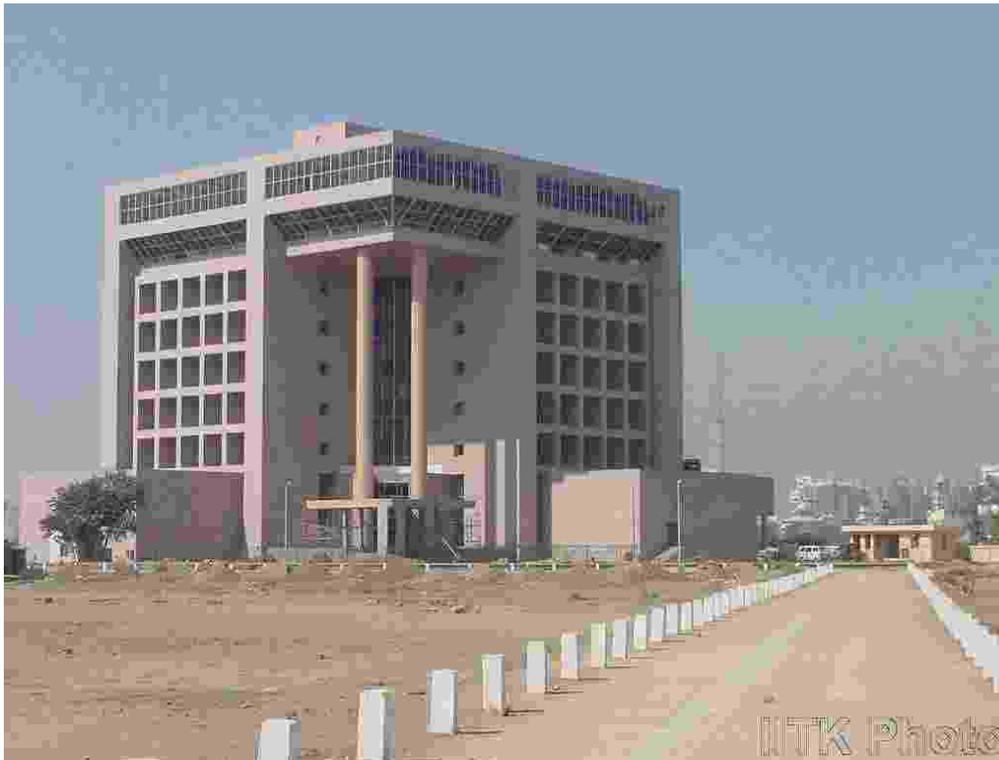
One of the numerous RC frame multistory buildings at Ahmedabad that withstood the earthquake shaking with only minor cracking in the masonry infill walls.

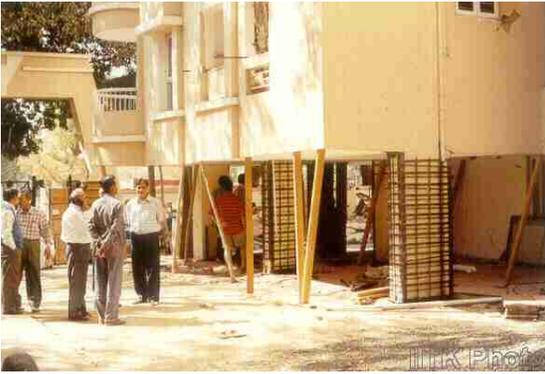
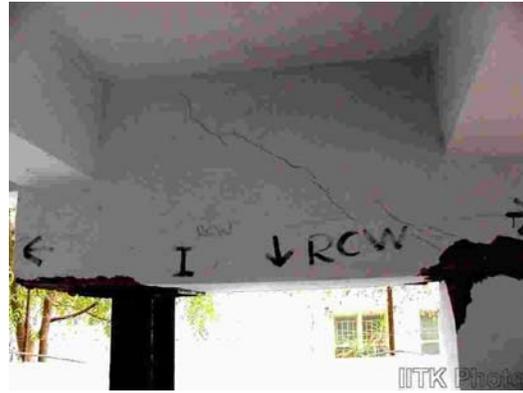
The practice of floating columns in the upper storeys is very common in the cities in India. Close-up view shows shear cracks in the cantilever stub beam supporting a floating column in a 4-storey RC frame residential building in Ahmedabad.

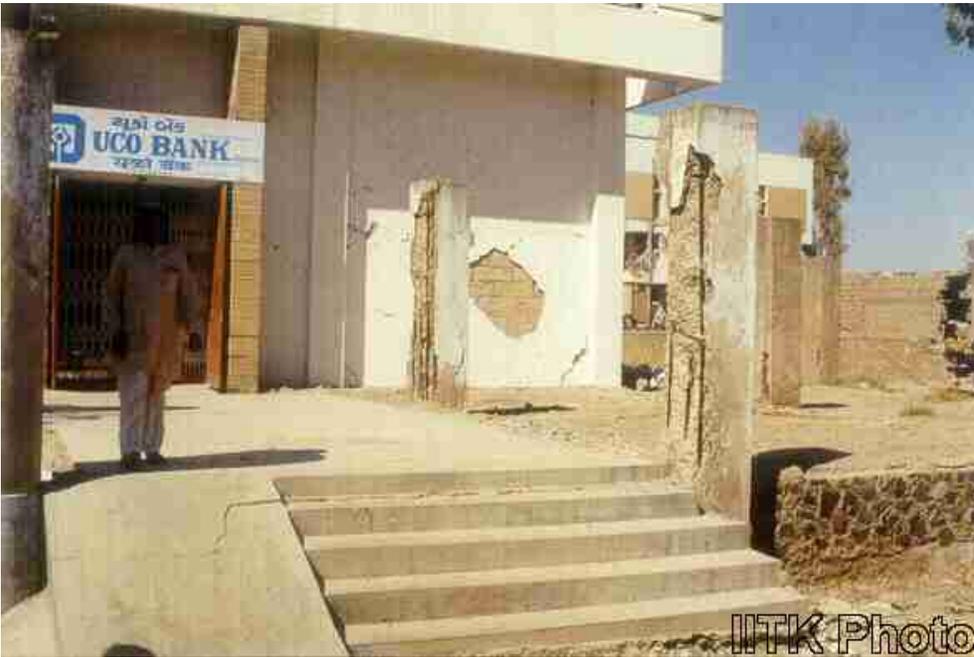
These columns left for future extension show inadequate spacing of stirrups.

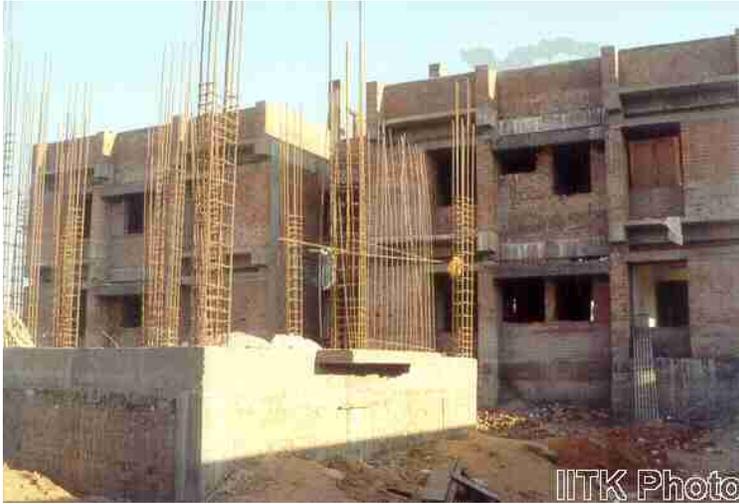
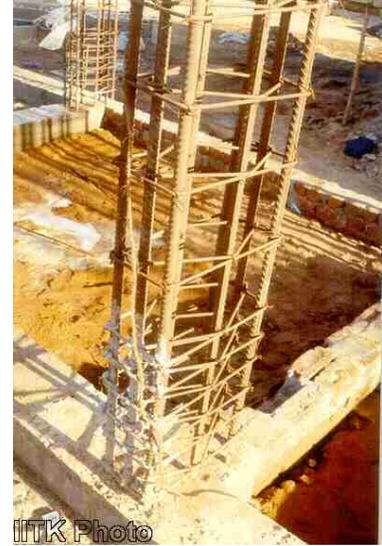
The area also offered examples of good RC detailing; residential building of Telecom department under construction at Bhuj.

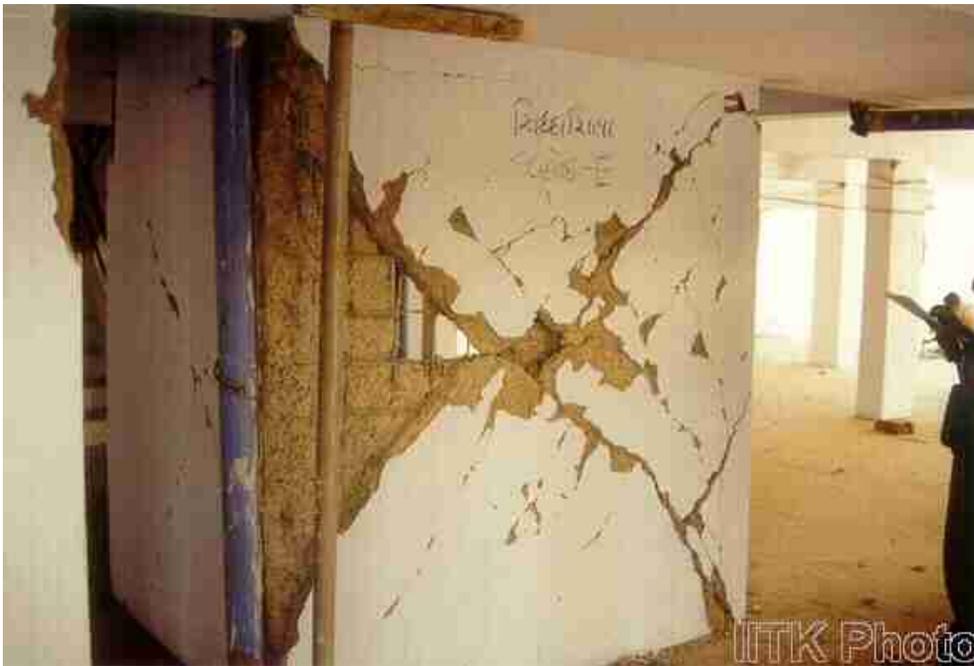
Severe shear cracking sustained by the RC elevator core wall in a four-storey RC frame building in Ahmedabad.

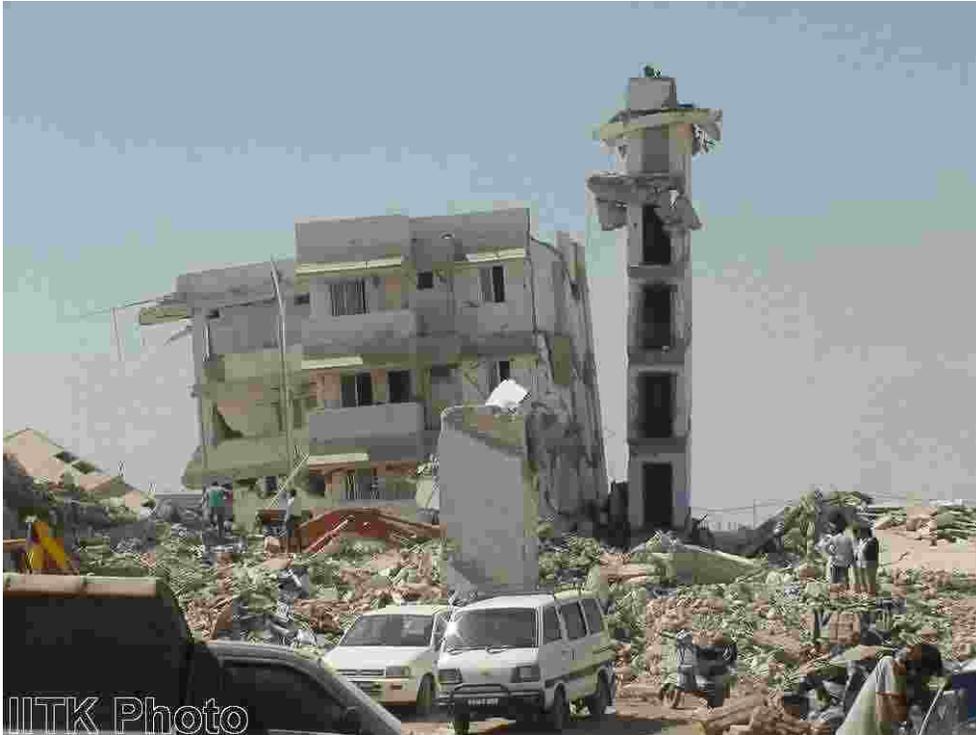
IITK Photo  
Insufficient connection between the RC elevator core and rest of the building lead to the underutilization of the lateral strength and stiffness of the elevator core.

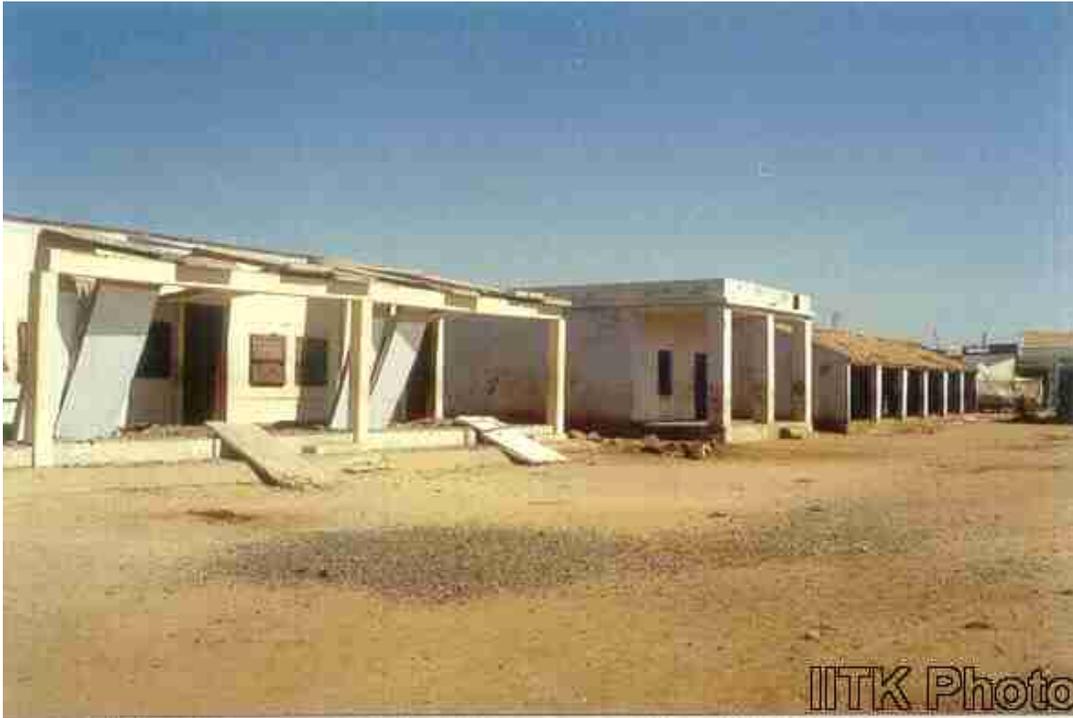
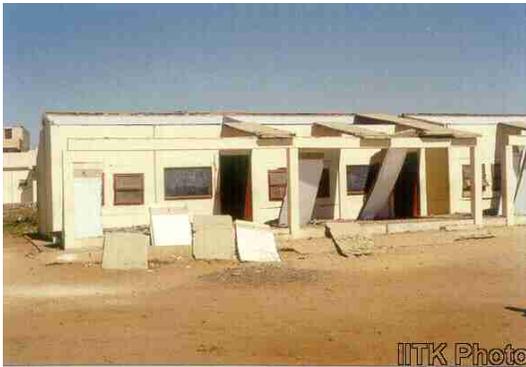
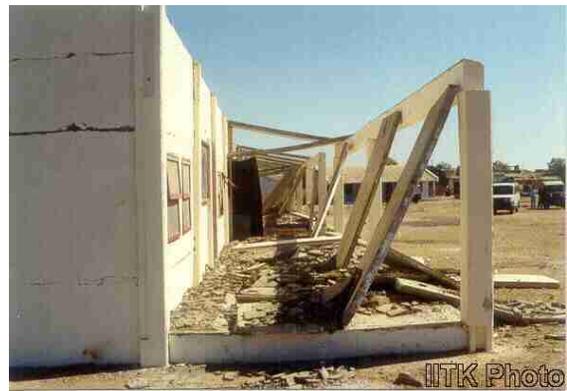
A school in Gandhidham had both traditional construction as well as RC precast buildings. In the *precast building*, the roof panels were dislodged atop the precast frame/wall system due to inadequate connections. In contrast, the traditional constructions alongside did better.

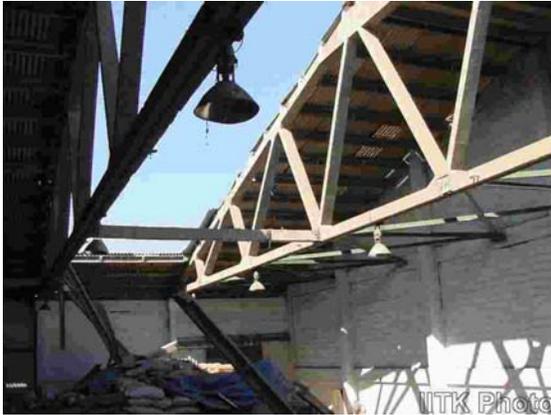
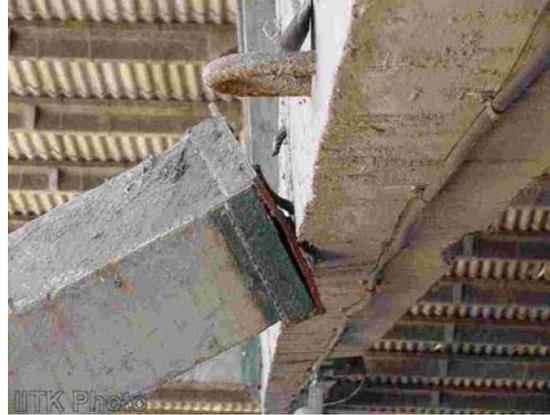
Partial collapse of the roof due to failure of ties between prestressed concrete trusses of the warehouse at Kandla port. Close-up view shows the failure of the connection welding between the tie and the truss.

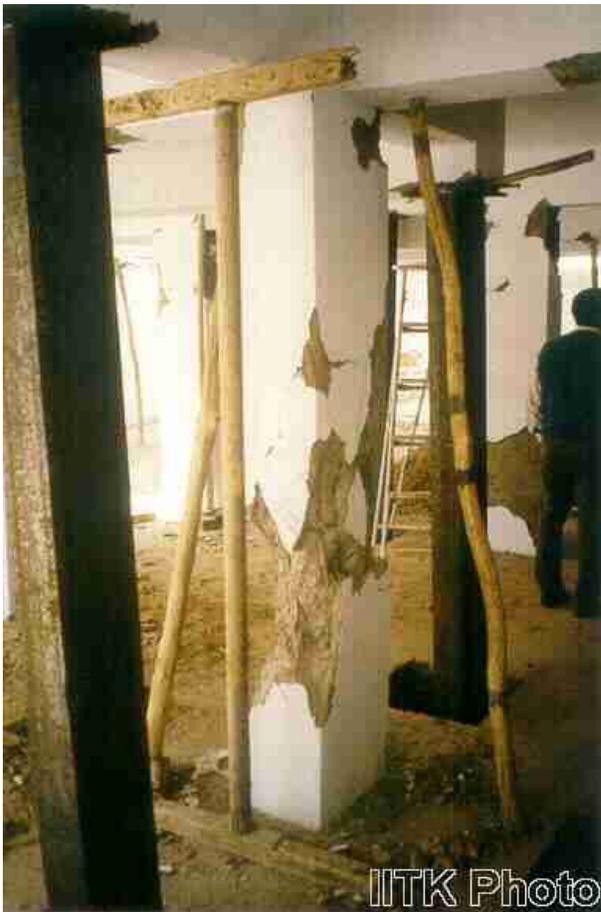
Buildings with open ground storeys in the affected area were "propped" by structural steel sections and wooded posts as an immediate measure by the residents.

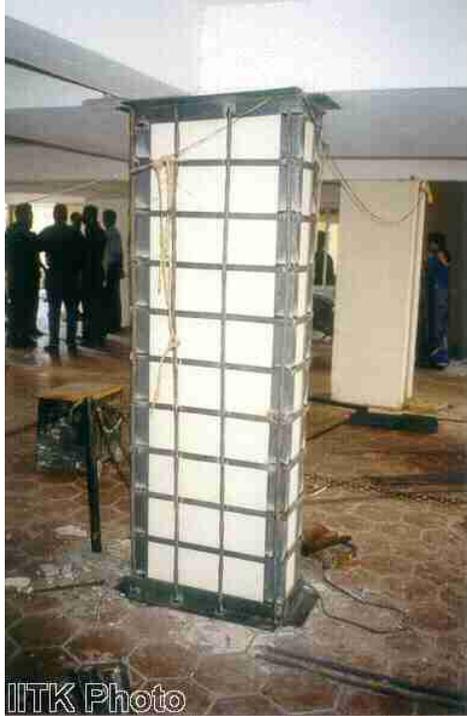
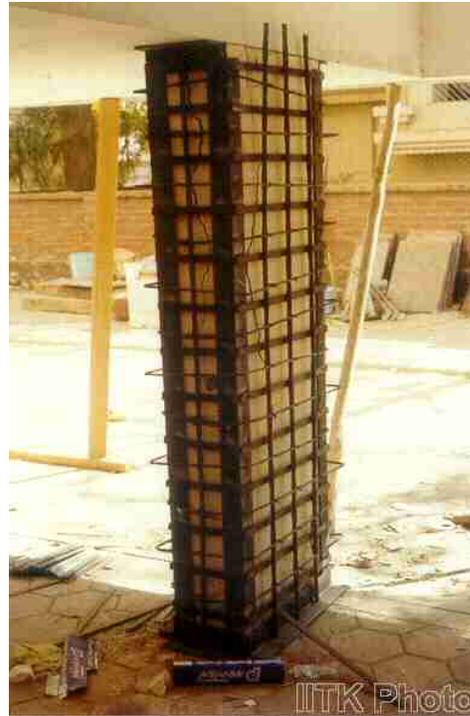
Improper jacketing of columns that was practiced immediately after the earthquake in numerous buildings at Ahmedabad. The new frame to be encased in concrete rested on the finished ground floor and not carried to the foundation. Similarly, it did not connect well with the beams above. Even the plaster of beams and columns was not removed.

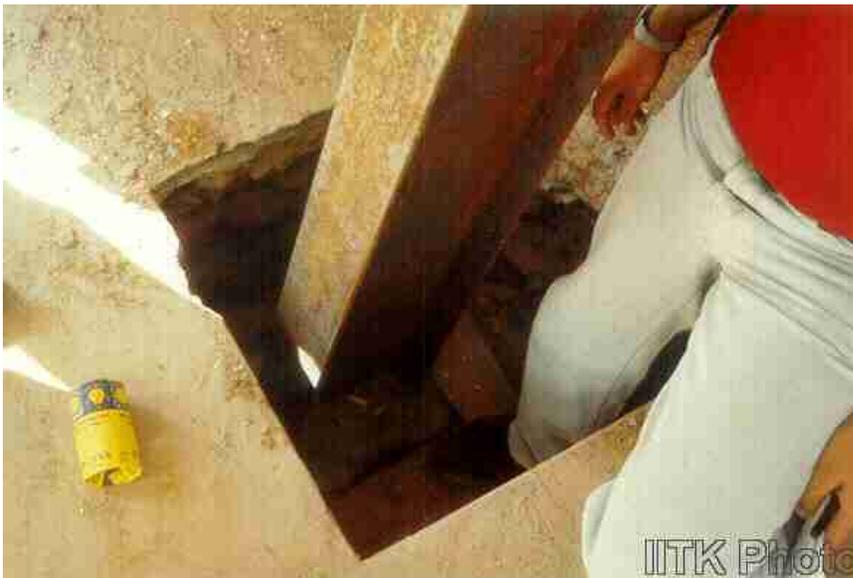
In some instances, a structural steel member was placed adjoining the RC damaged column. The old columns together with the adjoining steel member were jacketed with concrete. In this instance, the steel column was taken below the floor level but not extended till the foundation.

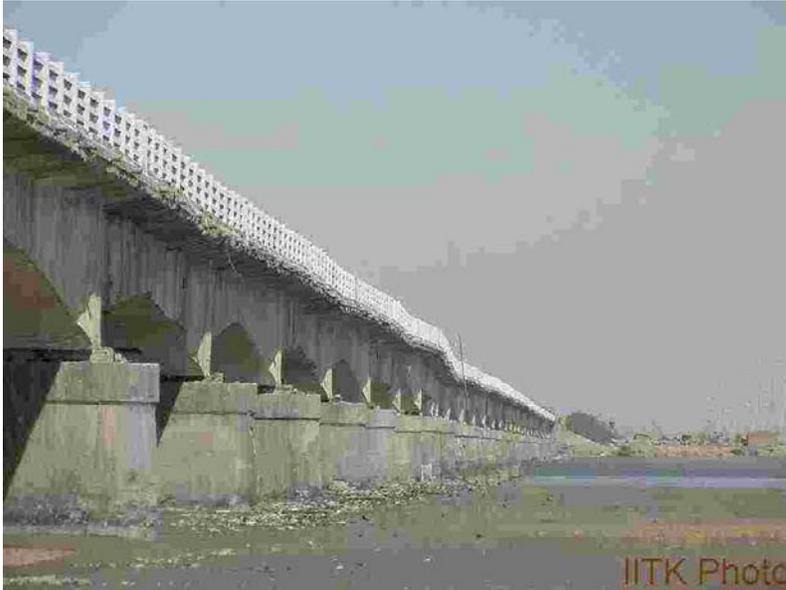
The old multispan balanced cantilever RC slab bridge with suspended spans at Surajbadi sustained severe damage at the bearings at most piers, and has lateral movement of the deck at one of the piers.

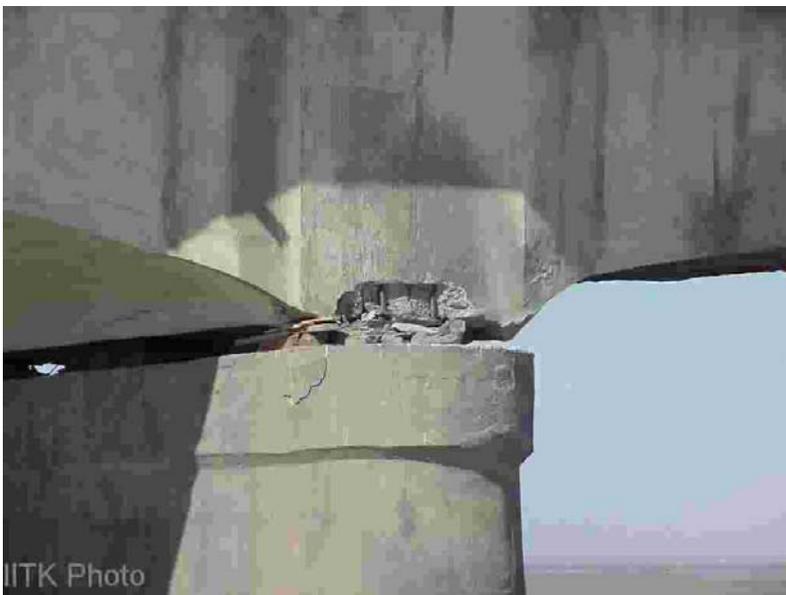
Close-up view of the damage sustained at the bearings on most piers of the old Surajbadi bridge.

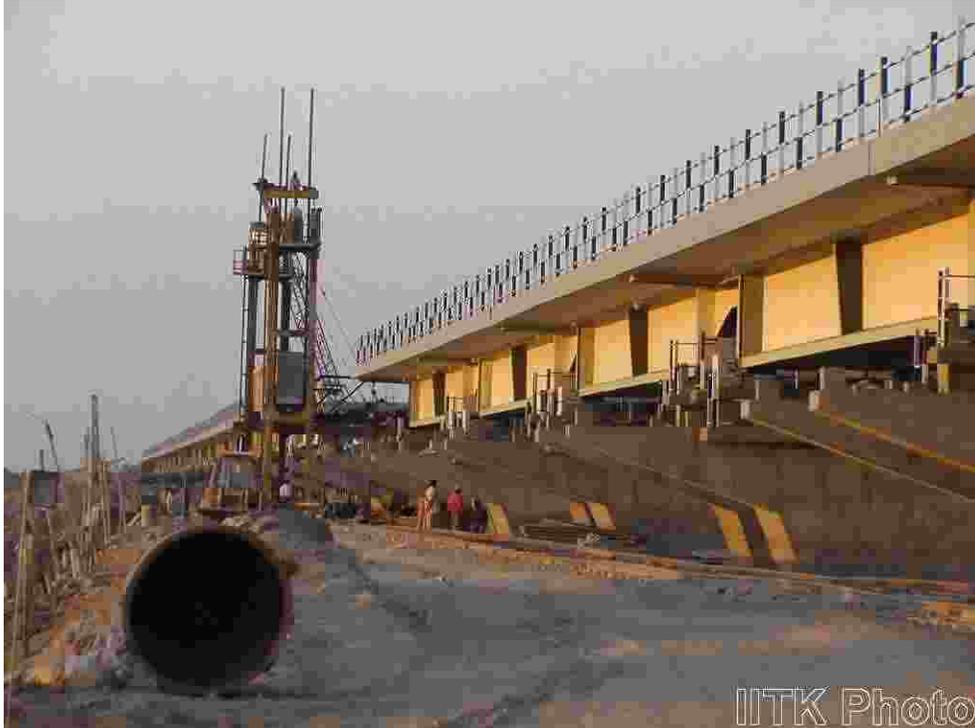
Prestressed concrete girder bridge nearing completion at Surajbadi. Completed spans sustained substantial damage like pounding of the deck slab, horizontal movement of girder, and damage at the bottom of girders.

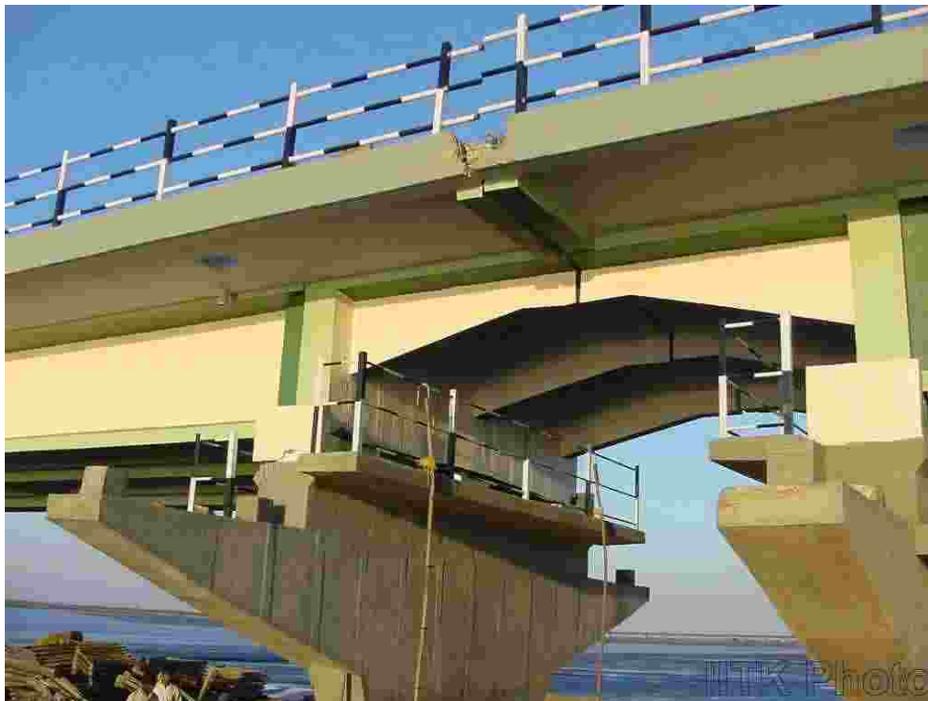
The longitudinal movement of the new Surajbadi bridge superstructures led to pounding at the deck slab level.

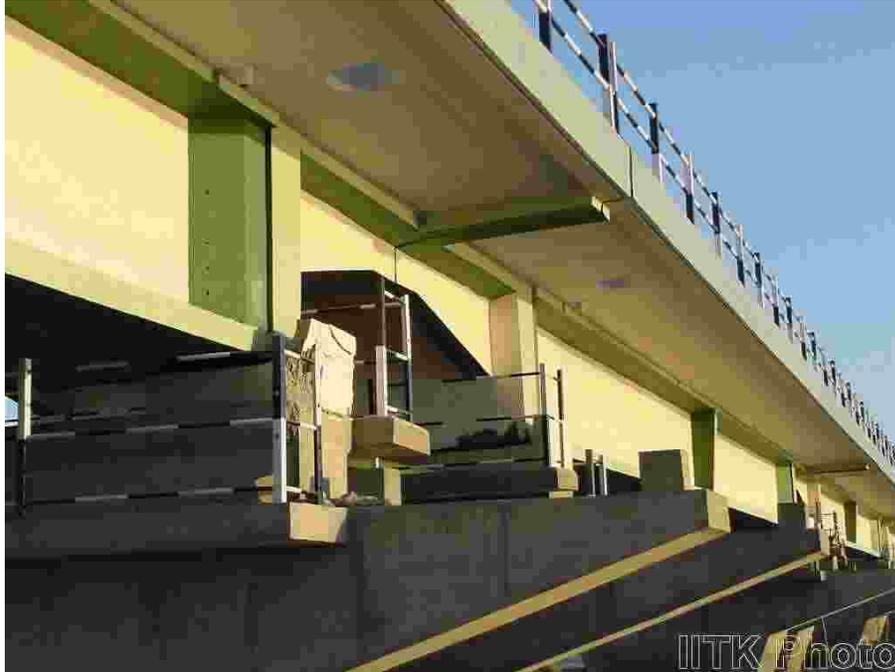
The bridge was provided with RC lateral restrainers to prevent dislodging of spans in the transverse direction. Most of these devices sustained damage due to lateral pounding by the spans.

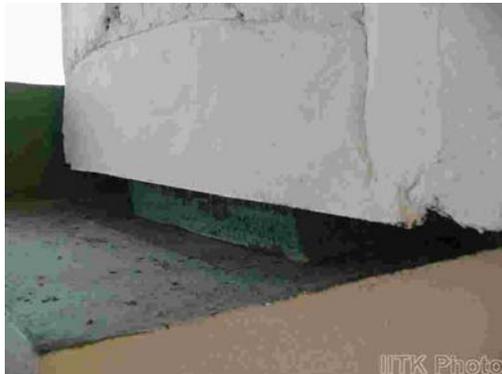
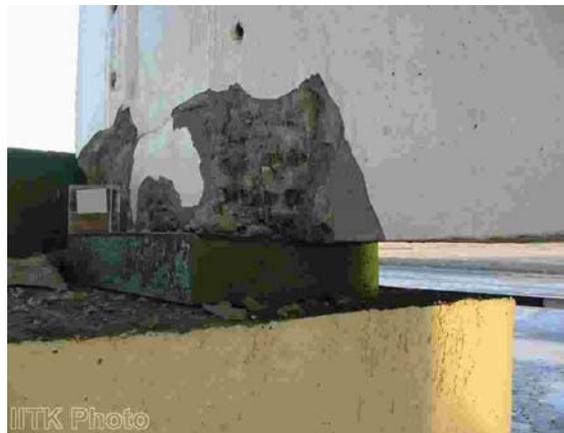
The movement of the girders in the new Surajbadi Bridge along the longitudinal and transverse directions imposed severe strains on the neoprene bearings and spalling of cover concrete at the bottom of the girders. More details on this bridge are also available at [www.tcpl.com](http://www.tcpl.com)

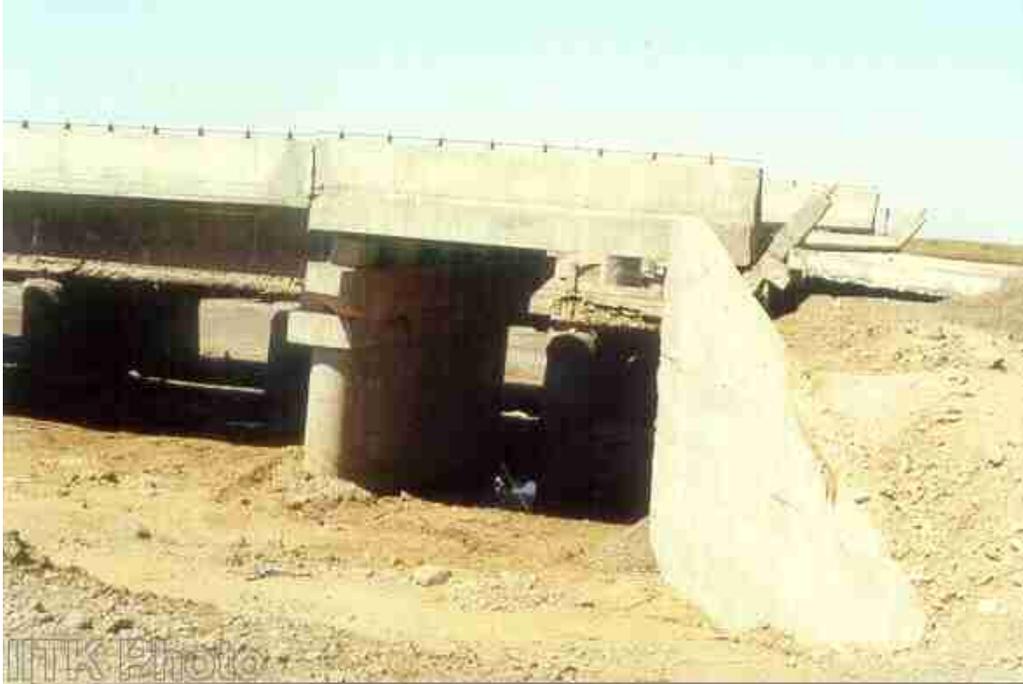
Lateral movement of soil at the abutment of the four-span RC bridge near Vondh.

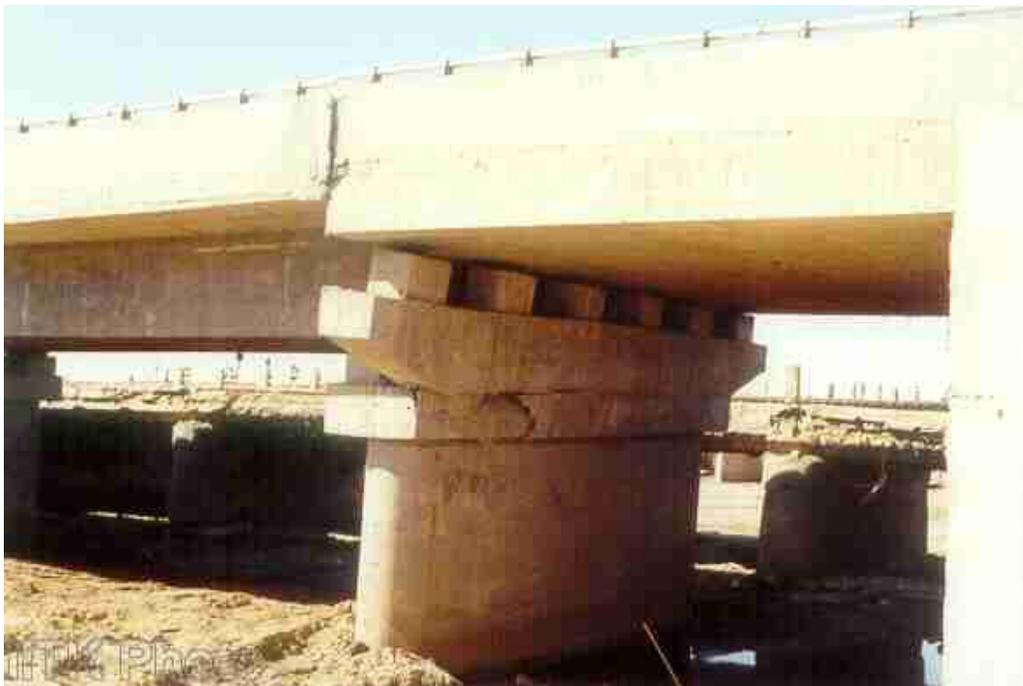
Damage to the unequal-height bed blocks at the RC bridge near Vondh. The pier supports two spans with different girder/slab depths.

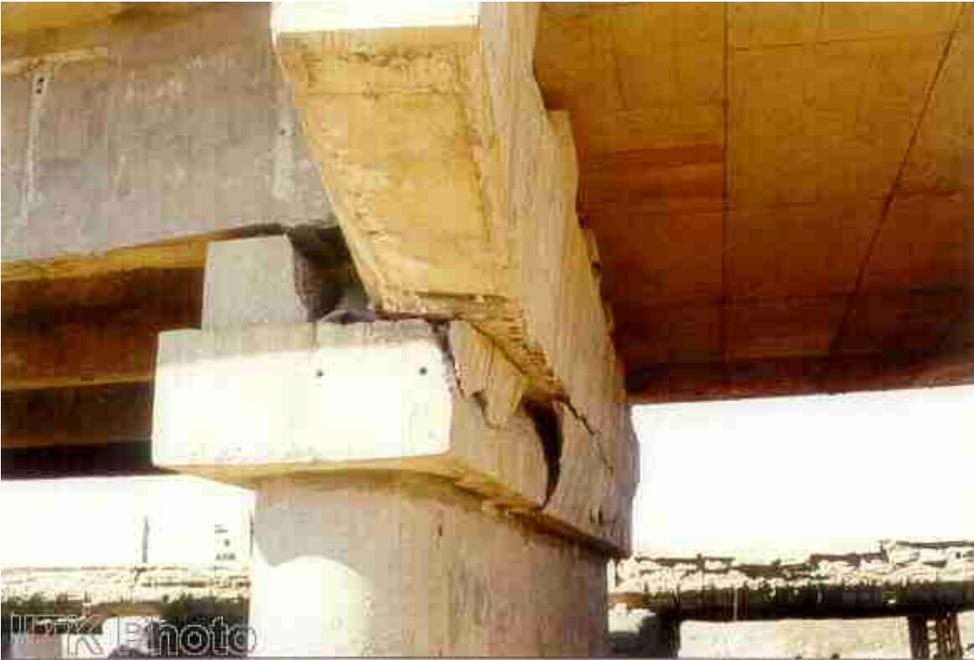
This pier at the RC bridge near Vondh was found to have a tilt. Considerable liquefaction was observed at the site.

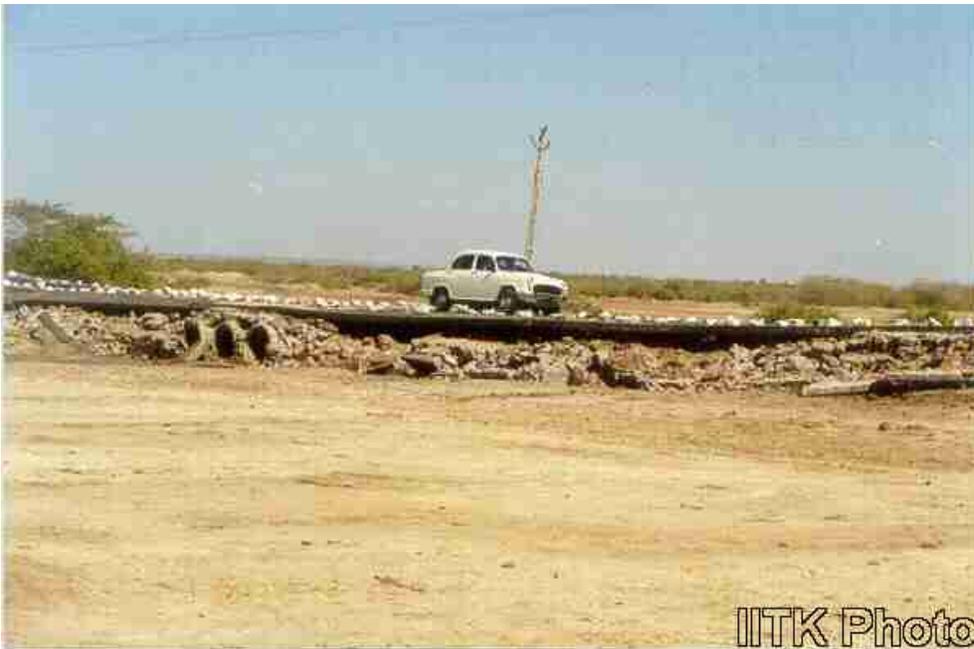
Damage to pipe culvert. The site had considerable liquefaction.

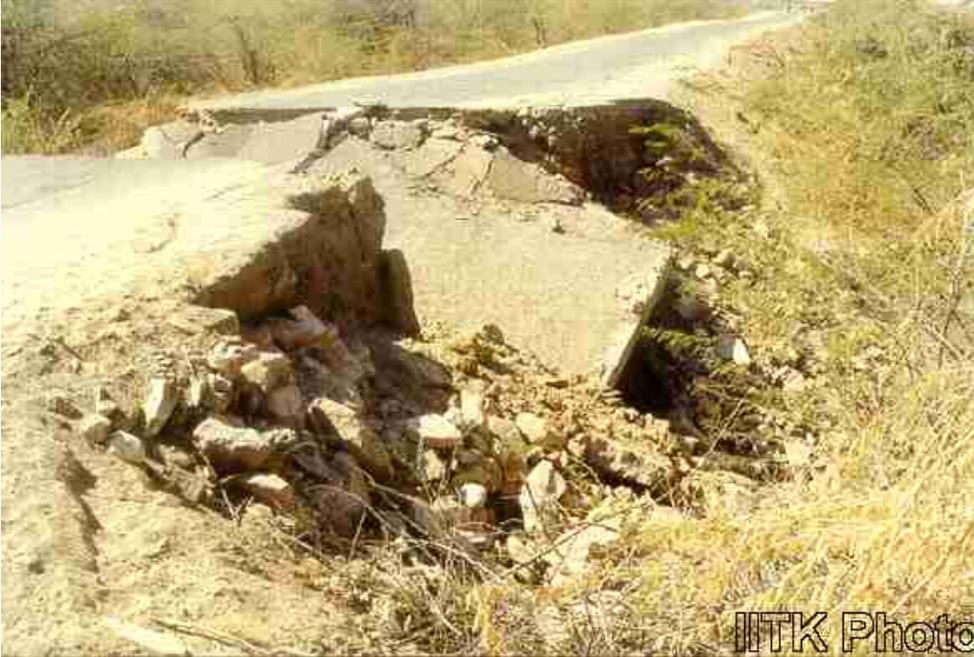
A number of RC slab culverts on stone masonry abutments sustained damage.
