# The Republic Day Earthquake in the land of M. K. Gandhi, The Father of the Nation

**Learning from Earthquakes ::** A field report on structural and geotechnical damages sustained during the 26 January 2001 M7.9 Bhuj Earthquake in Western India

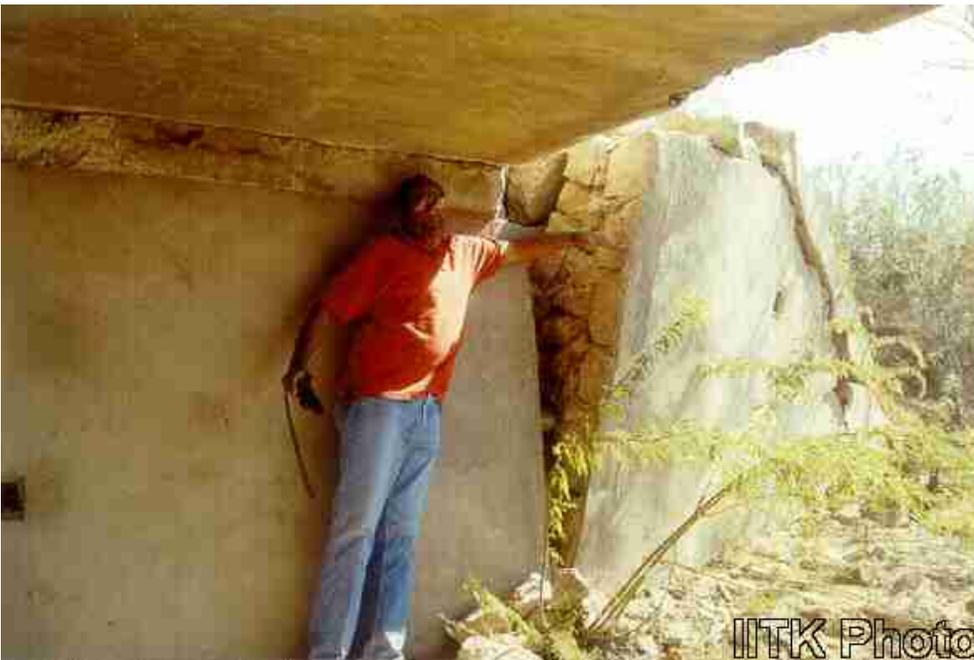
Lateral movement of the wing wall at the abutment of RC slab bridge.

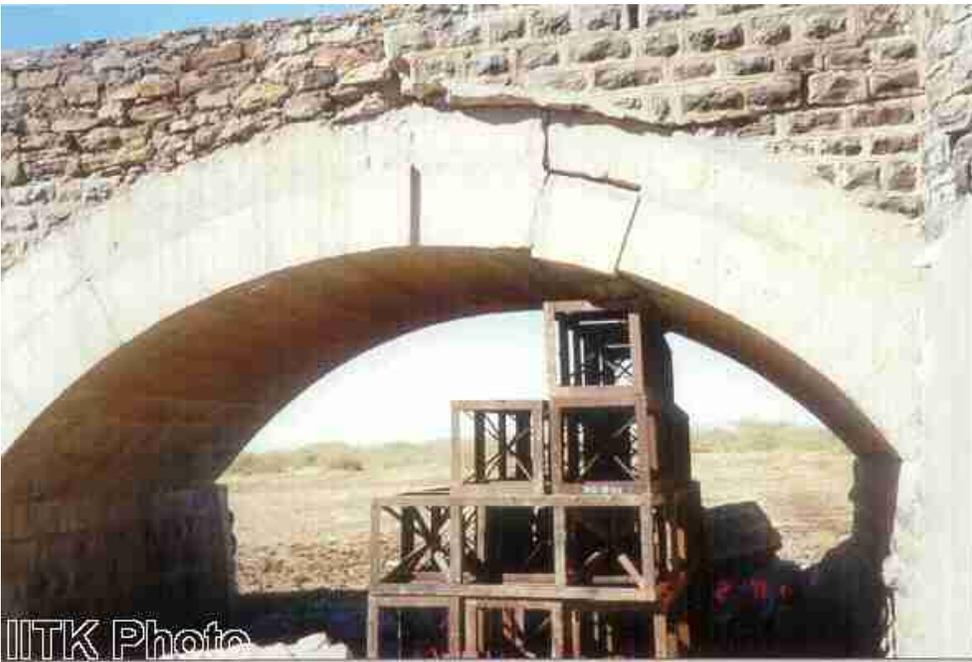
A number of old masonry arch bridges for Indian railways sustained extensive damage. This bridge is about 88 years old.

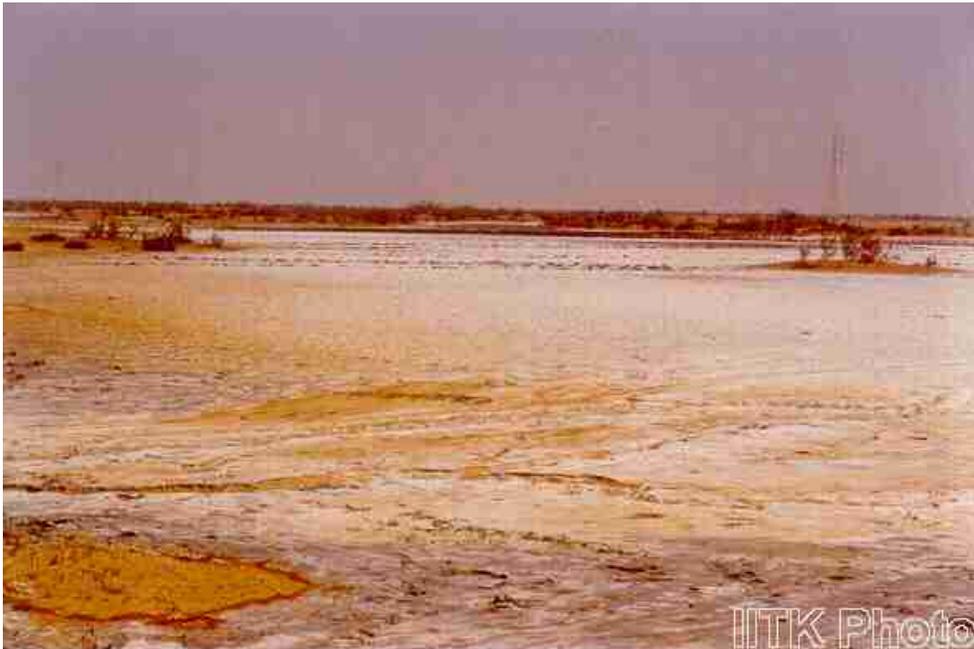
Extensive liquefaction in the Runn of Kutch; this did not affect the performance of the high-tension transmission lines in the area.

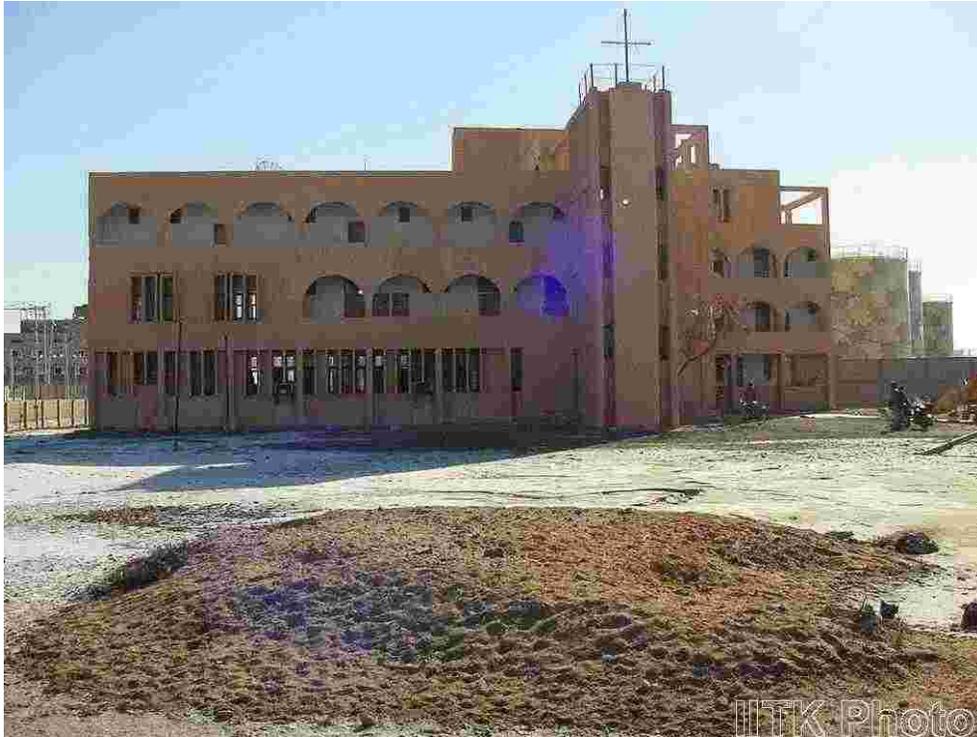
Extensive liquefaction near a 3-storey RC frame office building at Kandla port; building sustained only minor cracks in the walls, but settled down by about 70mm.

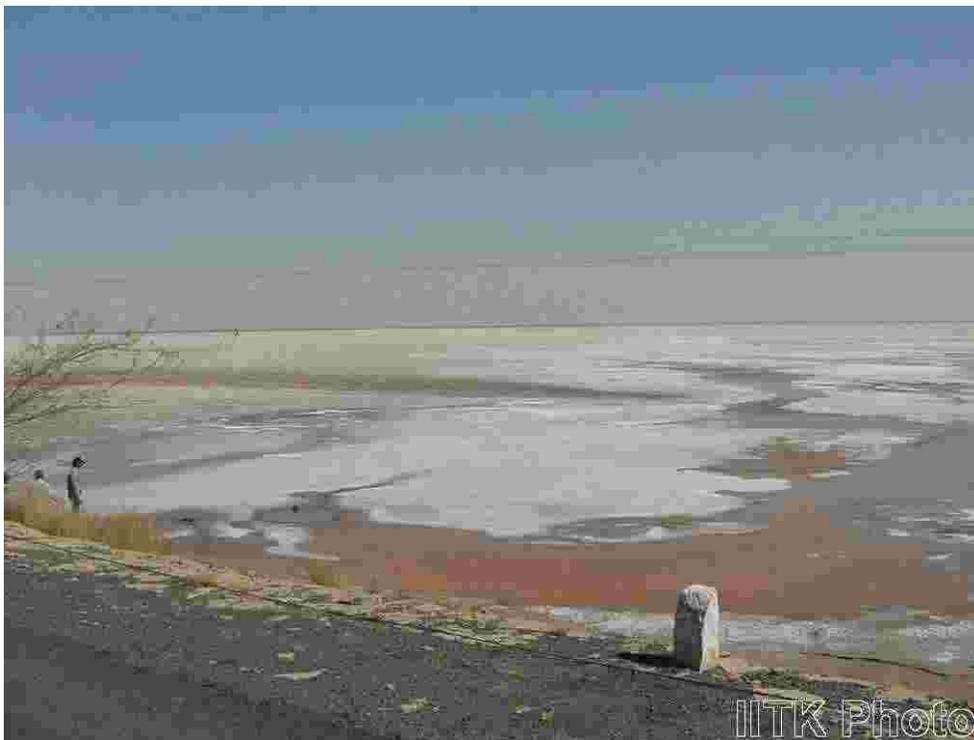
Extensive liquefaction near India Bridge at Khawda (The Great Runn of Kutch).

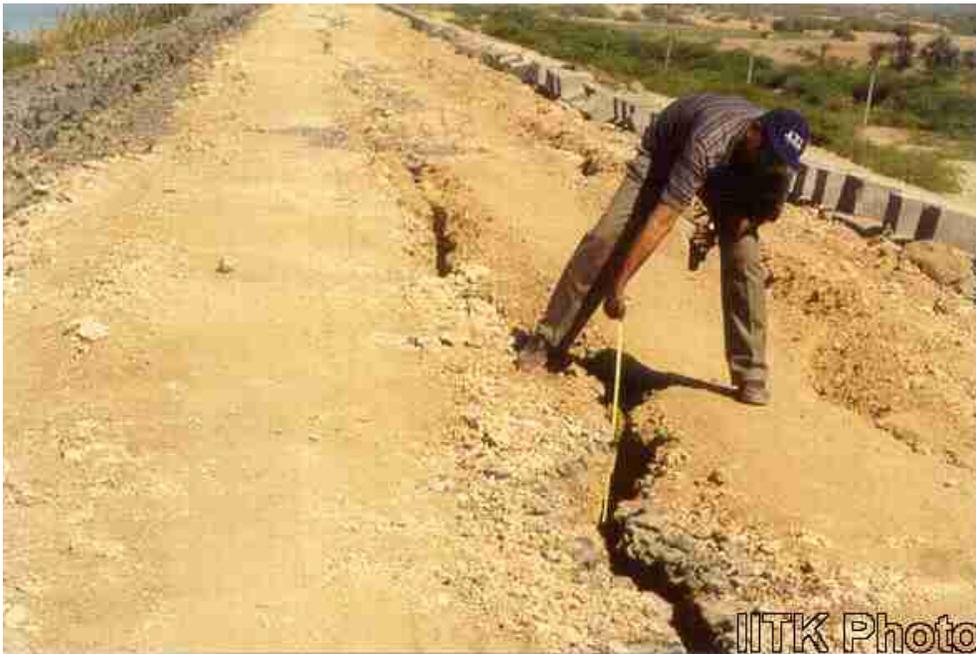
Cracks along the crest of the Tappar Dam

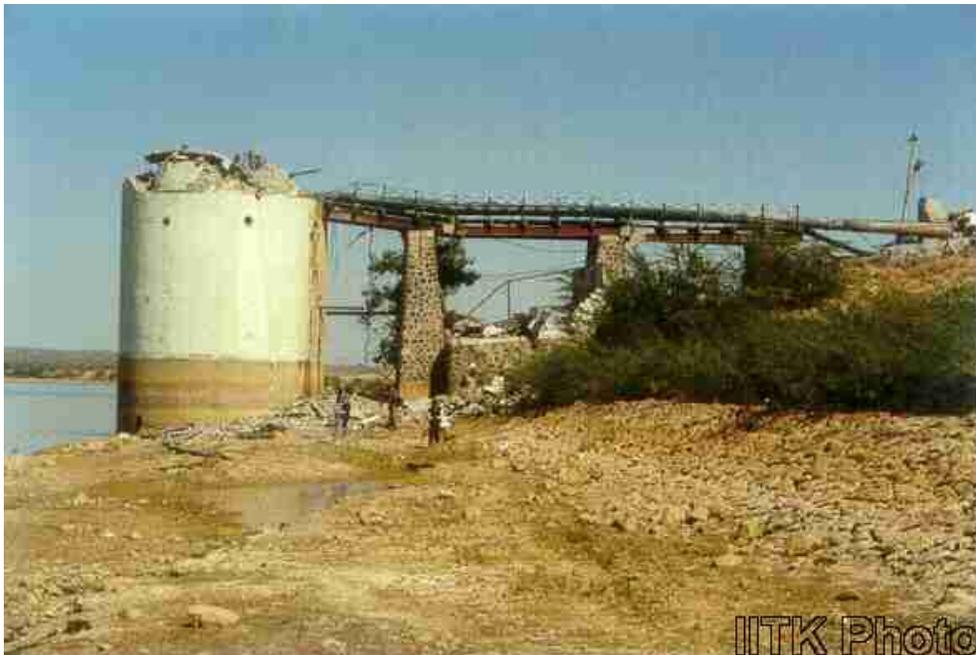
Collapse of the random rubble masonry intake tower at the Tappar Dam.

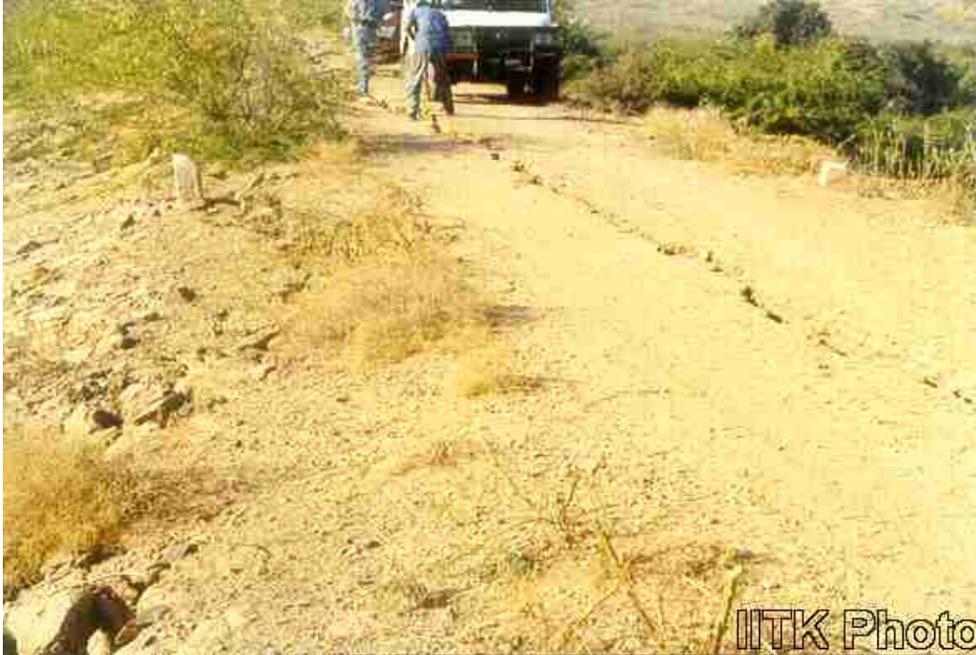
Longitudinal cracks along the crest and the downstream slope of the Kaswati Dam.

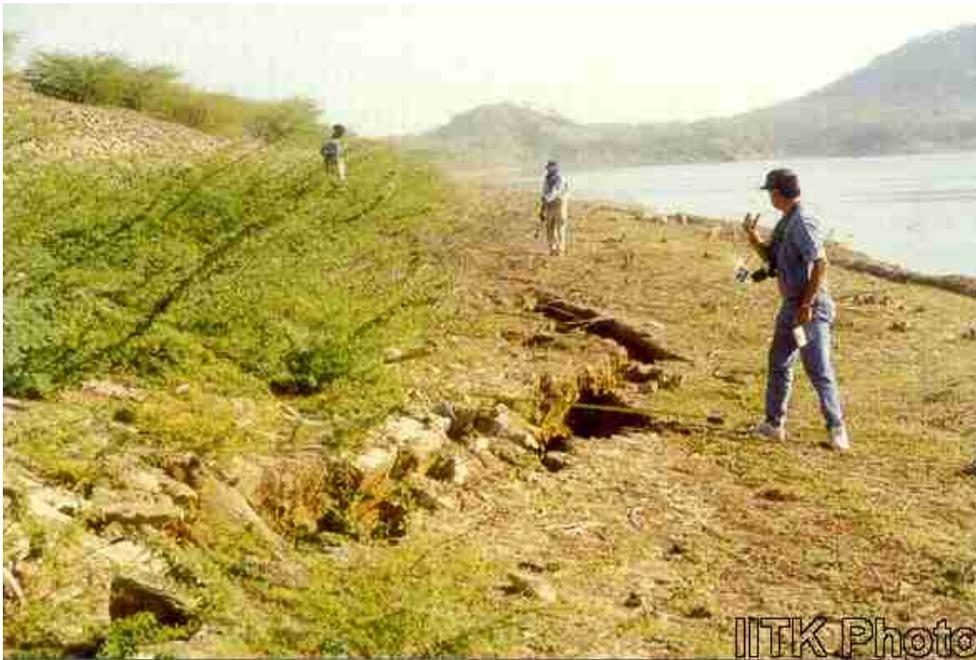
Lateral spreading at the toe of the Kaswati Dam.

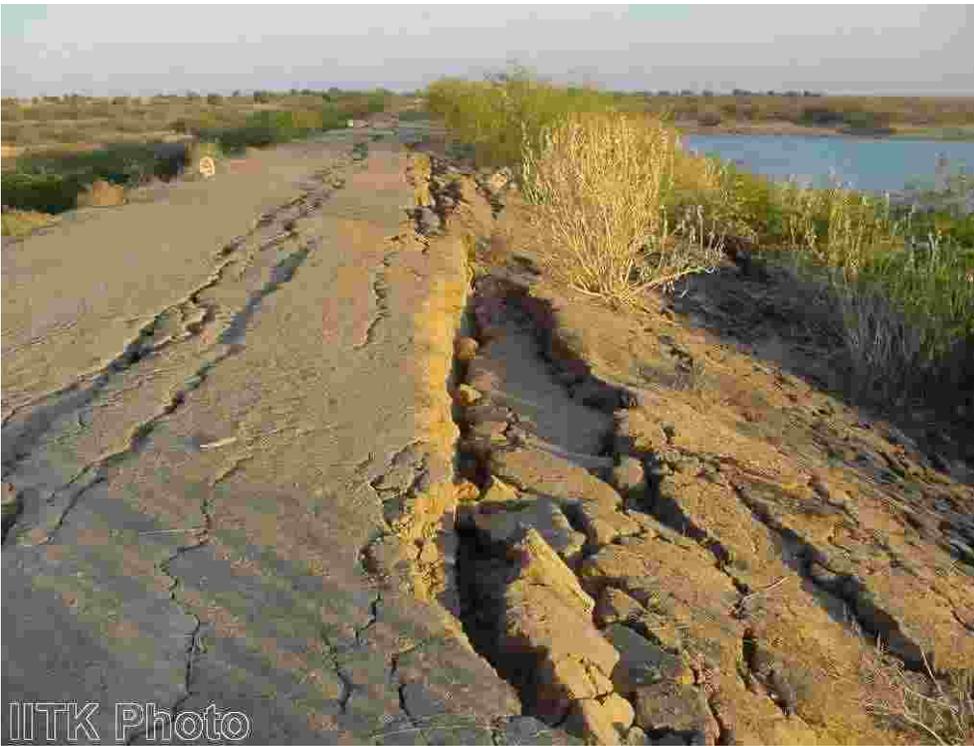
Failure of the upstream slope of the Fatehgadh dam.

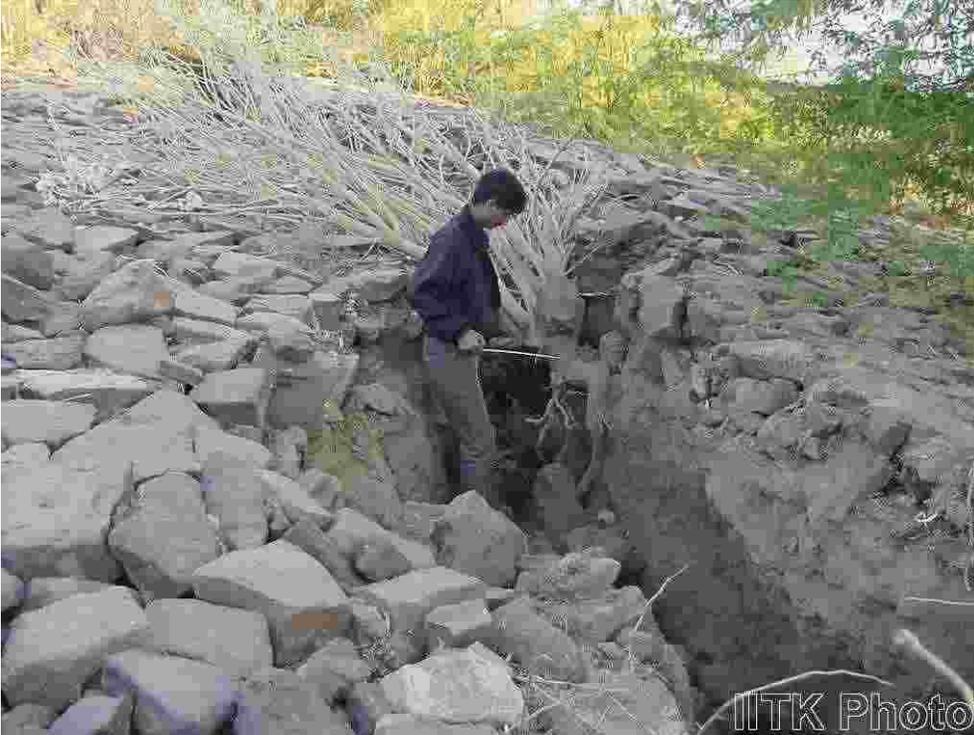
Massive cracks in the upstream embankment near the toe of the Fatehgadh dam.

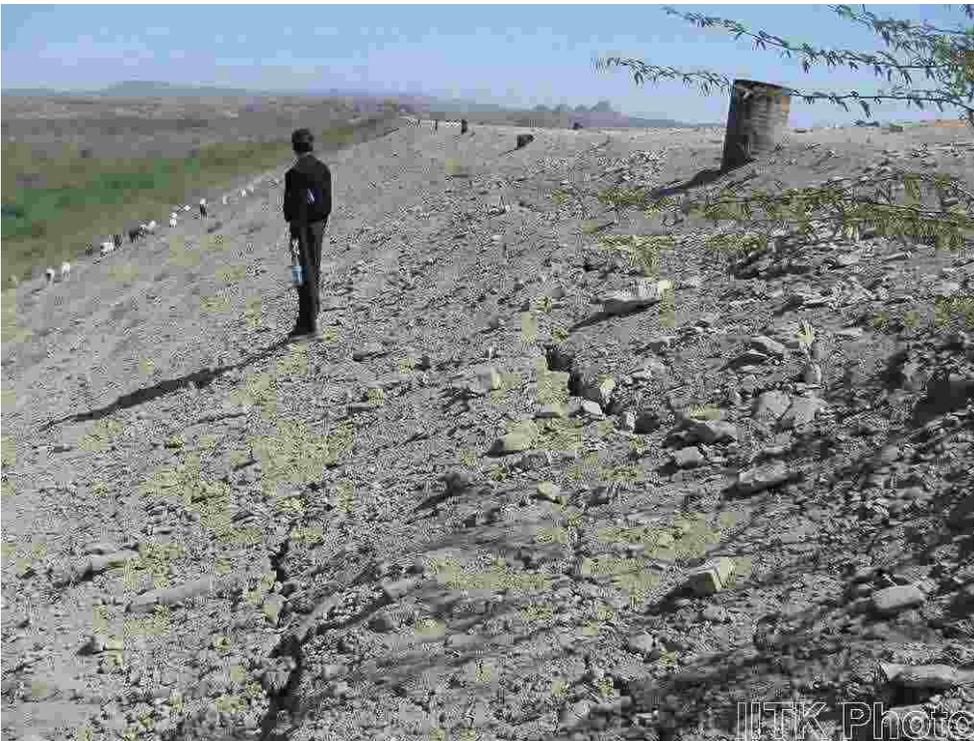
Lateral spreading of the downstream section of an earthen dam at Rudramata.

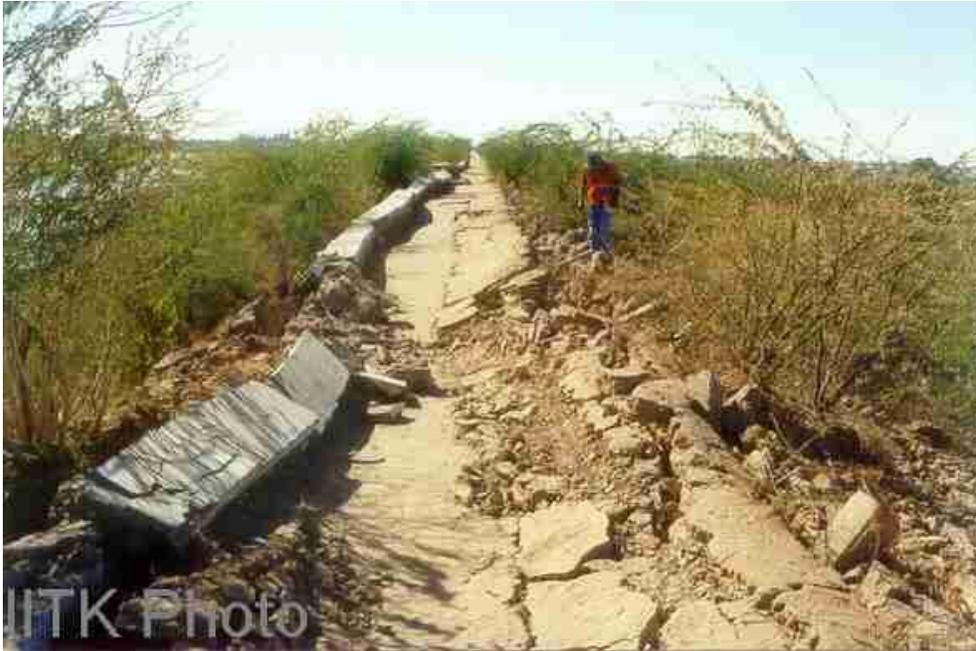
Cracks along the crest and vertical settlement of the Suvi dam.

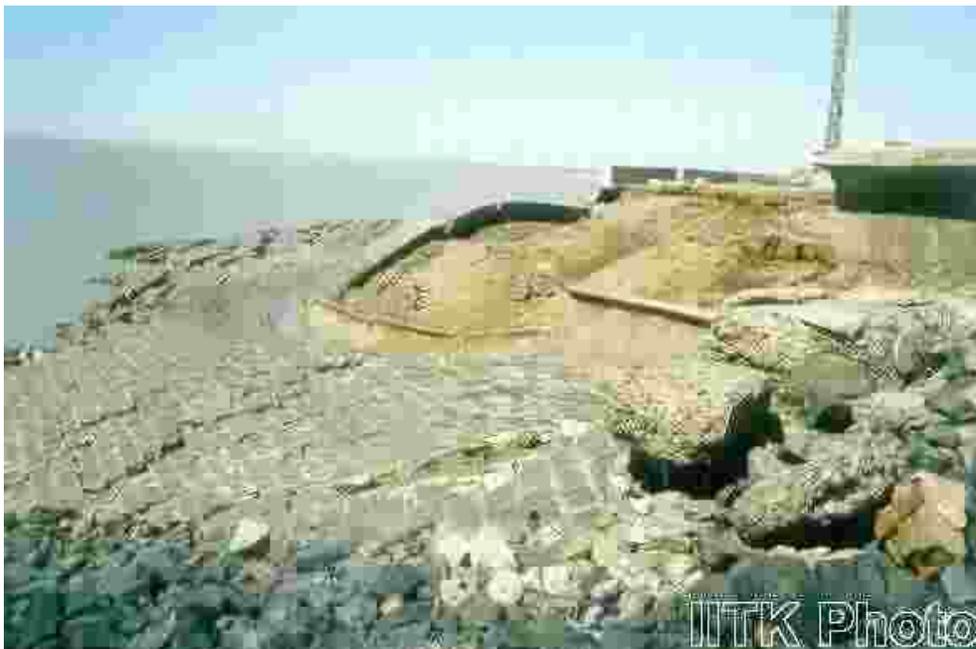
Failure of sea wall at Navlakhi port; over 50 meters stretch of the wall was washed away into the sea.

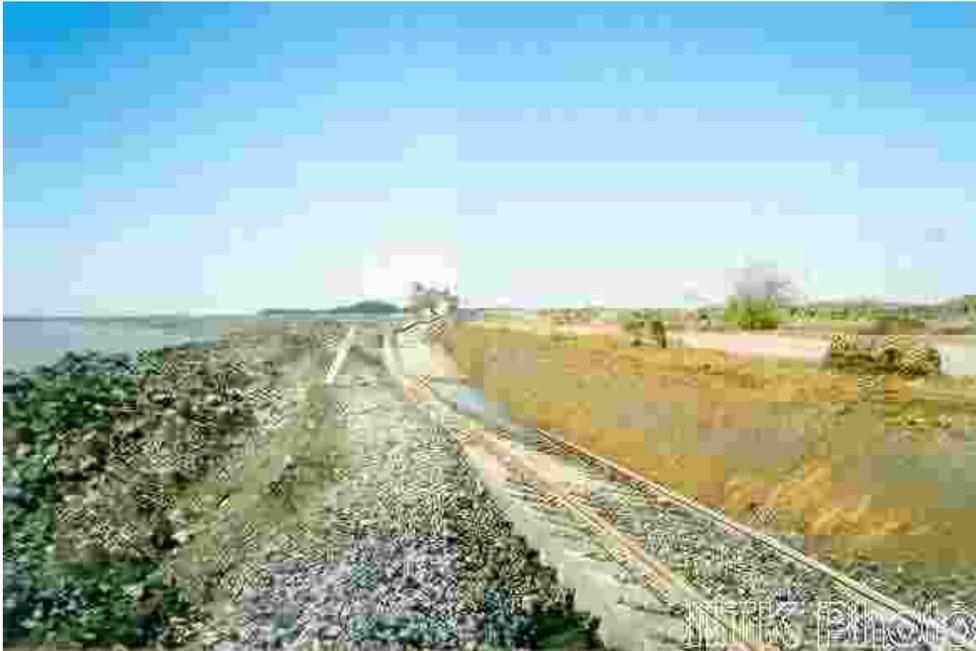
Massive slope failure of the rail-road embankment near Navlakhi port resulting in fracture of rails, and damage to prestressed concrete sleepers and panroll clips.

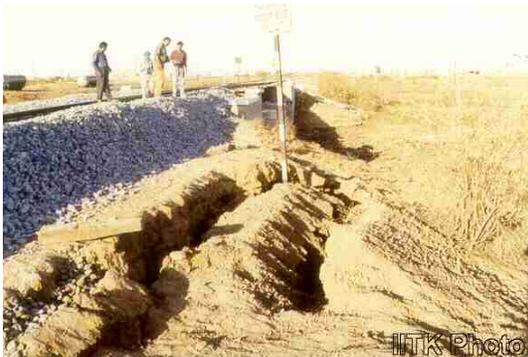
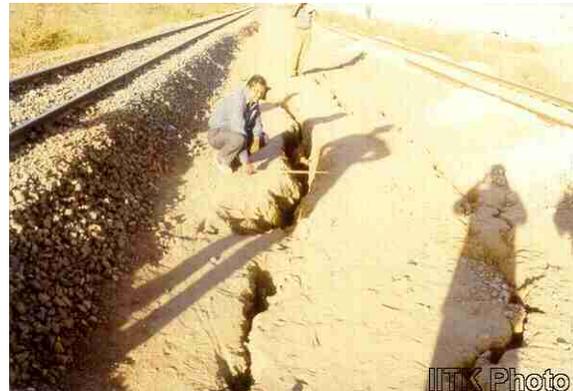
This rail embankment at Vaka Nala of about 5 meters height suffered extensive damage. The rails were hanging by about 1.0 to 1.5 meters after the earthquake. Ground liquefaction was observed at the base of the embankment.

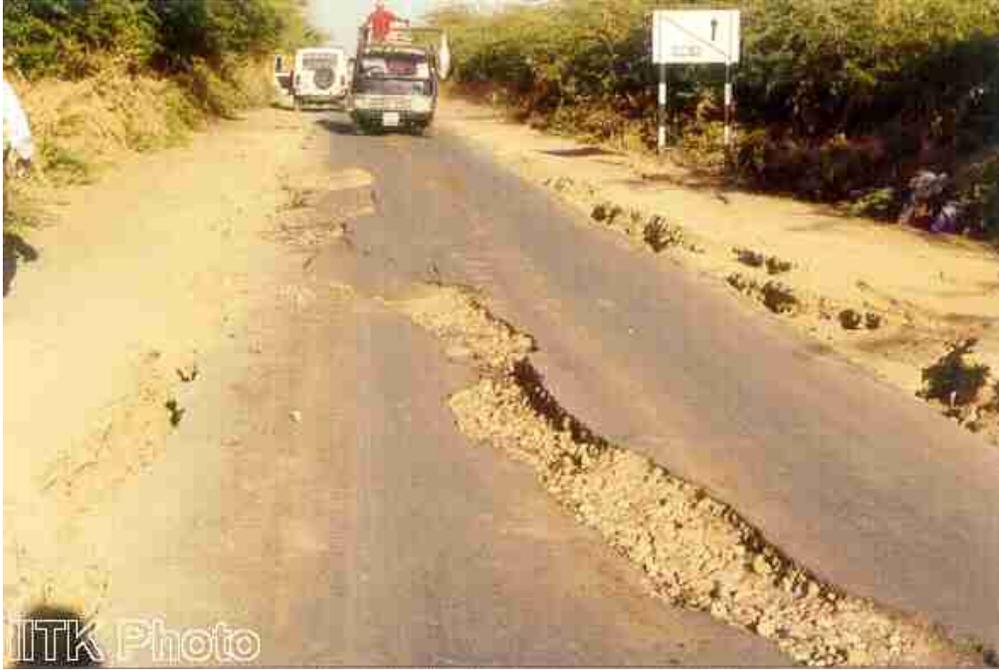
Damage to highway pavement near Rapar due to lateral spreading of soil.

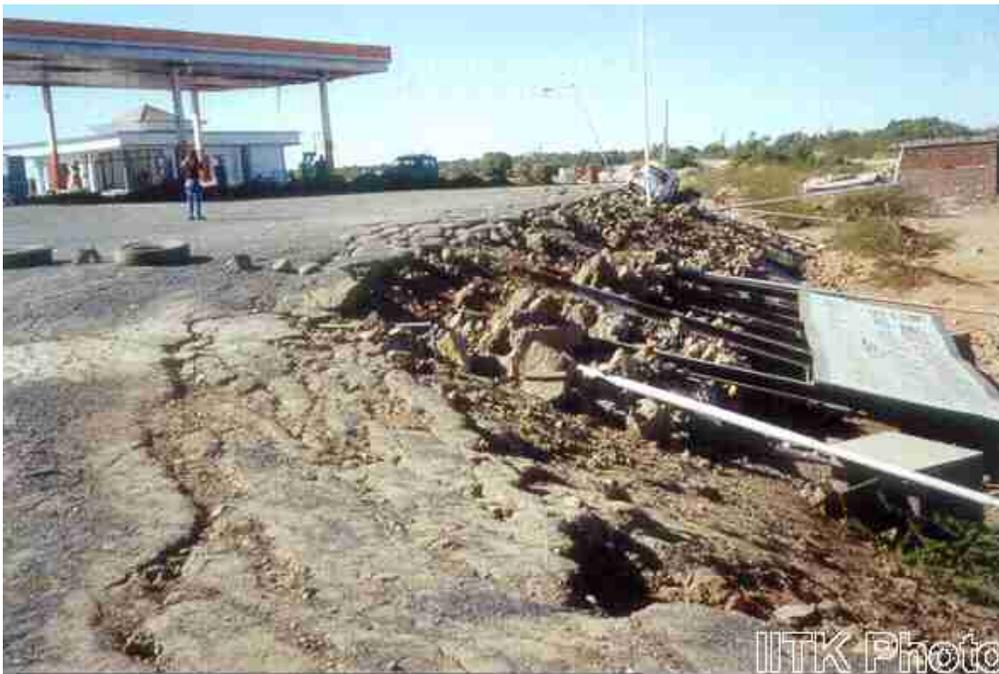
Damage to kerb of highway pavement due to lateral spreading of soil.

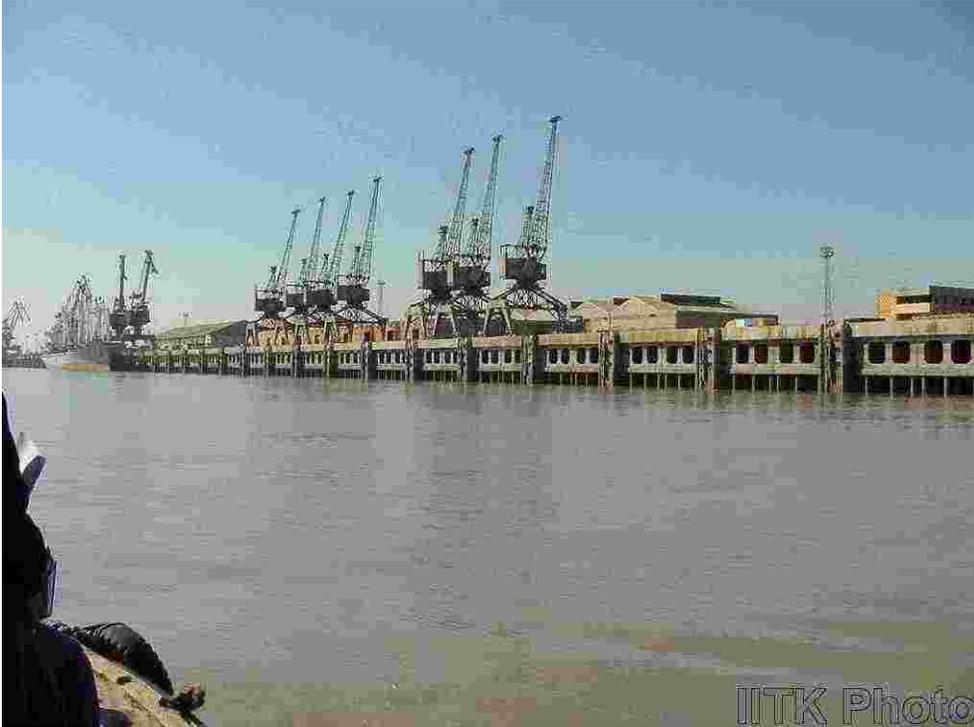
Wharf at Kandla port. Next picture shows damage to the pilons.

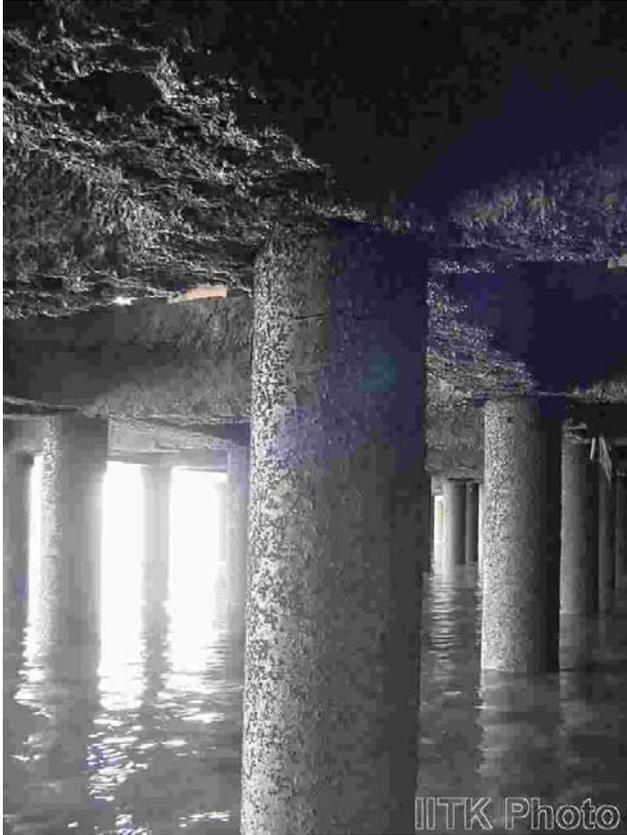
Flexural cracking of the piles at the jetty at Kandla port.

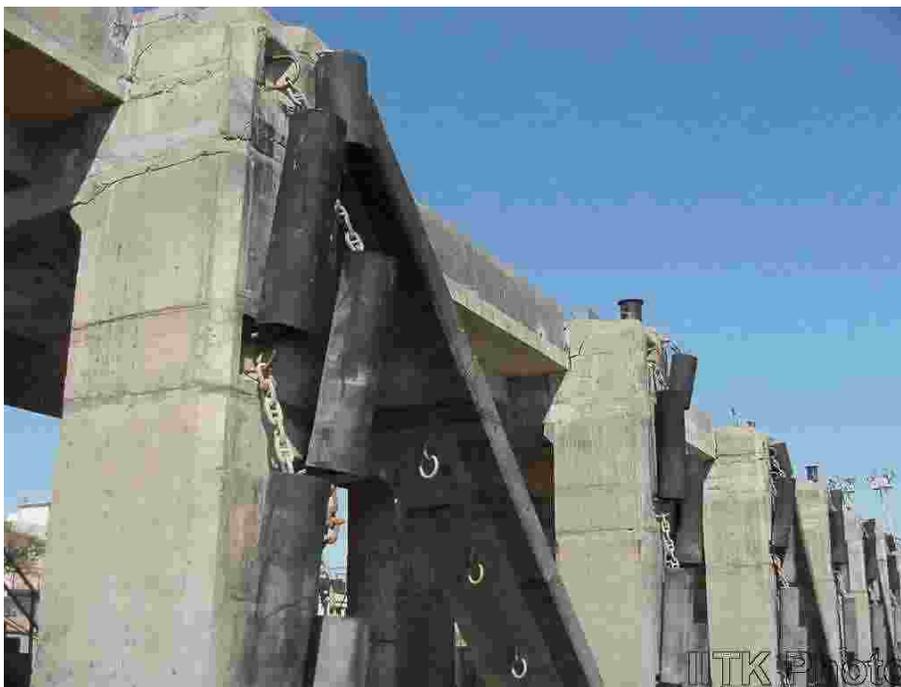
Flexural and shear cracks at the beam-column joint at the knee-bent frame supporting craft jetty at Kandla port.

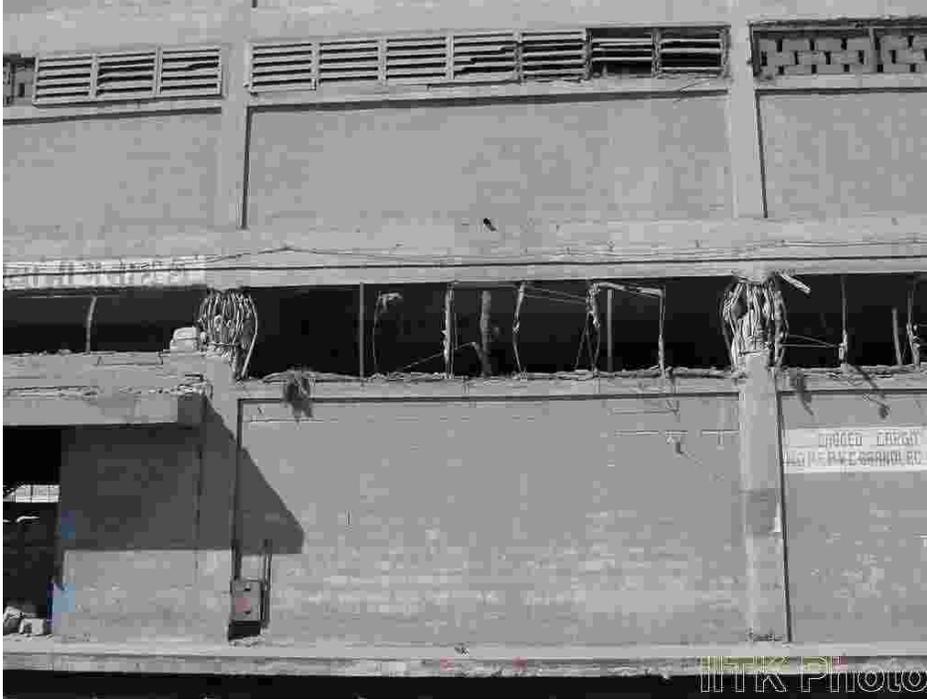
Severe damage (cyclic shear cracks) to the exterior short columns at the ventilators of the warehouse at Kandla port; opening of ties and buckling of longitudinal steel.

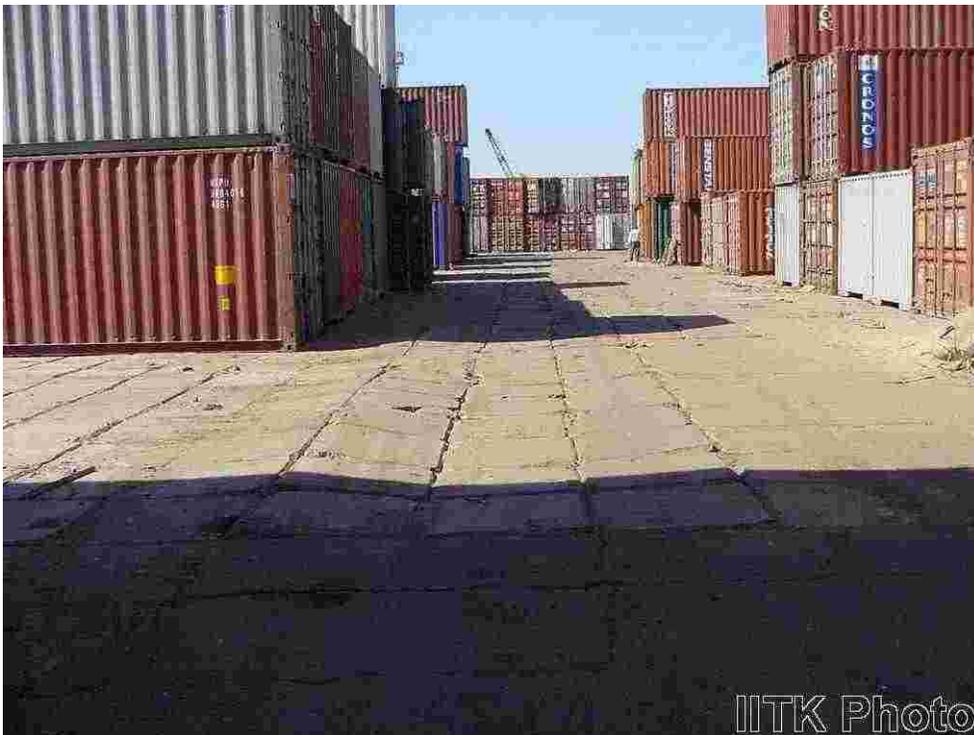
Undulations of floor tiles of the container terminal at Kandla port due to extensive liquefaction.

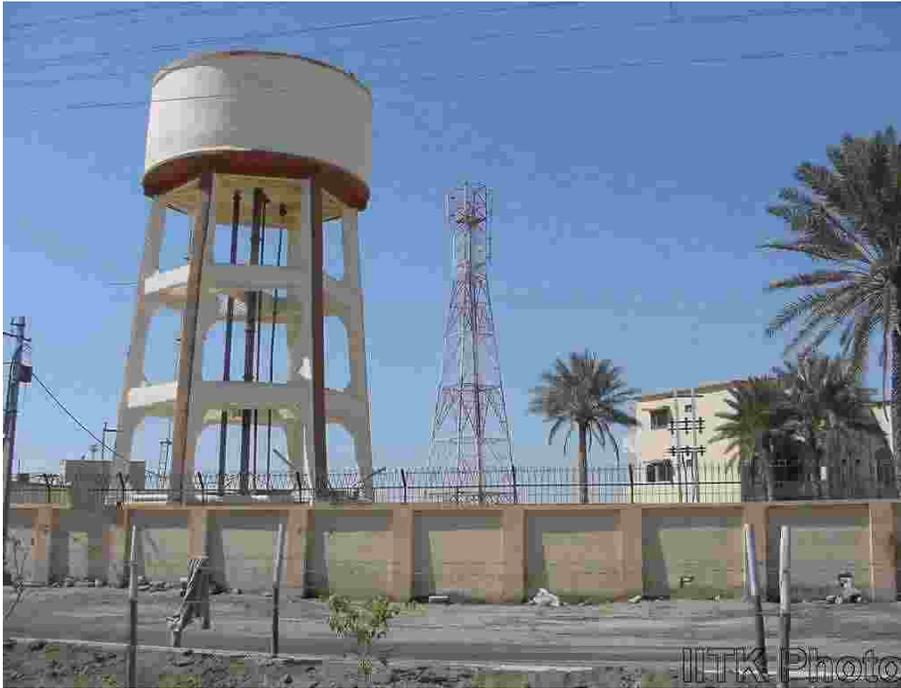
The earthquake did not cause significant damage to elevated water tanks on framed staging, steel communication towers, steel HT line towers, steel oil storage tanks, RC stacks and RC chimney stacks.

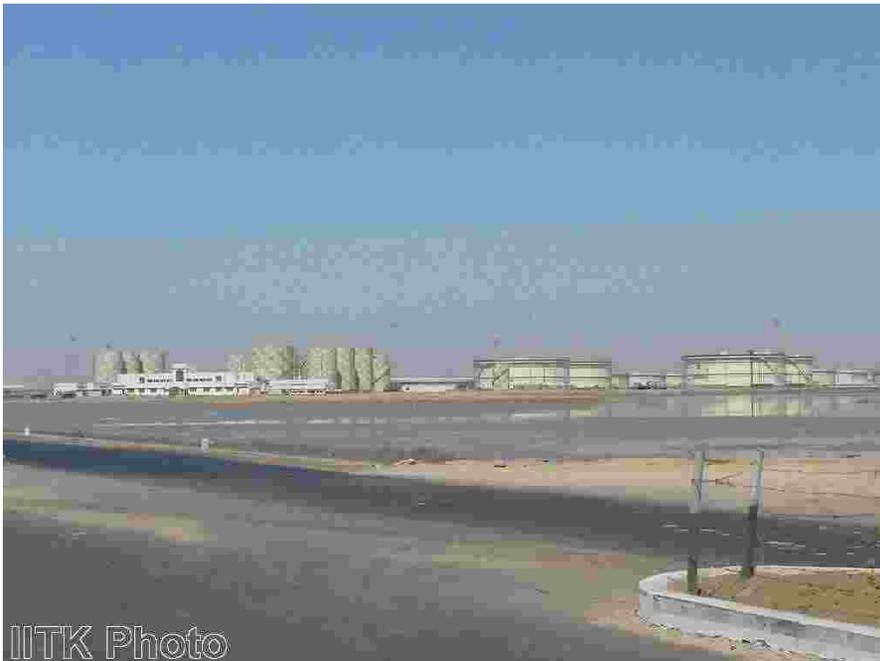
Steel oil storage tanks at Kandla port and elsewhere did well during the earthquake.

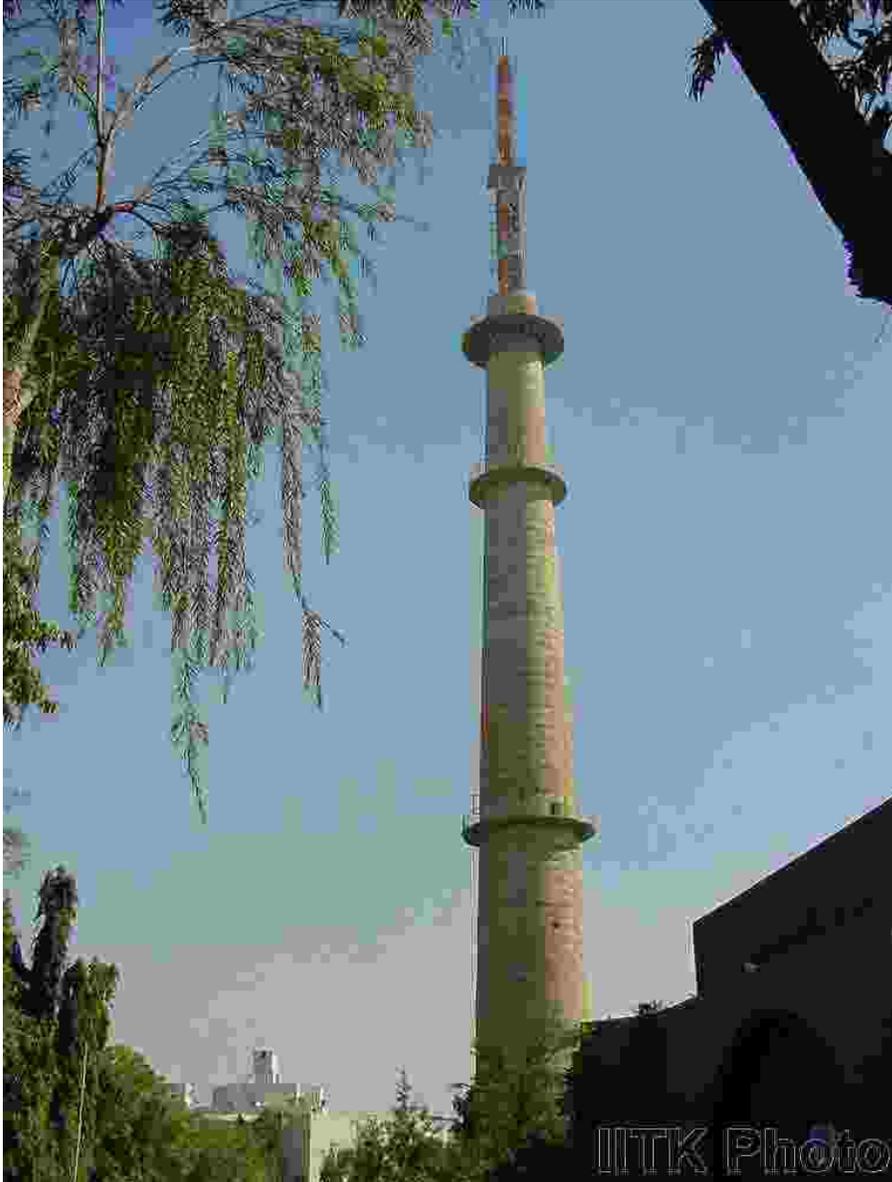
150 meter high TV transmission tower in Ahmedabad did not sustain any damage during the earthquake, even though the adjoining studio facility sustained significant damage in infill walls.

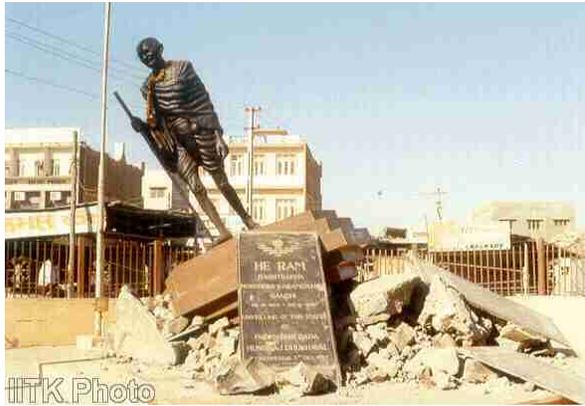
Note: The pedestal alone is shattered,  
the *Father of the Nation* is still standing.
