Some Observations on Engineering Aspects of the Jabalpur Earthquake of 22 May 1997

EERI Special Earthquake Report, EERI Newsletter, Vol.32, No.2, August 1997

Sudhir K. Jain, C.V.R. Murty and Jaswant N. Arlekar
Department of Civil Engineering
Indian Institute of Technology Kanpur

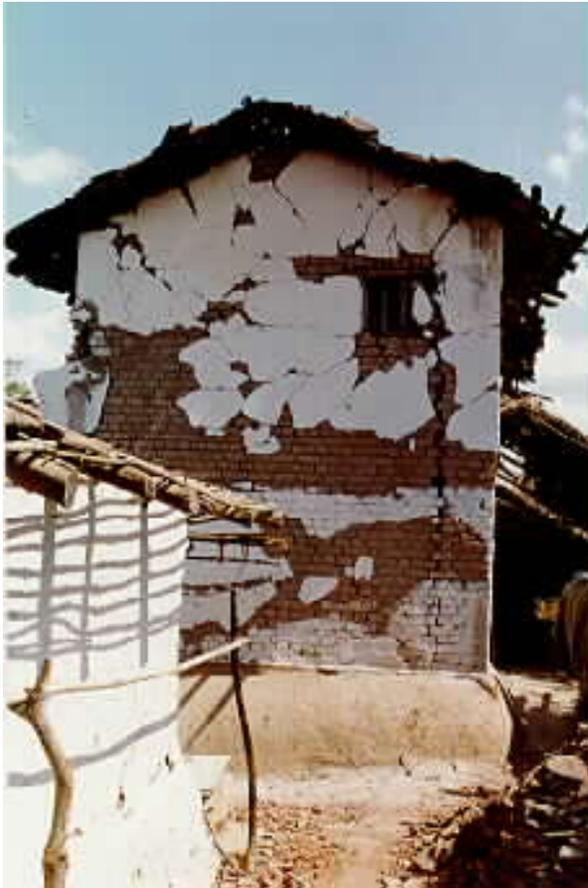
Some houses in rural as well as urban areas are built with burnt brick masonry in mud mortar. Unlike the traditional construction practice, the mud mortar is not reinforced with straw in this type of construction. Most structures of this type are one or two-story buildings whose walls are a single brick thick (230 mm). These structures sustained significant cracking (*Figure 3*).

Figure 3 - In rural and urban areas, houses are built using a single wythe of burnt brick with mud mortar. Buildings of this type suffered significant cracking.

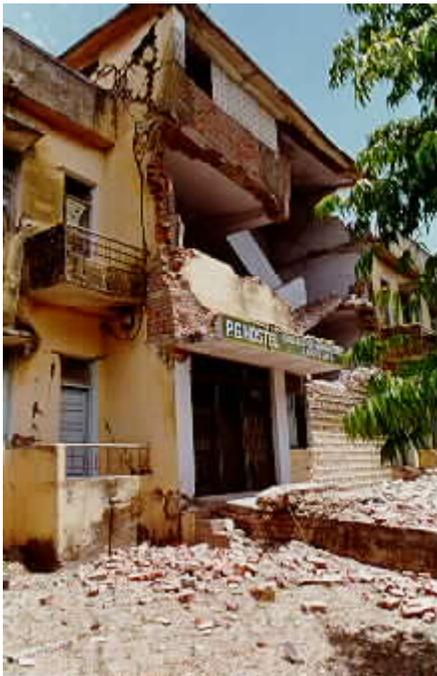
In the urban area, the maximum damage was experienced at the Jawaharlal Nehru Agricultural University campus in the Adhartal area of Jabalpur. The laboratory buildings and residential quarters were load-bearing brick masonry structures. The damage varied from traditional diagonal cracks in walls to partial collapse of buildings. The failures are attributed to the weak cement masonry walls and poor connection between the walls. The severe damage to the post-graduate students' hostel building is shown in *Figure 4*.

Figure 4 - Load-bearing brick masonry structures on the campus of Jawaharlal Nehru Agricultural University in Jabalpur were badly damaged.

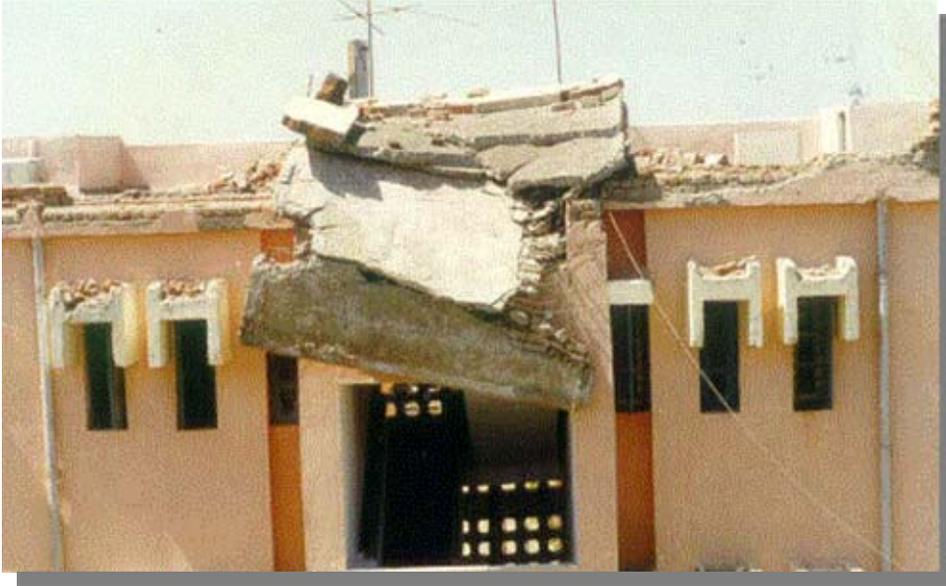
it. Vertical projections in houses (for example, chimneys) are known to be particularly prone to damage during earthquakes, and extensive damage to mummy is a clear indication of this behavior.

Figure 5 - Many staircase towers, called "mumty," which project about 2 m above the surrounding construction in masonry houses, collapsed.

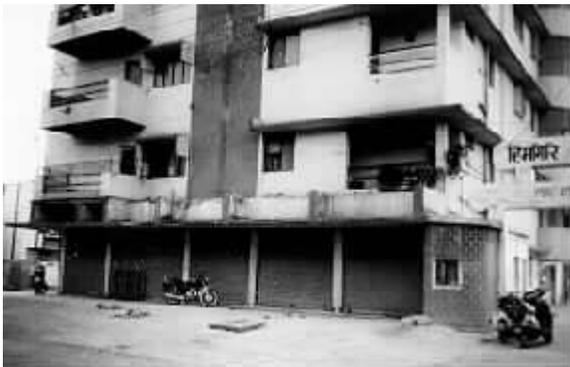
1. Hingiri Apartment in Jabalpur. This is a five-story RC frame building with brick infill located in the "Wright Town" area of Jabalpur. There are shops on two adjacent faces of the building at the ground story with brick masonry partition walls (*Figure 6*). The remaining corner of the building on the ground story is meant for parking and hence is "open," i.e., with no walls. The columns in the ground story in the parking area were badly damaged; shear failure of columns, opening of transverse ties, and buckling of longitudinal reinforcement bars occurred. There was only nominal damage in the upper stories consisting of cracks in the filler walls. This is a clear case where the columns were damaged as a result of the "soft first-story" effect. Moreover, loading on these columns may have increased through the torsion effect caused by higher lateral stiffness on the other side due to filler walls in the shops.

Figure 6 - The columns in the ground story parking area of the Hingiri Apartment Buildings, a five-story reinforced concrete building with brick infill, suffered shear failure.

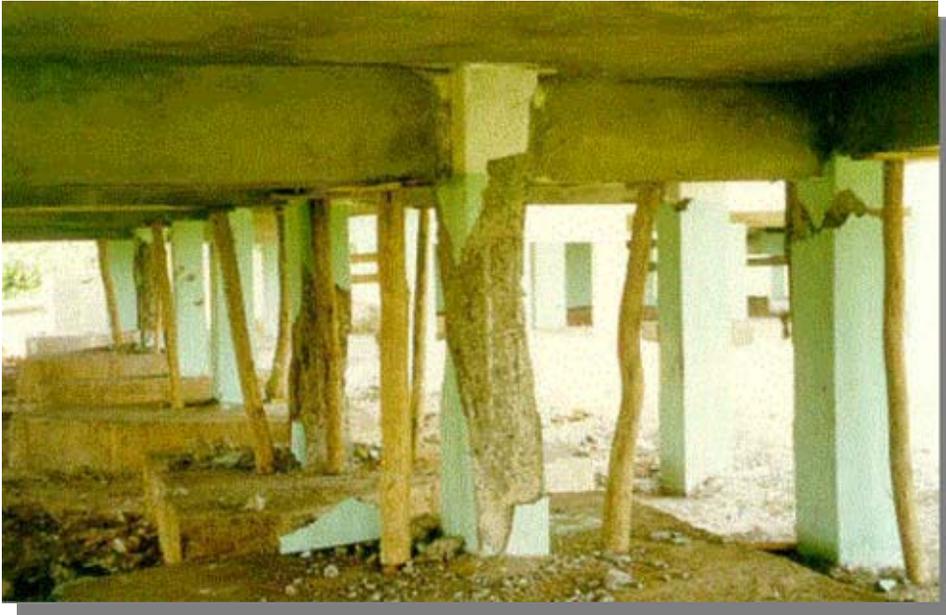
3. Youth Hostel Building in Jabalpur. This is a C-shaped RC frame building built by the Central Public Works Department but not then occupied. It is located in the Ranital area of Jabalpur. The building is located where there originally was a pond. It is supported on piles, pile caps, and stilt columns. Above the stilt columns are two stories with brick masonry infill. The damage is concentrated only in the stilt columns; severe cyclic shear cracking in many columns was observed (*Figure 7*). The soft story at the stilt level is clearly the primary reason for such severe damage.

Figure 7 - Built on piles and stilt columns on the site of a previous pond, the new, still unoccupied Youth Hostel in Jabalpur suffered serious damage to its stilt columns.

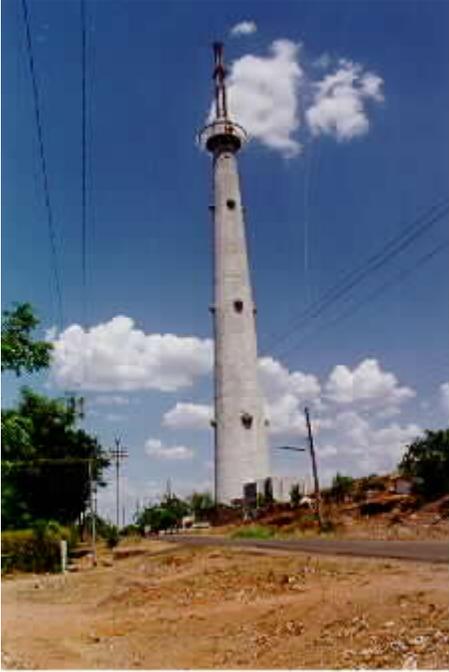
A 225m high TV tower (lower 175m RC shaft; upper 50m steel truss) located in the Katanga area of Jabalpur was built during 1989-1992 (*Figure 8*). Careful observation did not reveal any earthquake-induced distress. Minor cracks were seen at the junction of the concrete balcony and the concrete shaft, which may have been construction-related and therefore existed prior to the earthquake.

Figure 8 - No damage was observed to the 225 m high RC and steel TV tower in Katanga.

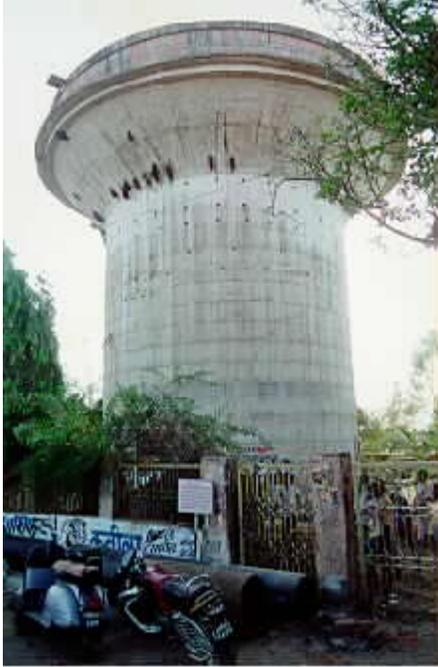
There are a number of elevated water tanks in the area for storage and distribution of drinking water. The majority of the elevated water tank structures are supported on reinforced concrete frame stagings, which did not suffer any damage. However, a 500,000 gallon-capacity shaft-supported tank (*Figure 9*), located in the Gadha area of Jabalpur, sustained horizontal cracking at the ground level and diagonal cracking in two directions at about every 15° angle subtended at the center. The horizontal cracking was restricted to two circumferentially equal segments. The tank is supported on piles in black cotton soil.

Figure 9 - Horizontal and diagonal cracking occurred at the base of the 500,000 gallon shaft-supported water tank.

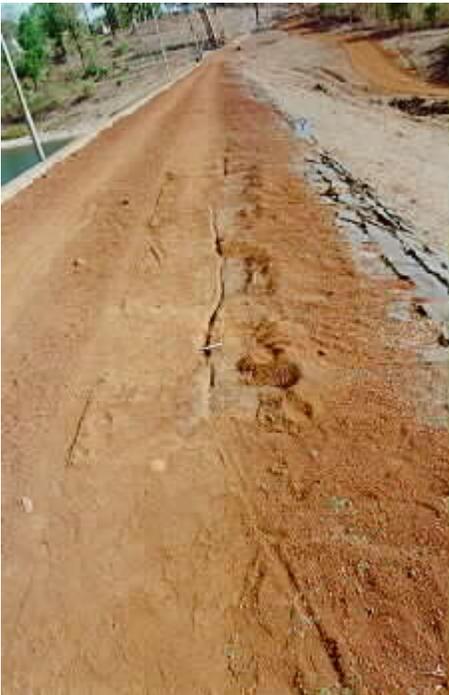
There are quite a few irrigation structures in the area. The concrete gravity dam at Burgi did not show any damage. However, a number of earthen dams located in the districts of Jabalpur and Mandla were reported to have developed longitudinal cracks. The team visited two such dams: the 16.9-m-high earth dam at Mahgaon (30 km east from Jabalpur), and the 29-m-high Matiyari dam (95 km southeast of Jabalpur). Both suffered longitudinal cracks along the crest and the down-stream face (*Figure 10*). These dams are made of the locally available black cotton soil, which is known for its high shrinkage characteristics in dry conditions. The intensity of shaking at village Mahgaon was about VII on the MSK scale, while that at Matiyari dam was about VI.

Figure 10 - Longitudinal cracks appeared along the crest and downstream face of several earthen dams.
