**PRELIMINARY REPORT ON THE IIT KANPUR RECONNAISSANCE SURVEY OF
THE SIKKIM (INDIA-NEPAL BORDER REGION) EARTHQUAKE OF SEPTEMBER 18, 2011**

Department of Civil Engineering
Indian Institute of Technology Kanpur, India

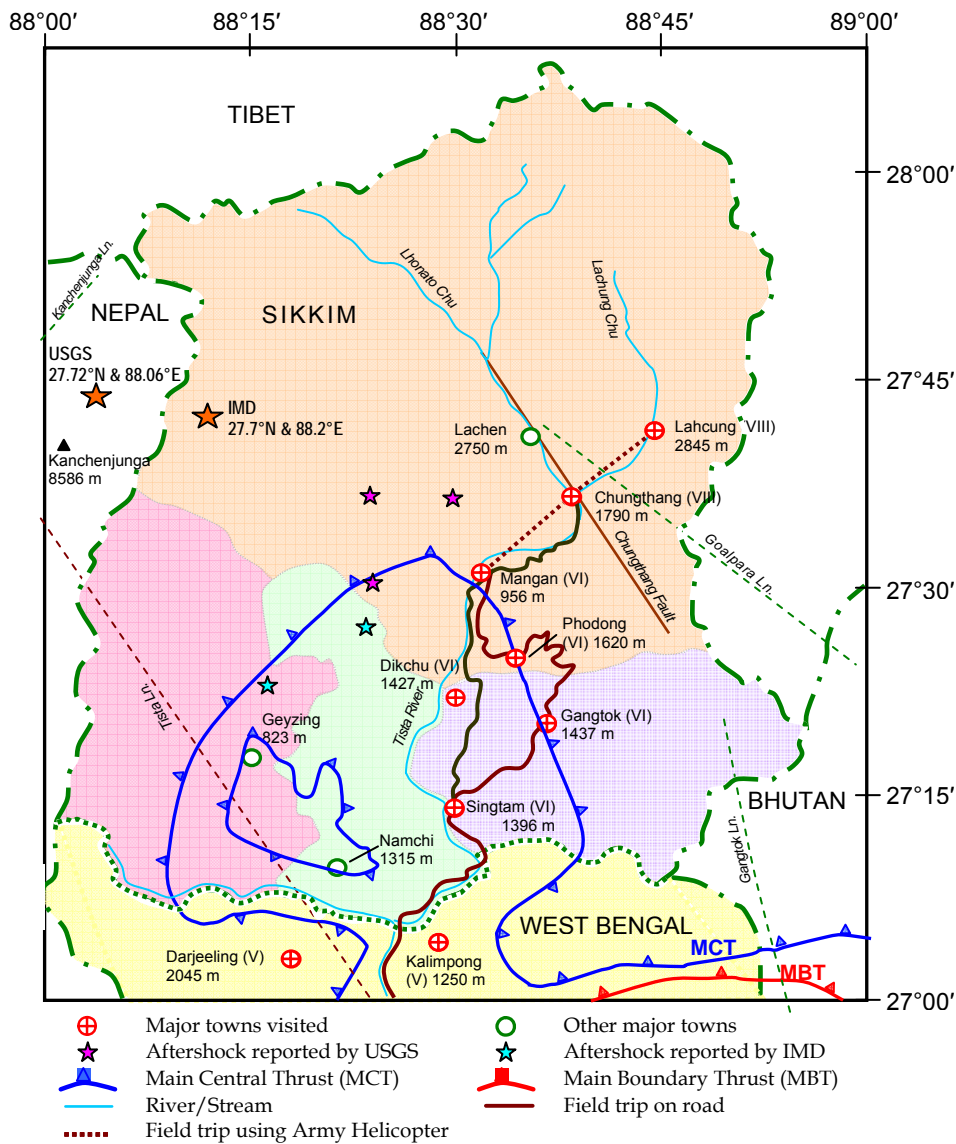
Fig. 1. Location of epicenter of the earthquake and its aftershocks, Main Central Thrust fault (MCT), Main Boundary Thrust fault (MBT) and the towns visited in India.

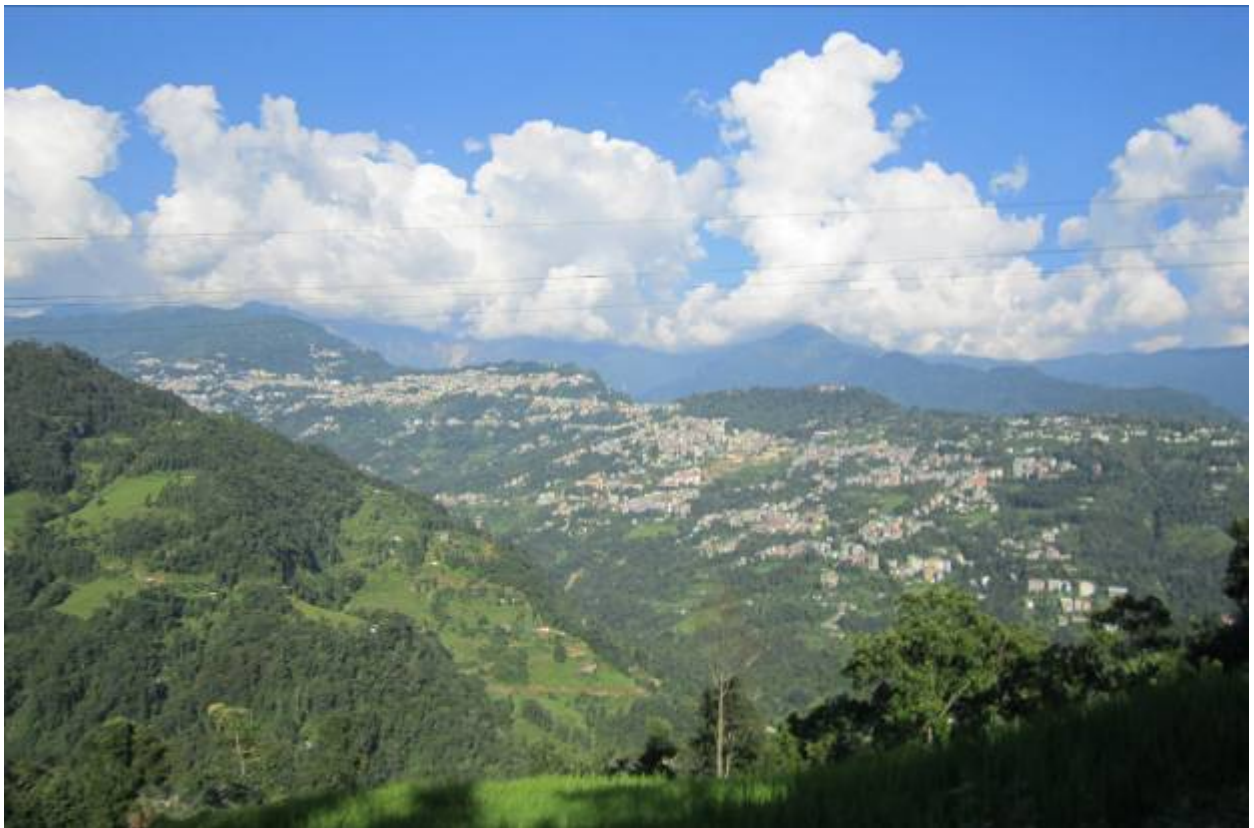
Fig. 2. Building stock in Gangtok city (Photo: Goutam Mondal)

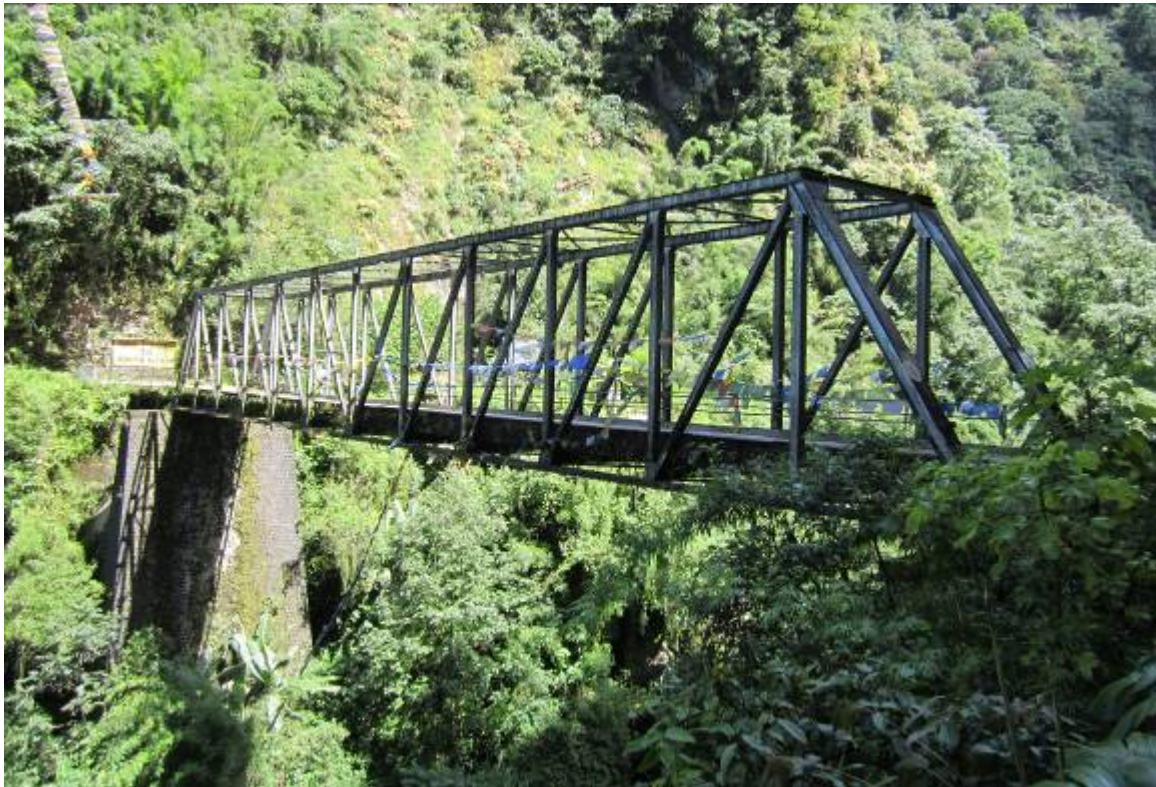
It was rather perplexing to discover that a great majority of both governmental and private RC-frame buildings seriously lacked earthquake-resistant features which are so essential for a satisfactory seismic performance in the design level shaking. Most of the RC buildings in Gangtok and Chungthang suffered varying degree of damage, from moderate to complete collapse during this earthquake (Fig. 10 to 12). Extensive damage to school and hospital buildings was reported in the worst affected regions of Sikkim and North Bengal (Fig. 13 and 14). Many unique and inherently poor construction features such as weak and very slender partition walls in brick/block masonry or in lightly reinforced/plain concrete, extended floor plans in upper stories supported on cantilevered beams and slabs, construction on sloped ground, unstable slopes, weak retaining walls, poor construction material etc., significantly added to the seismic vulnerability of structures. The area has a number of highway and pedestrian bridges on rivers, rivulets, and gorges. Only minor damage to a few highway bridges was noticed in the areas visited (Fig. 15 to 17).

Fig. 17. Undamaged steel truss bridge connecting West Sikkim and North Sikkim (Photo: Vaibhav Singhal)

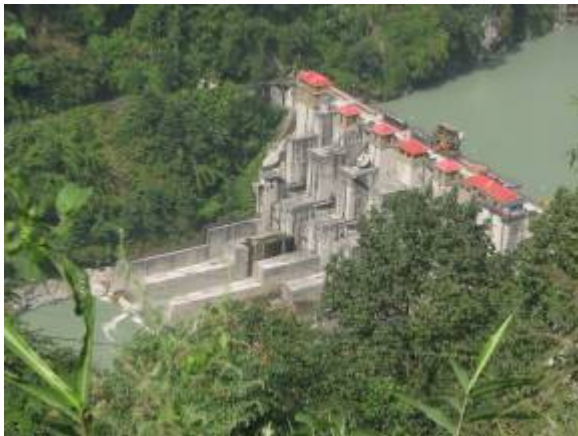
National Hydroelectric Power Corporation (NHPC) has constructed concrete gravity dams over Teesta River near Dikchu (Project Teesta-V: 513 Mega Watt) and Rangit River near Rangit Nagar (Project Rangit: 60 Mega Watt). Project Rangit is in operation since last 10 years and Project Teesta-V was completed recently and is in operation since last two years (Fig. 20). No damage due to earthquake shaking or landslide was observed in the body of any of these dams. The hydroelectric power stations performed extremely well; the only visible damage was minor cracking in masonry infill walls at various locations in the power stations. Severe landslides and ground deformations were observed near both the dam sites that resulted in accumulation of excessive debris and silt in the reservoir and on the downstream of the dam (Fig. 20d and 20e).

Fig. 20. Concrete gravity dams in operation at (a) Project Teesta-V, and (b) Project Rangit, (c) damaged electrical transformer at Teesta-V dam site, (d) ground deformation at Teesta-V dam site, and (e) accumulation of excessive debris and silt in reservoirs due to landslides (Photo: Kaustubh Dasgupta)
