# QUICK REPORT ON THE IIT KANPUR RECONNAISSANCE SURVEY OF THE SIKKIM (INDIA-NEPAL BORDER REGION) EARTHQUAKE OF SEPTEMBER 18, 2011

Department of Civil Engineering  
Indian Institute of Technology Kanpur, India

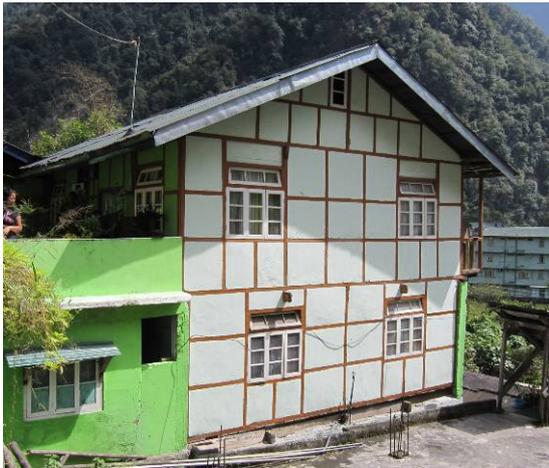
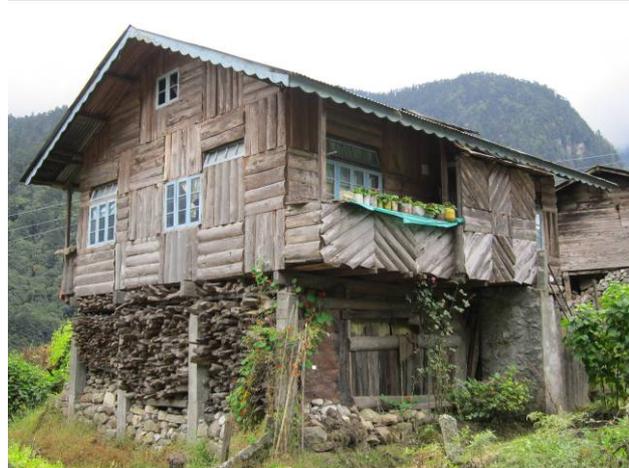
It was common practice in Sikkim to construct residential buildings using bamboo/wood, until the economic development aided by tourism industry got boosted in early nineties. These traditional constructions (*Shee-khim* and *Ikra* type) have better earthquake resistance as observed in the present and past earthquakes (Fig. 9).

**Fig. 9.** Traditional construction type (a) Ikra house (Photo: Vaibhav Singhal) (b) Shee-Khim house (Photo: Neha Parool)

Traditional construction like *Shee-khim* and *Ikra* type performed well as expected and needs to be reinstated. Buddhist temples being old and weak were deficient in strength and needs to be safeguarded against future tremors. Despite the available knowledge base, it is unfortunate that society is not adequately prepared due to lack of implementation and therefore the seismic risk in the region has risen to unacceptable levels which may lead to a large-scale disaster, if not mitigated.

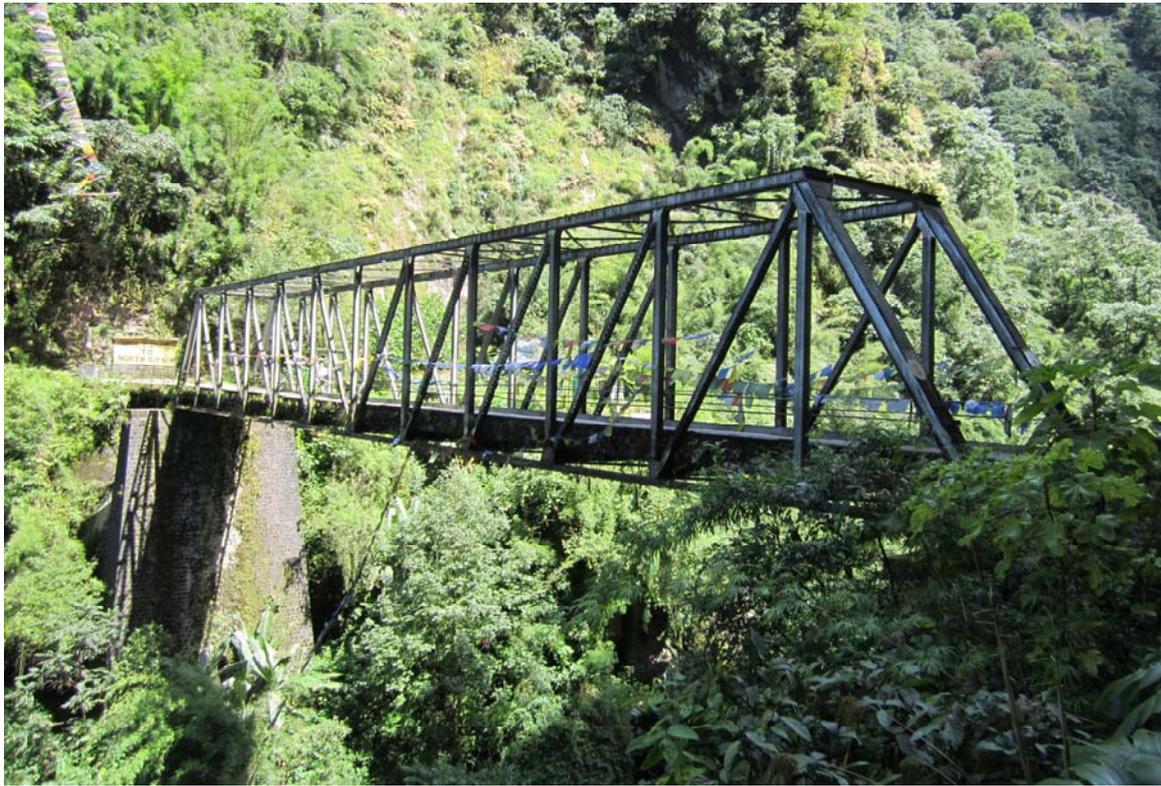
It was rather perplexing to discover that a great majority of both governmental and private RC-frame buildings seriously lacked earthquake-resistant features which are so essential for a satisfactory seismic performance in the design level shaking. Most of the RC buildings in Gangtok and Chungthang suffered varying degree of damage, from moderate to complete collapse during this earthquake (Figs. 10 to 12). Extensive damage to school and hospital buildings was reported in the worst affected regions of Sikkim and North Bengal (Figs. 13 and 14). Many unique and inherently poor construction features such as weak and very slender partition walls in brick/block masonry or in lightly reinforced/plain concrete, extended floor plans in upper stories supported on cantilevered beams and slabs, construction on sloped ground, unstable slopes, weak retaining walls, poor construction material etc., significantly added to the seismic vulnerability of structures. The area has a number of highway and pedestrian bridges on rivers, rivulets, and gorges. Only minor damage to a few highway bridges was noticed in the areas visited (Figs. 15 to 17).

**Fig. 17.** Undamaged steel truss bridge connecting West Sikkim and North Sikkim (Photo: Vaibhav Singhal)

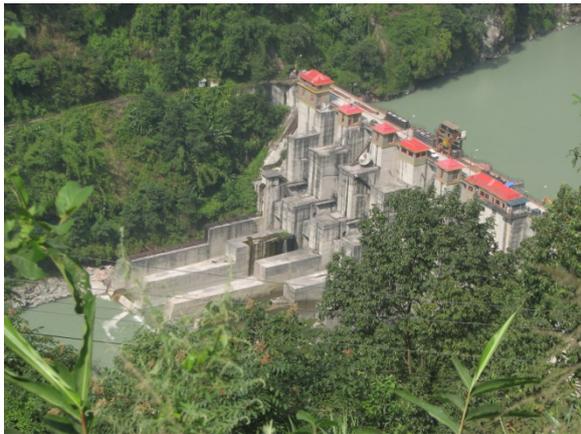
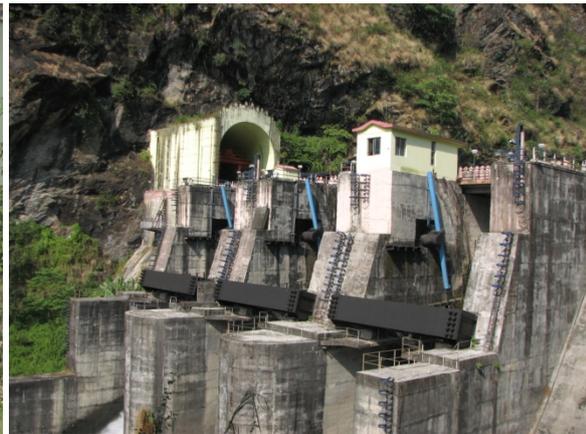
National Hydroelectric Power Corporation (NHPC) has constructed concrete gravity dams over Teesta River near Dikchu (Project Teesta-V: 513 Mega Watt) and Rangit River near Rangit Nagar (Project Rangit: 60 Mega Watt). Project Rangit is in operation since last 10 years and Project Teesta-V was completed recently and is in operation since last two years (Fig. 20). No damage due to earthquake shaking or landslide was observed in the body of any of these dams. The hydroelectric power stations performed extremely well; the only visible damage was minor cracking in masonry infill walls at various locations in the power stations. Severe landslides and ground deformations were observed near both the dam sites that resulted in accumulation of excessive debris and silt in the reservoir and on the downstream of the dam (Figs. 20d and 20e).

**Fig. 20.** Concrete gravity dams in operation at (a) Project Teesta-V, and (b) Project Rangit, (c) damaged electrical transformer at Teesta-V dam site, (d) ground deformation at Teesta-V dam site, and (e) accumulation of excessive debris and silt in reservoirs due to landslides (Photo: Kaustubh Dasgupta)
