## The *M* 6.9 Sikkim (India–Nepal Border) earthquake of 18 September 2011

**The *M* 6.9 Sikkim earthquake of 18 September 2011 was a remarkable event in the long history of the Himalayan earthquakes which presented a unique opportunity to reflect on the unacceptable rising trend of the seismic risk in the hilly regions. Many dramatic collapses and damages were disproportionate to the observed intensity of shaking and can be attributed to poor construction material, deficient workmanship and lack of compliance with seismic codes and earthquake-resistant construction practices. Many private and governmental buildings were constructed neglecting the seismic design and detailing requirements necessary in the Zone IV of the Indian seismic code IS 1893. The traditional construction practices prevalent in the area performed rather satisfactorily due to their inherent earthquake-resistant features. Old monastery temple structures of distinctive construction in stone masonry and timber suffered varying degree of damage to masonry walls ranging from minor damages to partial collapse. This event should be regarded as a preview of what is likely to happen in the event of a greater shaking ex

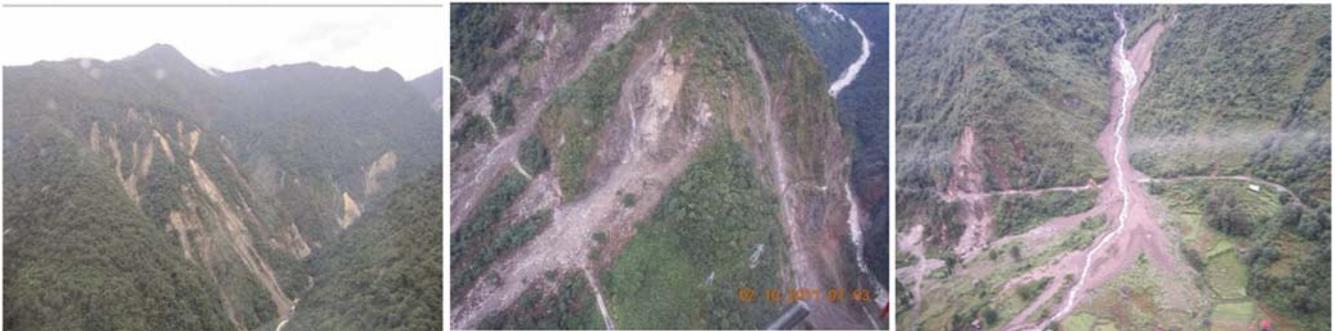
**Figure 3.** Aerial photographs showing typical landslides enroute from Mangan to Chungthang and Lachung.

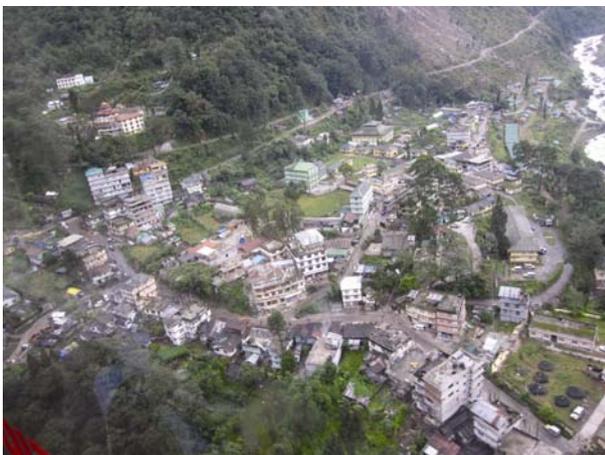
**Figure 4.** Aerial photograph of Chungthang town showing surrounding mountainous terrain and river valley.

Chunghang and Lachung in North Sikkim are two major towns which have suffered maximum damage caused by landslides and poor construction of buildings combined with intense shaking. The aerial photograph in Figure 4 shows the location of Chunghang town surrounded by mountainous terrain and river valley. The maximum intensity of shaking was observed to be VIII. In Lachung, rockslides and mudslides after two days of
