## M 6.7, 4 January 2016 Imphal earthquake: dismal performance of publicly-funded buildings

Durgesh C. Rai<sup>1,\*</sup>, Hemant B. Kaushik<sup>2</sup> and Vaibhav Singh<sup>3</sup>

**Keywords:** Earthquake effects, reinforced concrete frame, seismic vulnerability.

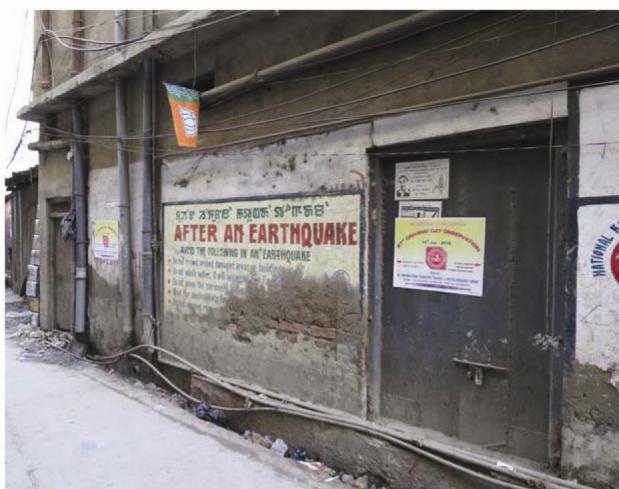
**Figure 14.** A message on a wall facing street in Imphal reminds that there is earthquake awareness in the region due to frequent shaking.

in Manipur along with superior quality of materials and workmanship. Despite considerable awareness in the public about earthquakes and associated risks (e.g. the old message on a wall shown in Figure 14), it appears that the public, as well as the administrators, chose to ignore the threat and continued to build structures which were not earthquake-resistant. Such ignorance has already been reported from other areas of north-eastern India that have also suffered huge loss during recent earthquakes<sup>14,15</sup>. Due to such negligence, many publicly-funded buildings suffered severe damage even during the moderate level earthquake of 4 January 2016. The damages to these structures under shaking intensity of VI–VII are not only ironic but also represent the utter betrayal of the public
